ECO INSPECTION CERTIFICATE

Order ID : 43644

121 Points Vehicle Inspection Certificate

Maruti Suzuki Alto 800 LXI, 2016

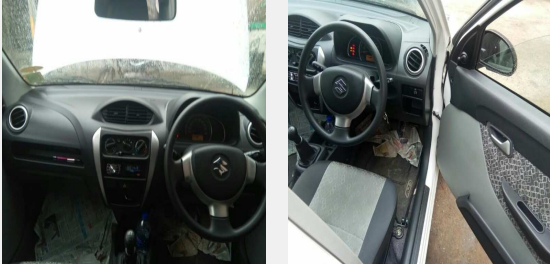
INSPECTION CHECKPOINTS	SCORE(X/10)	REMARKS/COMMENTS	OPTIONAL SPEND EST. (RS)
DOOR PANEL	6	SAFE	0
DOOR HINGES	6	GOOD	0
CARPET & FLOOR MAT	7	GOOD CONDITION	0
SEAT & SEAT BELT	7	WELL	0
DASHBOARD & INSTRUMENT PANEL	6	WORKING	0
HORN	7	GOOD	0
SPEAKERS & MUSIC SYSTEM	6	WORKING	0
HANDBRAKE	7	GOOD	0
STEERING-MOUNTED CONTROLS	7	WELL	0
PEDALS	7	SAFE	0
CENTRAL LOCK	7	GOOD	0
A/C VENTS & HEATER	7	WORKING	0
CUP HOLDERS	6	GOOD	0
NAVIGATION (NO)	10		0
ODOMETER	6	GOOD	0
POWER WINDOWS (YES)	6	GOOD	0
HAZARD LIGHT	6	WORKING	0

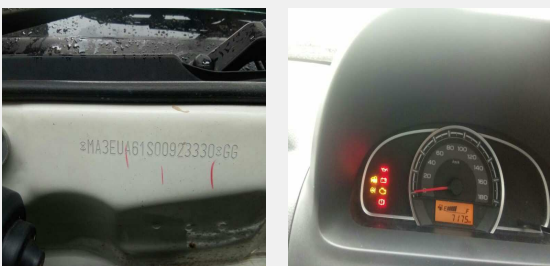
INSPECTION CHECKPOINTS	SCORE(X/10)	REMARKS/COMMENTS	OPTIONAL SPEND EST. (RS)
STEERING PERFORMANCE	6	GOOD	0
BRAKE PERFORMANCE	7	WELL	0
CLUTCH PERFORMANCE	7	GOOD	0
ENGINE NOISE	7	LESS NOISE	0
IGNITION SYSTEM	7	SMOOTH	0
SUSPENSION PERFORMANCE	7	SAFE	0
SUSPENSION FRONT SHOCKS	7	SAFE	0
SUSPENSION REAR SHOCKS	7	GOOD	0
TRANSMISSION ENGAGE	7	SMOOTH	0
CRUISE CONTROL (NO)	10		0
REAR PARKING SENSORS (NO)	10		0
REAR VIEW CAMERA (NO)	10		0

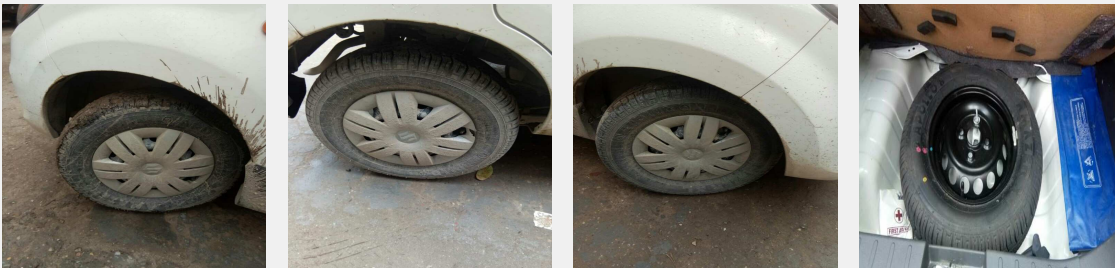
INSPECTION CHECKPOINTS	SCORE(X/10)	REMARKS/COMMENTS	OPTIONAL SPEND EST. (RS)
TYRES	6	GOOD	0
SPARE TYRE (YES)	6	GOOD	0
WHEEL ASSEMBLY (ALLOY RIM)	7	GOOD	0
