ECO INSPECTION CERTIFICATE

Order ID : 43922

121 Points Vehicle Inspection Certificate

Hyundai I20 ASTA 1.2, 2011

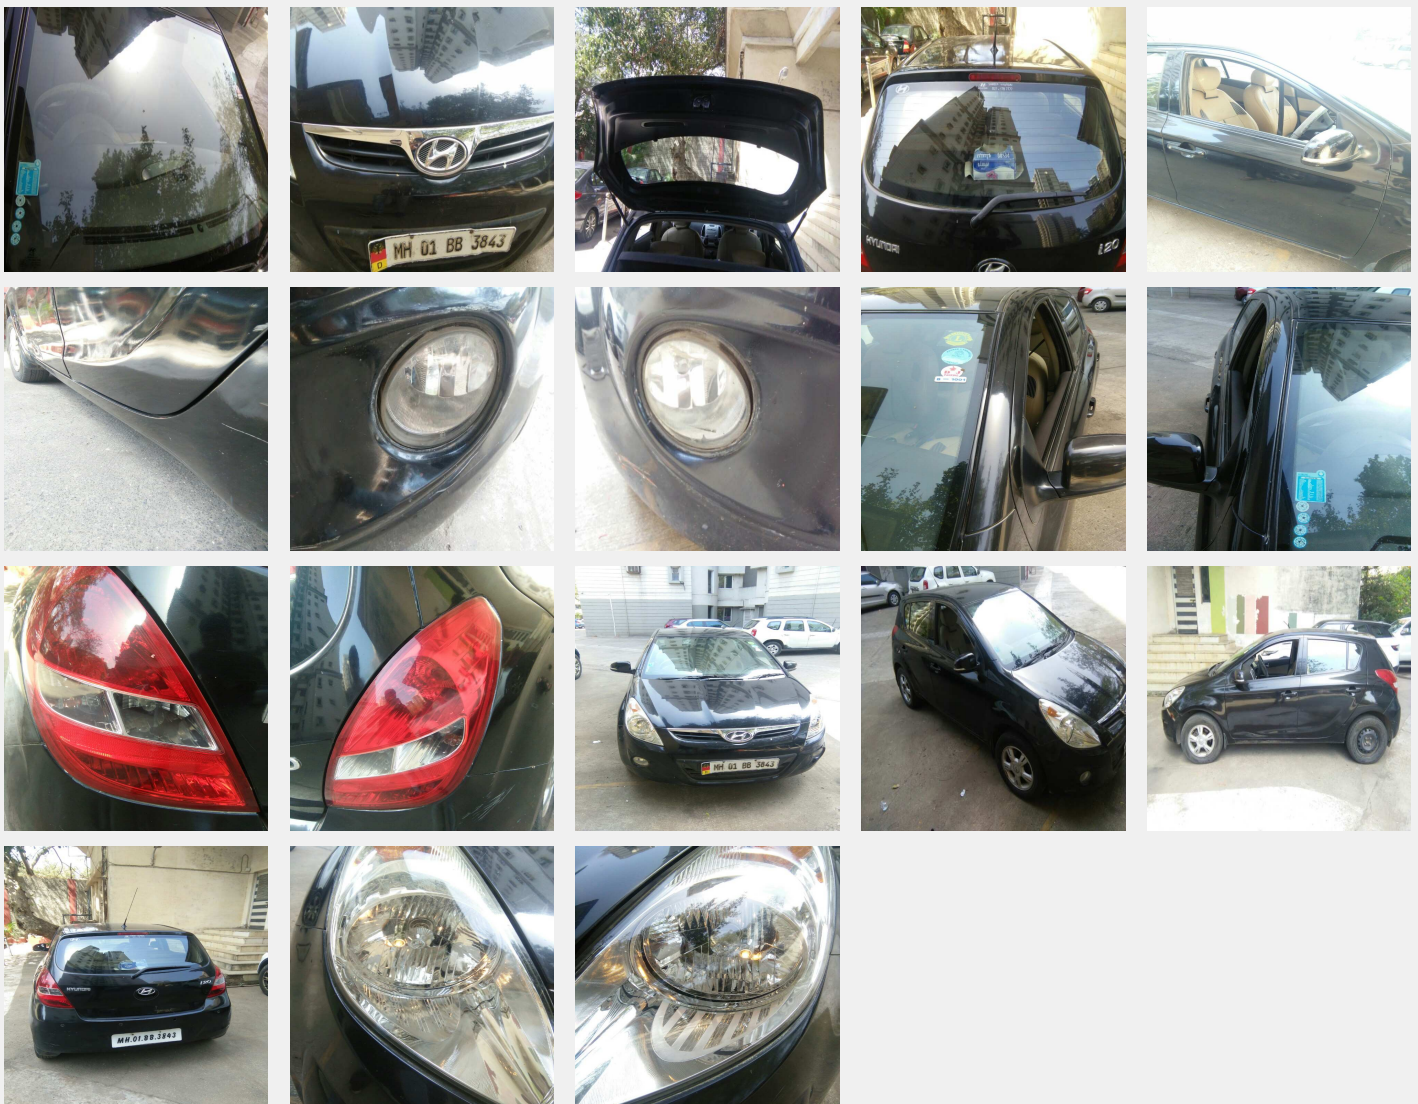
IMAGES

INSPECTION CHECKPOINTS	SCORE(X/10)	REMARKS/COMMENTS	OPTIONAL SPEND EST. (RS)
RH QUARTER PANEL	3	PAINTING REQUIRE	2500
RH RUNNING BOARD	5	PAINTING REQUIRE	2500
RH REAR DOOR	4	PAINTING REQUIRE	2500
RH FENDER	4	PAINTING REQUIRE	2500
ROOF (REGULAR)	4	DENT AVAILABLE	2500
