ECO INSPECTION CERTIFICATE

Order ID : 44043

121 Points Vehicle Inspection Certificate

Maruti Suzuki Wagon R LX, 2007

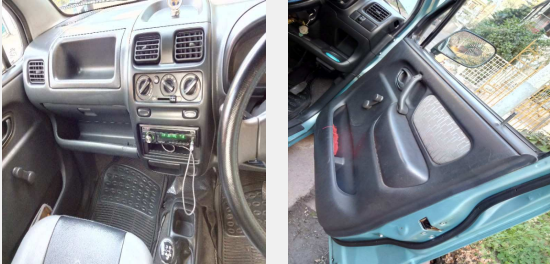
NEED ATTENTION ⚠️

INSPECTION CHECKPOINTS	SCORE(X/10)	REMARKS/COMMENTS	OPTIONAL SPEND EST. (RS)
DOOR PANEL	6	OK	0
DOOR HINGES	6	OK	0
CARPET & FLOOR MAT	7	OK	0
SEAT & SEAT BELT	7	OK	0
DASHBOARD & INSTRUMENT PANEL	7	OK	0
HORN	6	OK	0
SPEAKERS & MUSIC SYSTEM	7	OK	0
HANDBRAKE	6	OK	0
STEERING-MOUNTED CONTROLS	6	OK	0
PEDALS	7	OK	0
CENTRAL LOCK	6	OK	0
A/C VENTS & HEATER	6	OK	0
CUP HOLDERS	6	OK	0
ODOMETER	6	OK	0
POWER WINDOWS (YES)	6	OK	0
HAZARD LIGHT	6	OK	0
NAVIGATION (YES)	5	NOT AVAILABLE	0

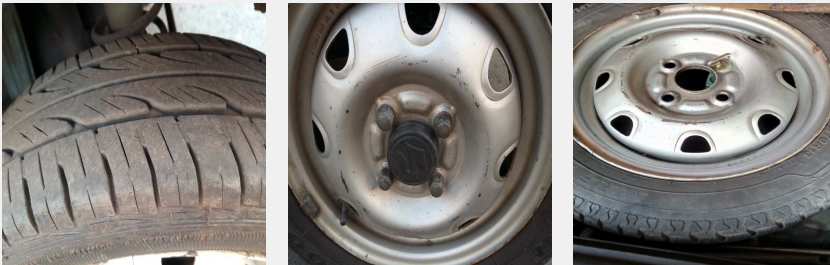
NEED ATTENTION ⚠

INSPECTION CHECKPOINTS	SCORE(X/10)	REMARKS/COMMENTS	OPTIONAL SPEND EST. (RS)
TYRES	7	OK	0
SPARE TYRE (YES)	6	OK	0
WHEEL ASSEMBLY (STEEL RIM)	6	OK	0

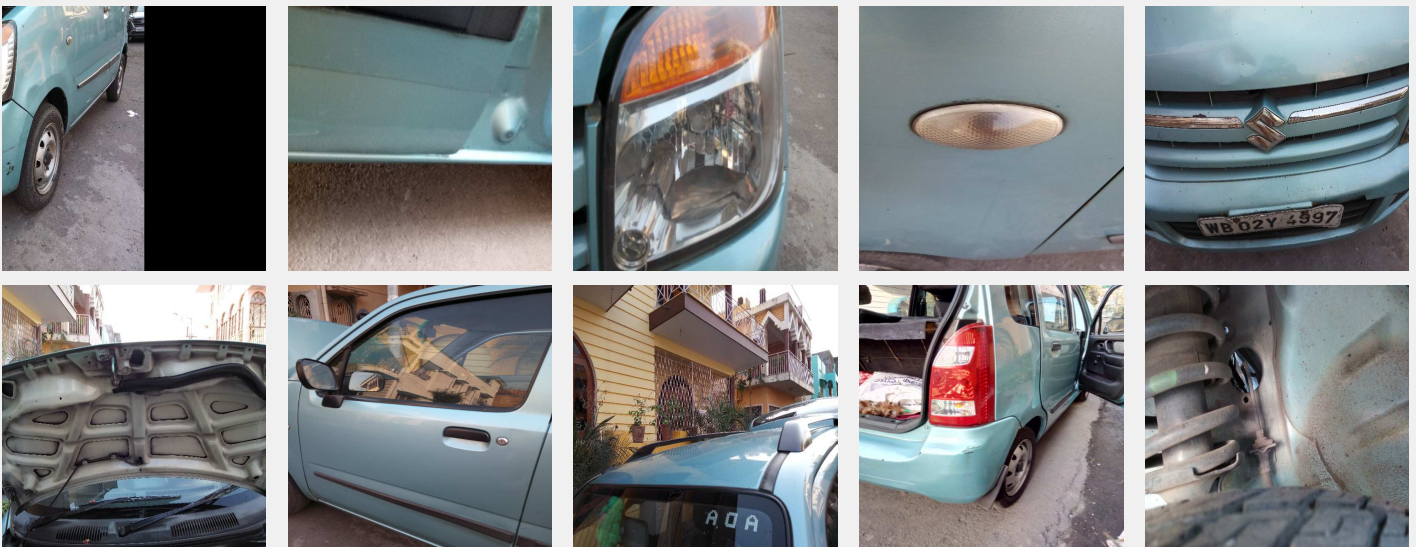
NEED ATTENTION ⚠️

INSPECTION CHECKPOINTS	SCORE(X/10)	REMARKS/COMMENTS	OPTIONAL SPEND EST. (RS)
LH FENDER	5	DENT	1000
LH QUARTER PANEL	5	DENT	1500
REAR BUMPER	5	DENT	1500
RH FENDER	5	DENT	1500
PAINT CONDITION	5	REQUIRED	20000
