ECO INSPECTION CERTIFICATE

121 Points Vehicle Inspection Certificate

Royal Enfield Classic 350CC, 2013

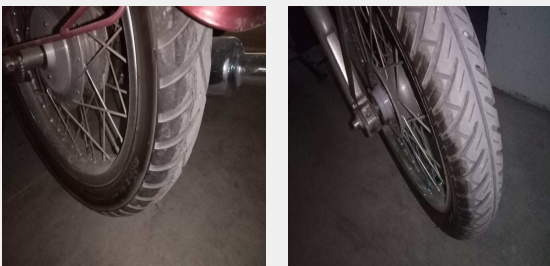
INSPECTION CHECKPOINTS	SCORE(X/10)	REMARKS/COMMENTS	OPTIONAL SPEND EST. (RS)
FRONT TYRE CONDITION & AIR PRESSURE	8		0
REAR TYRE CONDITION & AIR PRESSURE	8		0
WHEEL SPOKES FRONT	8		0
WHEEL SPOKES REAR	8		0
WHEEL RIM FRONT	8		0
WHEEL RIM REAR	8		0
WHEEL BEARINGS FRONT	8		0
WHEEL BEARINGS REAR	8		0
WHEEL SEALS FRONT	8		0
WHEEL SEALS REAR	8		0
BRAKE FUNCTION FRONT	8		0
BRAKE FUNCTION REAR	8		0
BRAKES CONDITION FRONT	8		0
BRAKES CONDITION REAR	8		0

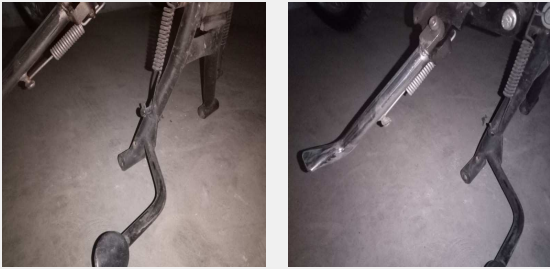
INSPECTION CHECKPOINTS	SCORE(X/10)	REMARKS/COMMENTS	OPTIONAL SPEND EST. (RS)
CENTRE STAND CONDITION	8		0
CENTRE STAND RETENTION	8		0
SIDE STAND CONDITION	8		0
SIDE STAND RETENTION	8		0
