# ECO INSPECTION CERTIFICATE

Order ID : 45881

121 Points Vehicle Inspection Certificate

## Fiat Punto EMOTION PACK 1.4, 2010

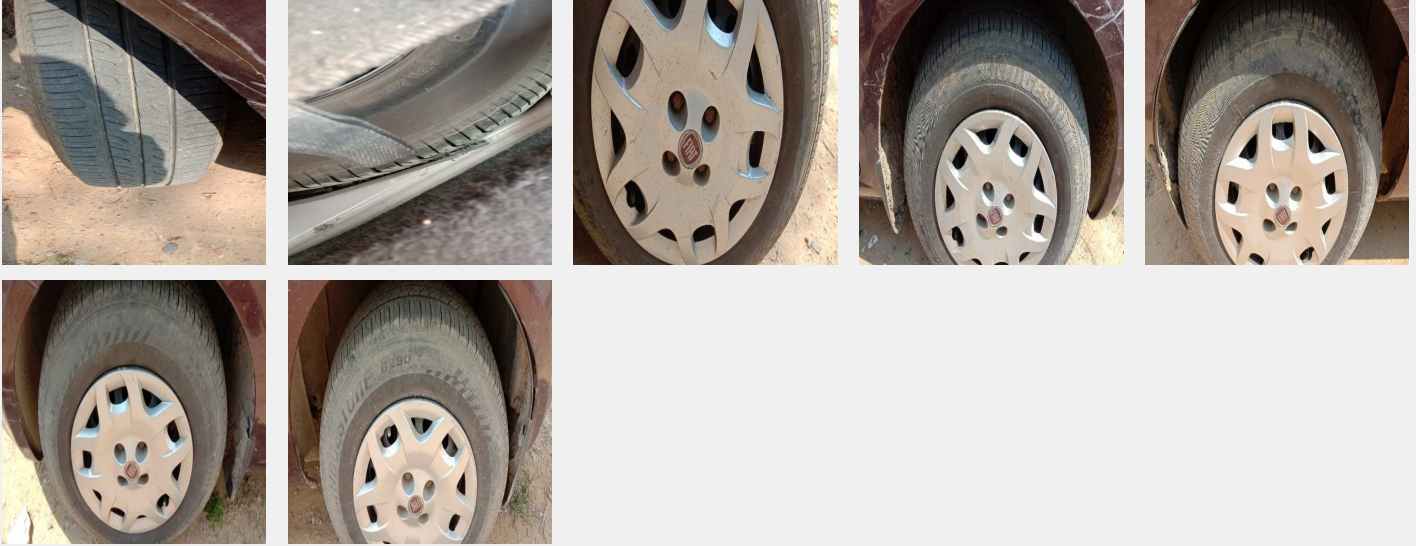
## IMAGES

INSPECTION CHECKPOINTS	SCORE(X/10)	REMARKS/COMMENTS	OPTIONAL SPEND EST. (RS)
TYRES	7	GOOD CONDITION	0
SPARE TYRE (YES)	7	GOOD CONDITION	0
WHEEL ASSEMBLY (STEEL RIM)	7	GOOD CONDITION	0

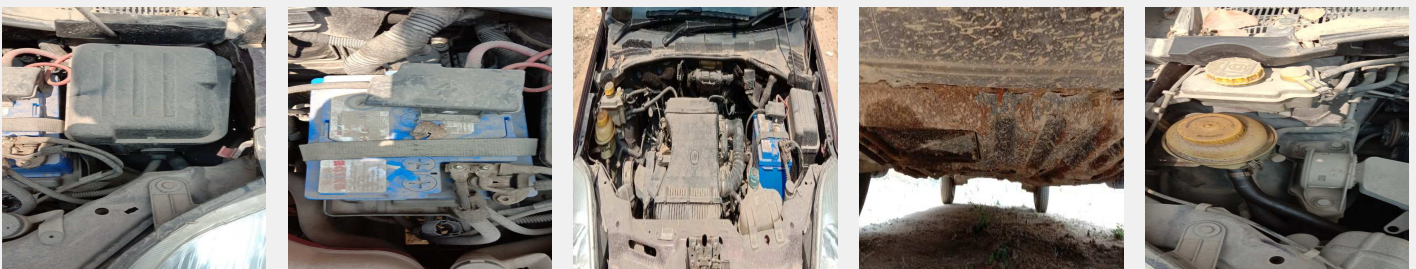
## IMAGES

INSPECTION CHECKPOINTS	SCORE(X/10)	REMARKS/COMMENTS	OPTIONAL SPEND EST. (RS)
LH APRON	7	GOOD CONDITION	0
RH APRON	7	GOOD CONDITION	0
RADIATOR	7	GOOD CONDITION	0
WIRING	7	GOOD CONDITION	0
BATTERY	7	GOOD CONDITION	0
BRAKE FLUID LEVEL	7	GOOD CONDITION	0
ENGINE OIL	7	GOOD CONDITION	0
COOLANT LEVEL	7	GOOD CONDITION	0
BRAKE & COOLANT HOSE PIPES	7	GOOD CONDITION	0
UNDERCARRIAGE	7	GOOD CONDITION	0
EXHAUST SYSTEM	7	GOOD CONDITION	0

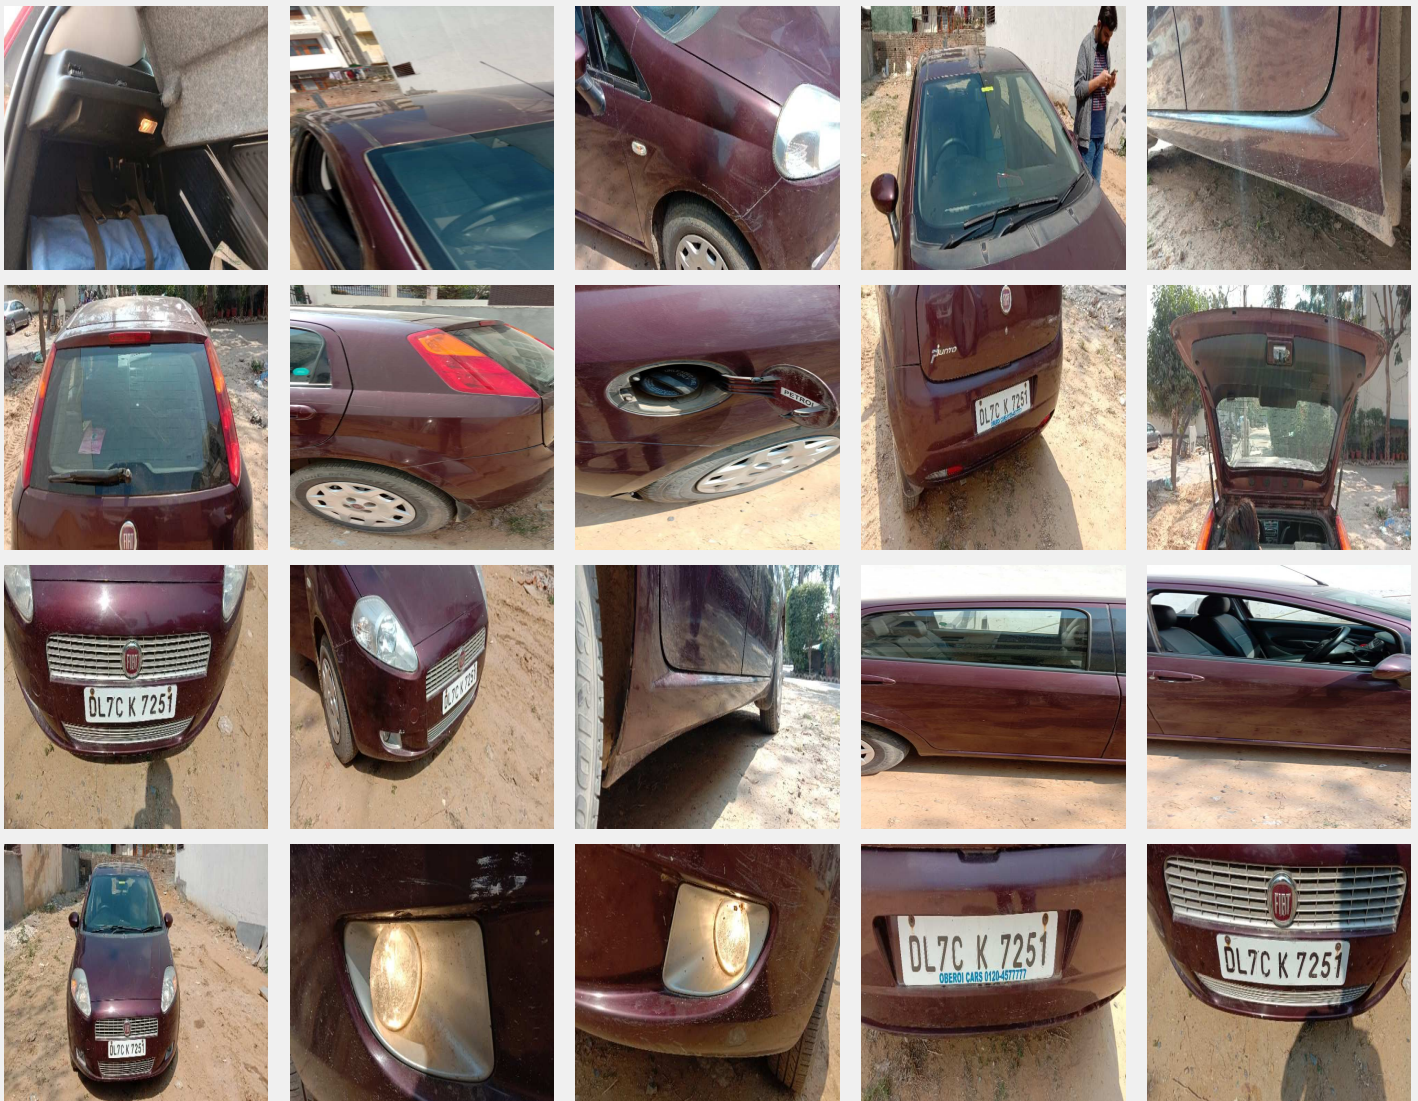
## IMAGES

INSPECTION CHECKPOINTS	SCORE(X/10)	REMARKS/COMMENTS	OPTIONAL SPEND EST. (RS)
ROOF (REGULAR)	7	GOOD CONDITION	0
PAINT CONDITION	7		0
LH FENDER	4	NEED PAINT	1500
RH QUARTER PANEL	5	NEED TO PAINT	1500
BODY RUST	0	NA	0
