ECO INSPECTION CERTIFICATE

Order ID : 47693

121 Points Vehicle Inspection Certificate

Skoda Fabia AMBIENTE 1.2 TDI, 2010

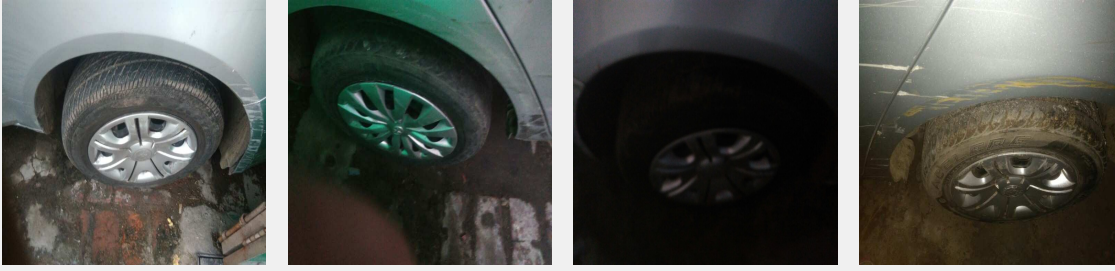
IMAGES

INSPECTION CHECKPOINTS	SCORE(X/10)	REMARKS/COMMENTS	OPTIONAL SPEND EST. (RS)
TYRES	6		0
SPARE TYRE (YES)	6		0
WHEEL ASSEMBLY (STEEL RIM)	6		0

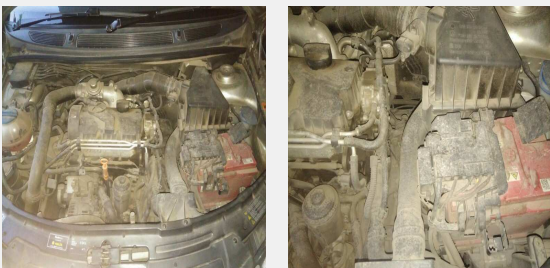
IMAGES

INSPECTION CHECKPOINTS	SCORE(X/10)	REMARKS/COMMENTS	OPTIONAL SPEND EST. (RS)
LH APRON	6		0
RH APRON	6		0
RADIATOR	6		0
WIRING	6		0
BATTERY	6		0
BRAKE FLUID LEVEL	6		0
ENGINE OIL	6		0
COOLANT LEVEL	6		0
BRAKE & COOLANT HOSE PIPES	7		0
UNDERCARRIAGE	6		0
EXHAUST SYSTEM	6		0

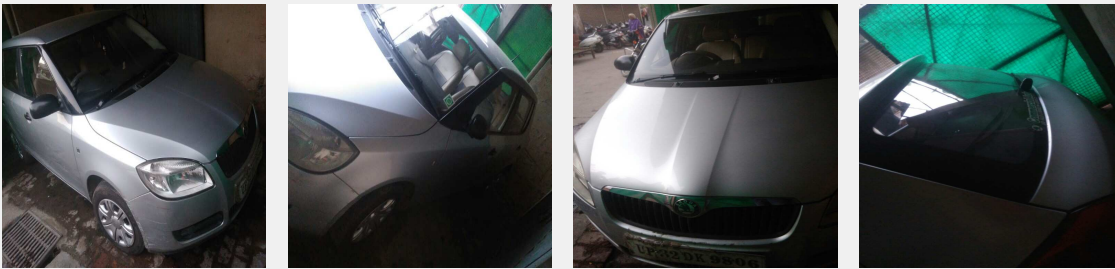
IMAGES

INSPECTION CHECKPOINTS	SCORE(X/10)	REMARKS/COMMENTS	OPTIONAL SPEND EST. (RS)
BODY RUST	6		0
ROOF (REGULAR)	6		0
FRONT BUMPER	3	SCRATCHES	2500
GRILLE	1	BROKEN	2000
PAINT CONDITION	4	SCRATCHES	20000
