ECO INSPECTION CERTIFICATE

121 Points Vehicle Inspection Certificate

Mahindra Scorpio 2.6 CRDE, 2005

MAKE	MAHINDRA	TRANSMISSION TYPE	MANUAL
MODEL	SCORPIO	REGISTRATION NO.	GJ18AB2278
YEAR	2005	VIN/CHASIS NUMBER	MA1TA2BSC52L8794
TRIM	2.6 CRDE	KMS RUN	111826
COLOR	SILVER	INSURANCE EXPIRY	2019-3-8
BODY TYPE	SUV	LOCATION	AHMEDABAD
FUEL TYPE	DIESEL	ENGINE SOUND LINK	LISTEN ENGINE SOUND

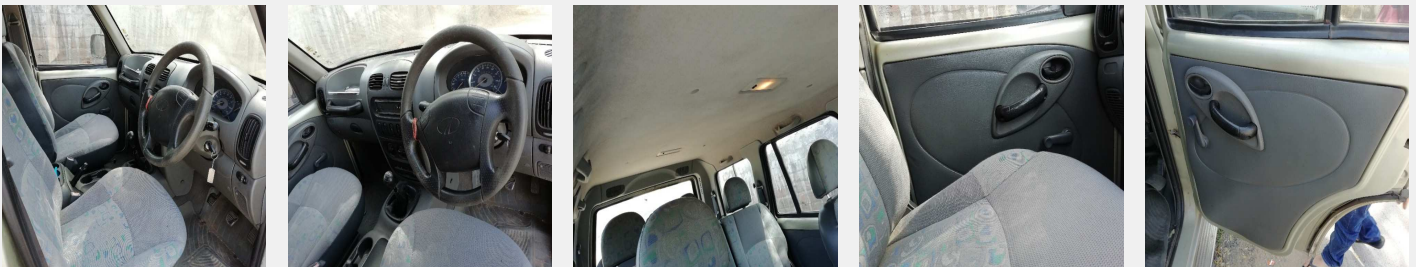
IMAGES

INTERIOR

INSPECTION CHECKPOINTS	SCORE(X/10)	REMARKS/COMMENTS	OPTIONAL SPEND EST. (RS)
DOOR PANEL	7	GOOD CONDITION	0
DOOR HINGES	7	GOOD CONDITION	0
CARPET & FLOOR MAT	7	GOOD CONDITION	0
SEAT & SEAT BELT	7	GOOD CONDITION	0
DASHBOARD & INSTRUMENT PANEL	7	GOOD CONDITION	0
HORN	7	GOOD CONDITION	0
SPEAKERS & MUSIC SYSTEM	7	GOOD CONDITION	0
HANDBRAKE	7	GOOD CONDITION	0
STEERING-MOUNTED CONTROLS	7	GOOD CONDITION	0
PEDALS	7	GOOD CONDITION	0
CENTRAL LOCK	7	GOOD CONDITION	0
A/C VENTS & HEATER	7	GOOD CONDITION	0
CUP HOLDERS	7	GOOD CONDITION	0
NAVIGATION (NO)	10		0
ODOMETER	7	GOOD CONDITION	0
POWER WINDOWS (NO)	10		0
HAZARD LIGHT	7	GOOD CONDITION	0

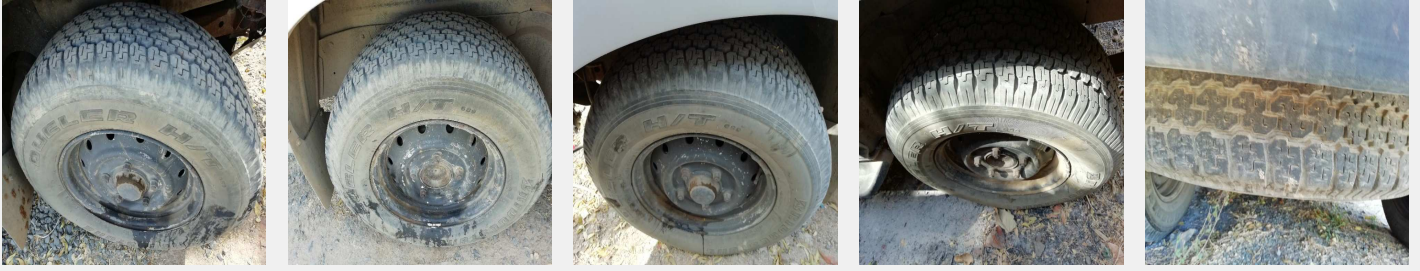
IMAGES

WHEEL

INSPECTION CHECKPOINTS	SCORE(X/10)	REMARKS/COMMENTS	OPTIONAL SPEND EST. (RS)
TYRES	8	GOOD CONDITION	0
SPARE TYRE (YES)	6	NEUTRAL CONDITION	0
WHEEL ASSEMBLY (STEEL RIM)	7	GOOD CONDITION	0

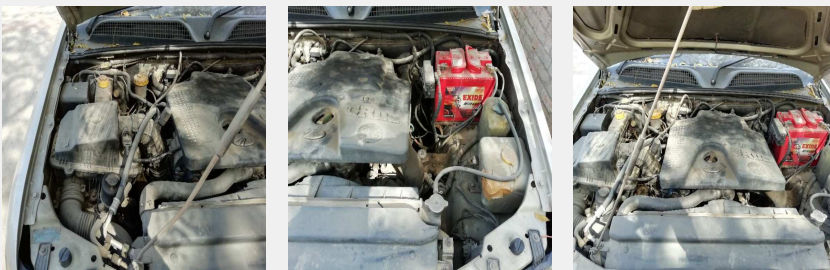
IMAGES

HOOD

INSPECTION CHECKPOINTS	SCORE(X/10)	REMARKS/COMMENTS	OPTIONAL SPEND EST. (RS)
LH APRON	8	GOOD CONDITION	0
RH APRON	8	GOOD CONDITION	0
RADIATOR	7	GOOD CONDITION	0
WIRING	7	GOOD CONDITION	0
BATTERY	7	GOOD CONDITION	0
BRAKE FLUID LEVEL	7	GOOD CONDITION	0
ENGINE OIL	7	GOOD CONDITION	0
COOLANT LEVEL	7	GOOD CONDITION	0
BRAKE & COOLANT HOSE PIPES	7	GOOD CONDITION	0
UNDERCARRIAGE	7	GOOD CONDITION	0
EXHAUST SYSTEM	7	GOOD CONDITION	0

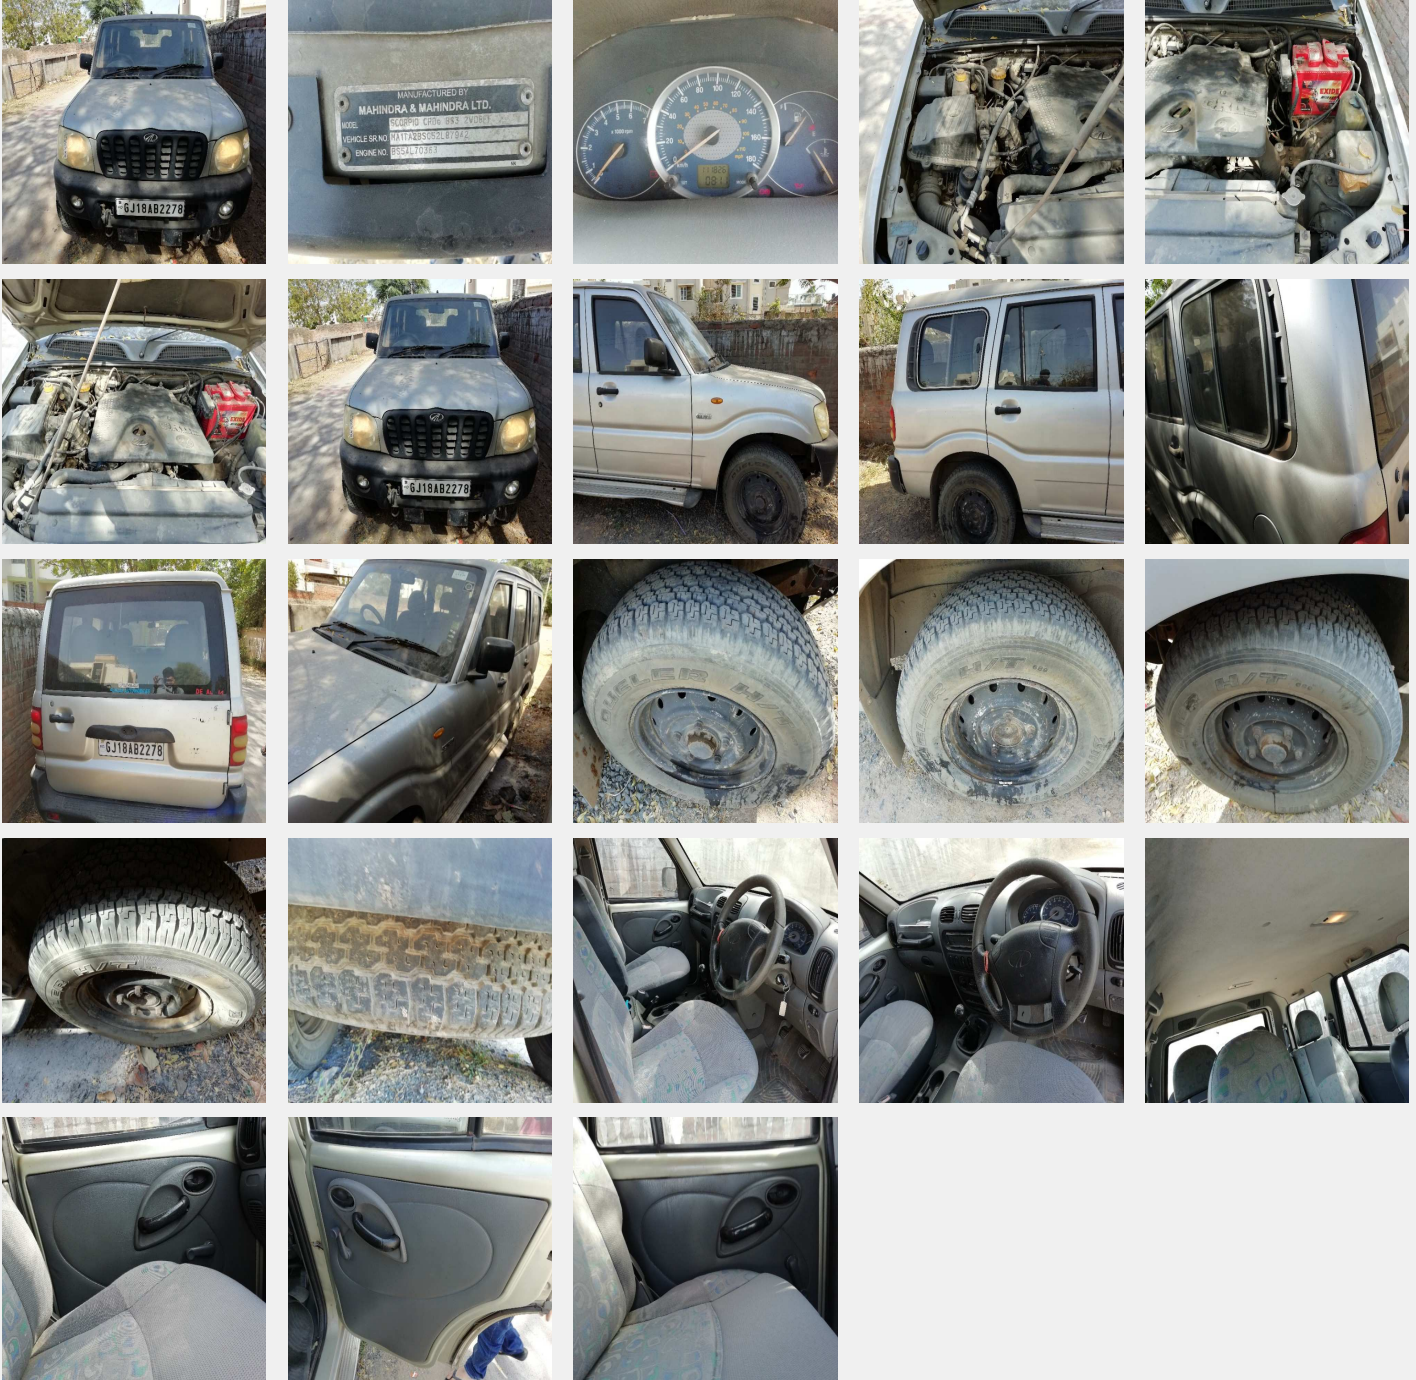
IMAGES

INSPECTION CHECKPOINTS	SCORE(X/10)	REMARKS/COMMENTS	OPTIONAL SPEND EST. (RS)
LICENSE PLATE	7	GOOD CONDITION	0
FRONT BUMPER	7	GOOD CONDITION	0
HEAD LIGHTS	6	HEAD LIGHT RESTORATION REQUIRE	1200
GRILLE	7	GOOD CONDITION	0
TURN SIGNAL	7	GOOD CONDITION	0
FOG LAMPS	7	GOOD CONDITION	0
HOOD	7	GOOD CONDITION	0
PILLAR	7	GOOD CONDITION	0
FRONT WINDSHIELD	7	GOOD CONDITION	0
SIDE VIEW MIRRORS	7	GOOD CONDITION	0
LH FENDER	7	GOOD CONDITION	0
LH FRONT DOOR	7	GOOD CONDITION	0
LH REAR DOOR	7	GOOD CONDITION	0
LH RUNNING BOARD	7	GOOD CONDITION	0
LH QUARTER PANEL	7	GOOD CONDITION	0
FUEL LID	7	GOOD CONDITION	0
REAR WINDSHIELD	7	GOOD CONDITION	0
REAR BUMPER	7	GOOD CONDITION	0
TAIL LIGHT	6	YELLOWISH	0
TRUNK LID/TAIL GATE	6	GOOD CONDITION	0
LUGGAGE COMPARTMENT LIGHT	7	GOOD CONDITION	0
RH QUARTER PANEL	7	GOOD CONDITION	0
RH RUNNING BOARD	7	GOOD CONDITION	0
RH REAR DOOR	7	GOOD CONDITION	0

INSPECTION CHECKPOINTS	SCORE(X/10)	REMARKS/COMMENTS	OPTIONAL SPEND EST. (RS)
RH FRONT DOOR	7	GOOD CONDITION	0
RH FENDER	7	GOOD CONDITION	0
BODY RUST	7	GOOD CONDITION	0
ROOF (REGULAR)	7	GOOD CONDITION	0
PAINT CONDITION	6	NEUTRAL CONDITION	0

Neutral condition
