ECO INSPECTION CERTIFICATE

121 Points Vehicle Inspection Certificate

Volkswagen Vento TRENDLINE DIESEL, 2011

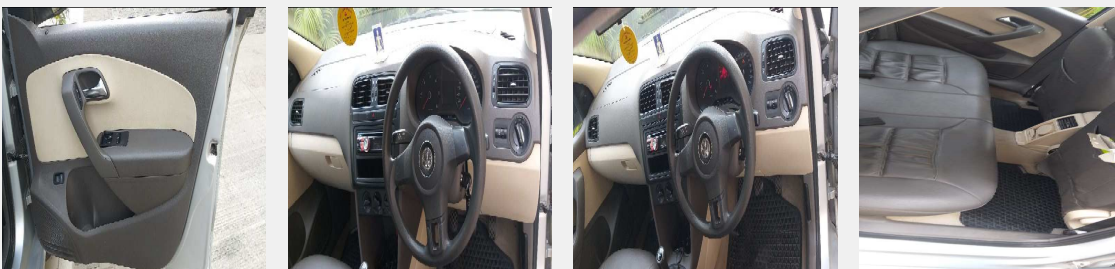
INTERIOR

INSPECTION CHECKPOINTS	SCORE(X/10)	REMARKS/COMMENTS	OPTIONAL SPEND EST. (RS)
DOOR PANEL	7	GOOD	0
DOOR HINGES	7	GOOD	0
CARPET & FLOOR MAT	7	GOOD	0
SEAT & SEAT BELT	7	GOOD	0
DASHBOARD & INSTRUMENT PANEL	7	GOOD	0
HORN	7	GOOD	0
SPEAKERS & MUSIC SYSTEM	7	GOOD	0
HANDBRAKE	7	GOOD	0
STEERING-MOUNTED CONTROLS	6	GOOD	0
PEDALS	7	GOOD	0
CENTRAL LOCK	7	GOOD	0
A/C VENTS & HEATER	7	GOOD	0
CUP HOLDERS	7	GOOD	0
NAVIGATION (NO)	10		0
ODOMETER	7	GOOD	0
POWER WINDOWS (YES)	7	GOOD	0
HAZARD LIGHT	7	GOOD	0

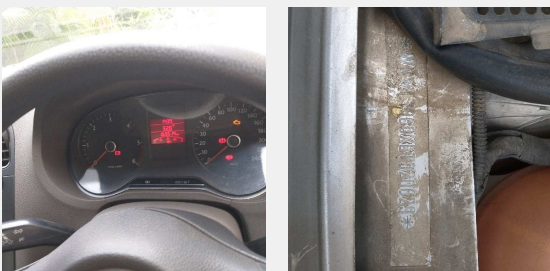
TEST DRIVE

INSPECTION CHECKPOINTS	SCORE(X/10)	REMARKS/COMMENTS	OPTIONAL SPEND EST. (RS)
STEERING PERFORMANCE	7	GOOD	0
BRAKE PERFORMANCE	7	GOOD	0
CLUTCH PERFORMANCE	7	GOOD	0
ENGINE NOISE	7	GOOD	0
IGNITION SYSTEM	7	GOOD	0
SUSPENSION PERFORMANCE	7	GOOD	0
SUSPENSION FRONT SHOCKS	7	GOOD	0
SUSPENSION REAR SHOCKS	7	GOOD	0
TRANSMISSION ENGAGE	7	GOOD	0
CRUISE CONTROL (NO)	10		0
REAR PARKING SENSORS (NO)	10		0
REAR VIEW CAMERA (NO)	10		0

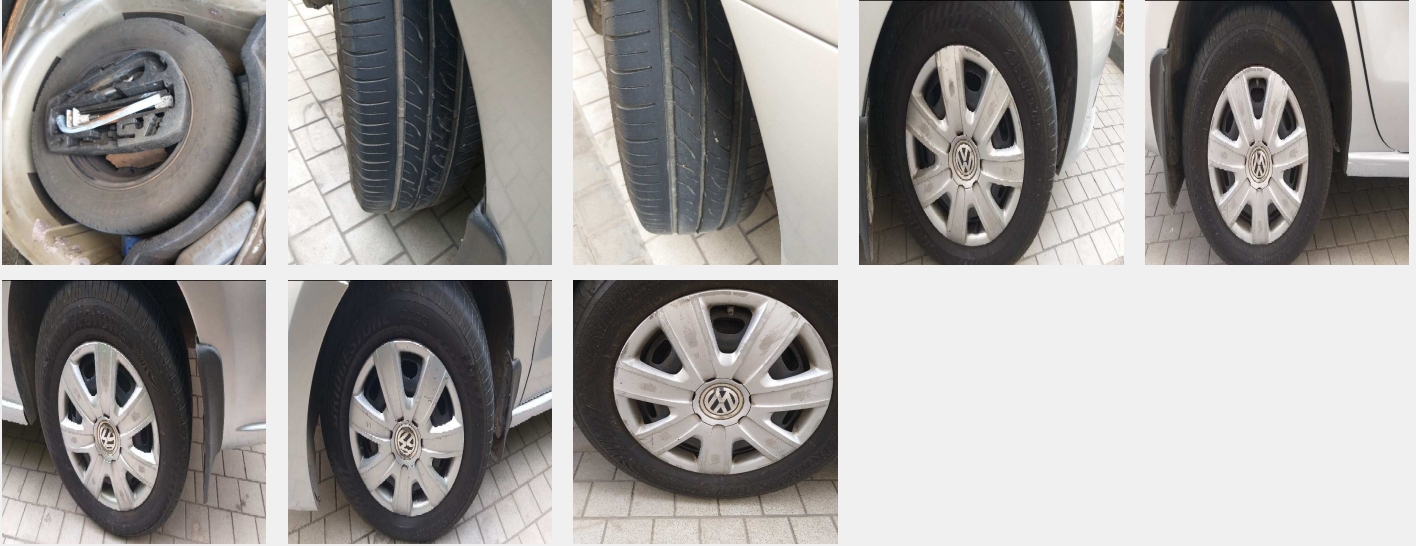
INSPECTION CHECKPOINTS	SCORE(X/10)	REMARKS/COMMENTS	OPTIONAL SPEND EST. (RS)
TYRES	7	GOOD	0
SPARE TYRE (YES)	7	GOOD	0
WHEEL ASSEMBLY (STEEL RIM)	7	GOOD	0

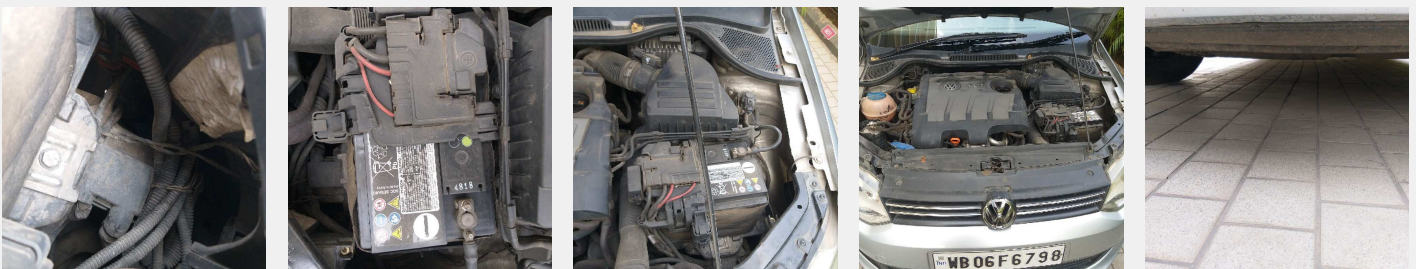
HOOD

INSPECTION CHECKPOINTS	SCORE(X/10)	REMARKS/COMMENTS	OPTIONAL SPEND EST. (RS)
LH APRON	8	GOOD	0
RH APRON	7	GOOD	0
RADIATOR	7	GOOD	0
WIRING	7	GOOD	0
BATTERY	7	GOOD	0
BRAKE FLUID LEVEL	7	GOOD	0
ENGINE OIL	7	GOOD	0
COOLANT LEVEL	7	GOOD	0
BRAKE & COOLANT HOSE PIPES	7	GOOD	0
UNDERCARRIAGE	7	GOOD	0
EXHAUST SYSTEM	7	GOOD	0

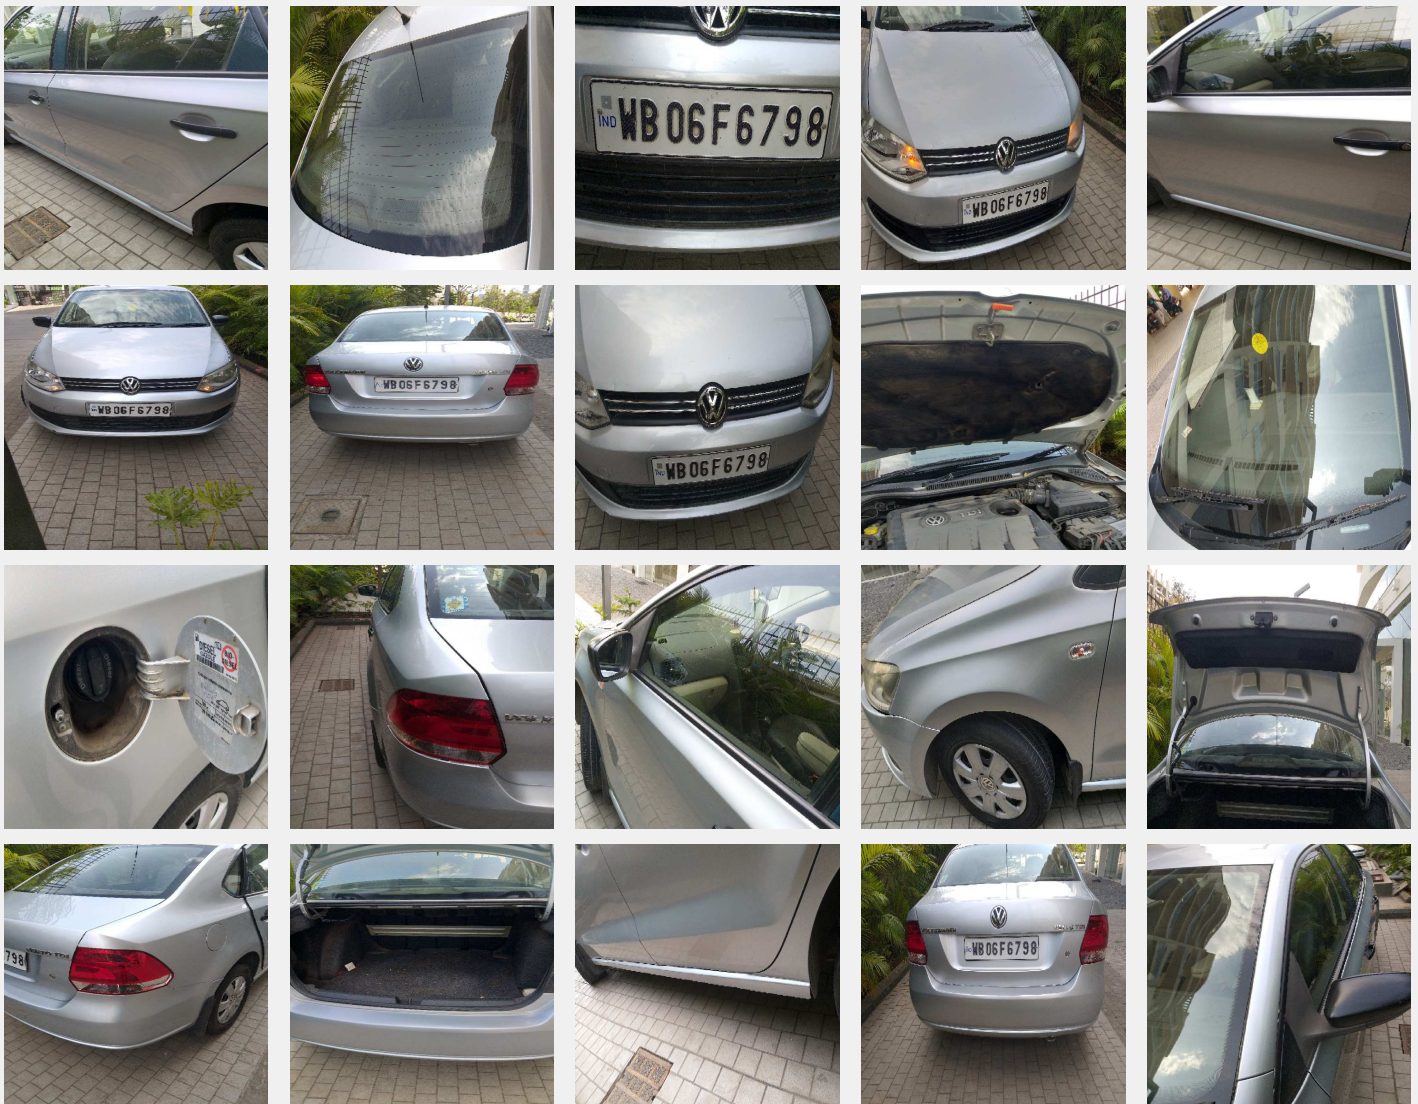
EXTERIOR (CONTINUED)

INSPECTION CHECKPOINTS	SCORE(X/10)	REMARKS/COMMENTS	OPTIONAL SPEND EST. (RS)
RH FRONT DOOR	7	GOOD	0
RH FENDER	6	GOOD	0
ROOF (REGULAR)	7	GOOD	0
PAINT CONDITION	6	BUMPED PAINTED	0
BODY RUST	5	NO	0
