# ECO INSPECTION CERTIFICATE

Order ID : 50571

121 Points Vehicle Inspection Certificate

## Hyundai Getz Prime 1.1 Gvs, 2007

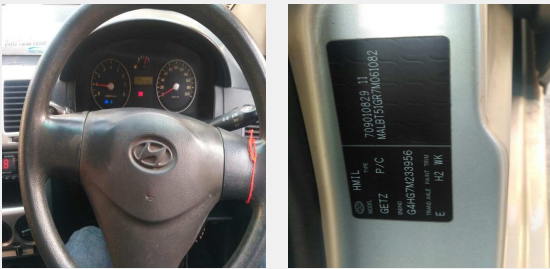
INSPECTION CHECKPOINTS	SCORE(X/10)	REMARKS/COMMENTS	OPTIONAL SPEND EST. (RS)
BRAKE PERFORMANCE	6	FAIR CONDITION	0
IGNITION SYSTEM	6	FAIR CONDITION	0
SUSPENSION PERFORMANCE	6	FAIR CONDITION	0
SUSPENSION FRONT SHOCKS	6	FAIR CONDITION	0
TRANSMISSION ENGAGE	6	FAIR CONDITION	0
STEERING PERFORMANCE	5	STEERING HARD NEED TO CHECK AND REPAIR	1000
CLUTCH PERFORMANCE	5	CLUTH HARD NEED TO CHECK AND REPAIR	4000
ENGINE NOISE	5	ENGINE NOISE NEED TO CHECK AND REPAIR	2500
SUSPENSION REAR SHOCKS	5	BOTH SUSPENSION DAME NEED TO CHANGE	3800
CRUISE CONTROL (YES)	0	NA	0
REAR PARKING SENSORS (YES)	0	NA	0
REAR VIEW CAMERA (YES)	0	NA	0

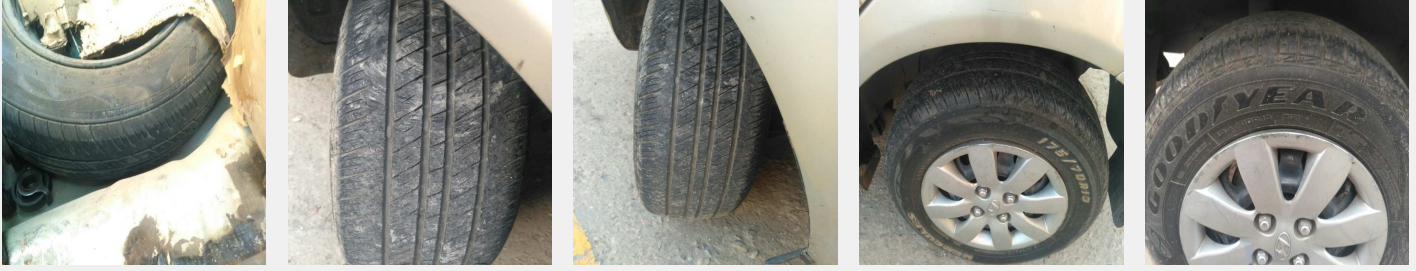
INSPECTION CHECKPOINTS	SCORE(X/10)	REMARKS/COMMENTS	OPTIONAL SPEND EST. (RS)
TYRES	6	FAIR CONDITION	0
SPARE TYRE (YES)	7	GOOD CONDITION	0
WHEEL ASSEMBLY (STEEL RIM)	6	FAIR CONDITION	0

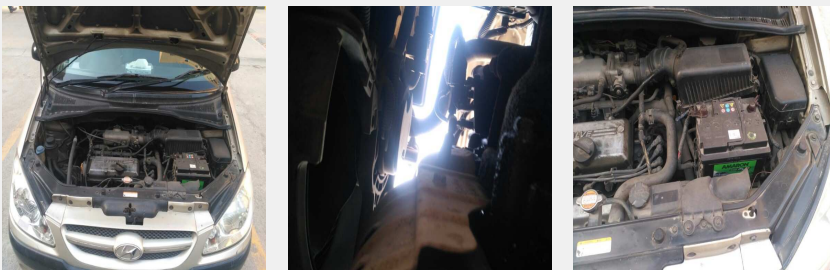
INSPECTION CHECKPOINTS	SCORE(X/10)	REMARKS/COMMENTS	OPTIONAL SPEND EST. (RS)
LH APRON	6	FAIR CONDITION	0
RH APRON	6	FAIR CONDITION	0
RADIATOR	6	FAIR CONDITION	0
WIRING	6	FAIR CONDITION	0
BATTERY	7	GOOD CONDITION	0
BRAKE FLUID LEVEL	6	FAIR CONDITION	0
ENGINE OIL	6	FAIR VISCOSITY	0
COOLANT LEVEL	6	MINIMUM LEVEL	0
BRAKE & COOLANT HOSE PIPES	6	FAIR CONDITION	0
UNDERCARRIAGE	6	FAIR CONDITION	0
EXHAUST SYSTEM	6	FAIR CONDITION	0

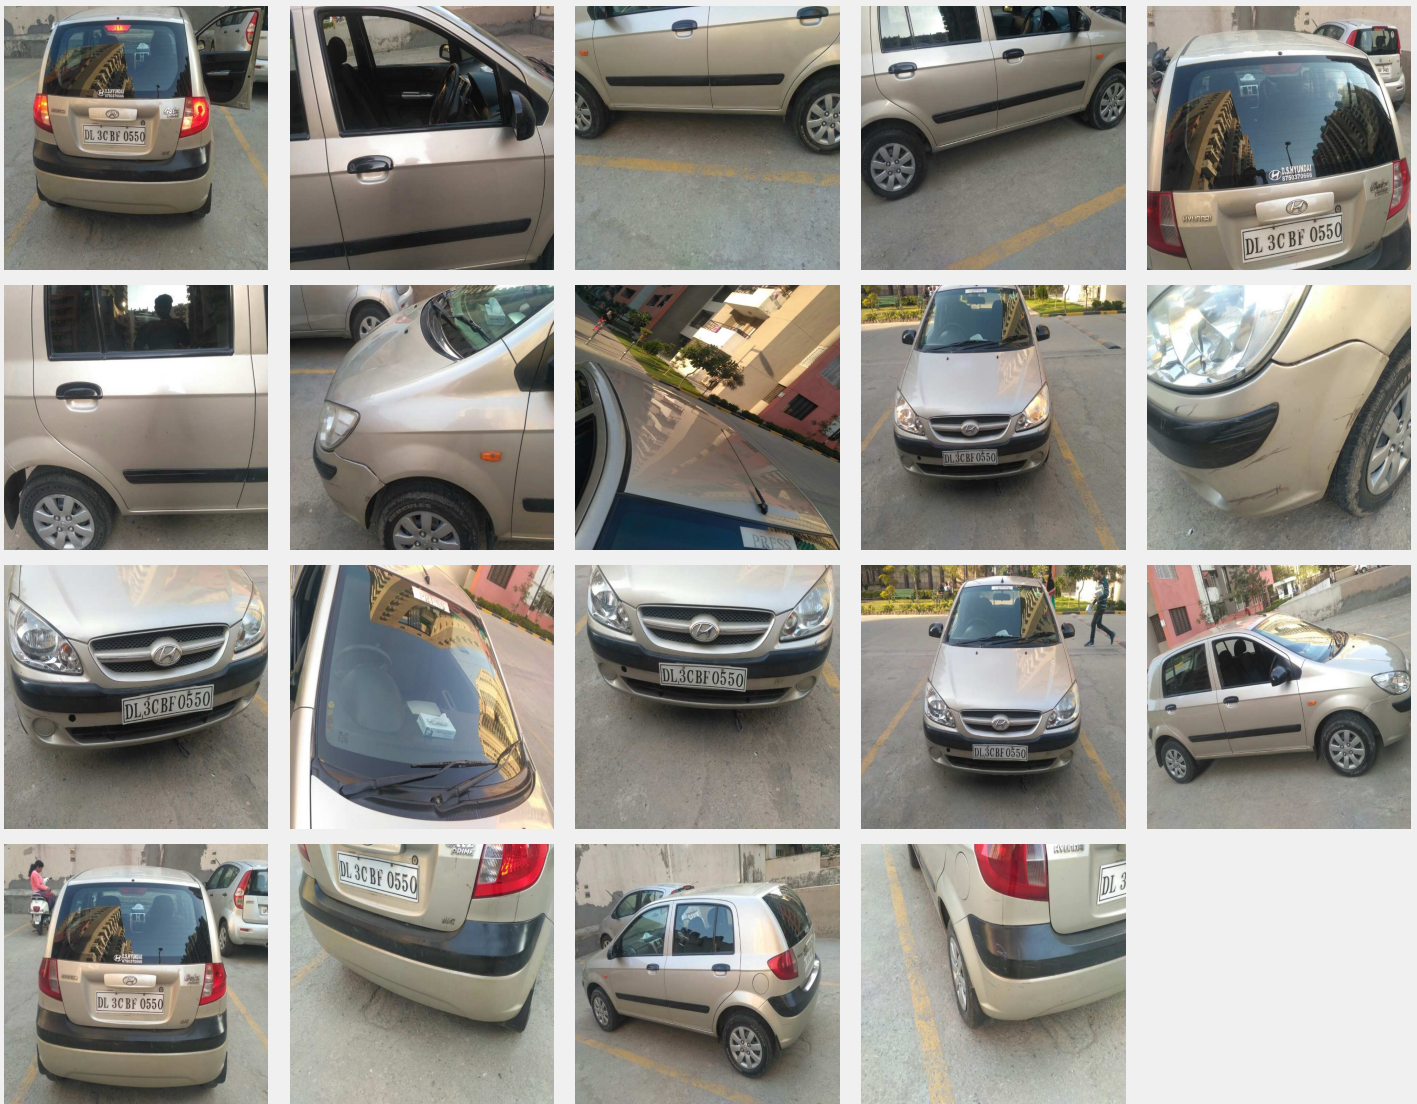
INSPECTION CHECKPOINTS	SCORE(X/10)	REMARKS/COMMENTS	OPTIONAL SPEND EST. (RS)
LICENSE PLATE	6	FAIR CONDITION	0
FRONT BUMPER	7	DENT AND SCRATCHES AND BUMPER NEED TO BE REPAIR	2000
HEAD LIGHTS	6	FAIR CONDITION	0
GRILLE	6	FAIR CONDITION	0
TURN SIGNAL	6	FAIR CONDITION	0
HOOD	6	FAIR CONDITION	0
PILLAR	6	FAIR CONDITION	0
FRONT WINDSHIELD	6	FAIR CONDITION	0
SIDE VIEW MIRRORS	6	FAIR CONDITION	0
LH FENDER	6	SCRATCHES	0
LH FRONT DOOR	6	FAIR CONDITION	0
LH REAR DOOR	6	FAIR CONDITION	0
LH RUNNING BOARD	6	FAOR CONDITION	0
LH QUARTER PANEL	6	FAIR CONDITION	0
FUEL LID	6	FAIR CONDITION	0
REAR WINDSHIELD	6	FAIR CONDITION	0
REAR BUMPER	6	SCRATCHES	400
TAIL LIGHT	6	FAIR CONDITION	0
TRUNK LID/TAIL GATE	6	FAIR CONDITION	0
LUGGAGE COMPARTMENT LIGHT	6	FAIR CONDITION	0
RH QUARTER PANEL	6	FAIR CONDITION	0
RH RUNNING BOARD	6	FAIR CONDITION	0
RH REAR DOOR	6	SCRATCHES	400
RH FRONT DOOR	6	SCRATCHES	300

INSPECTION CHECKPOINTS	SCORE(X/10)	REMARKS/COMMENTS	OPTIONAL SPEND EST. (RS)
RH FENDER	6	FAIR CONDITION	0
BODY RUST	6	FAIR CONDITION	0
ROOF (REGULAR)	6	FAIR CONDITION	0
PAINT CONDITION	6	FAIR CONDITION	0
FOG LAMPS	0	NA	0

All body scratches and dent need to repair and service due cluth hard and engine noise check and ne
