ECO INSPECTION CERTIFICATE

Order ID : 51188

121 Points Vehicle Inspection Certificate

Mitsubishi Pajero Sport 4X4 MT, 2013

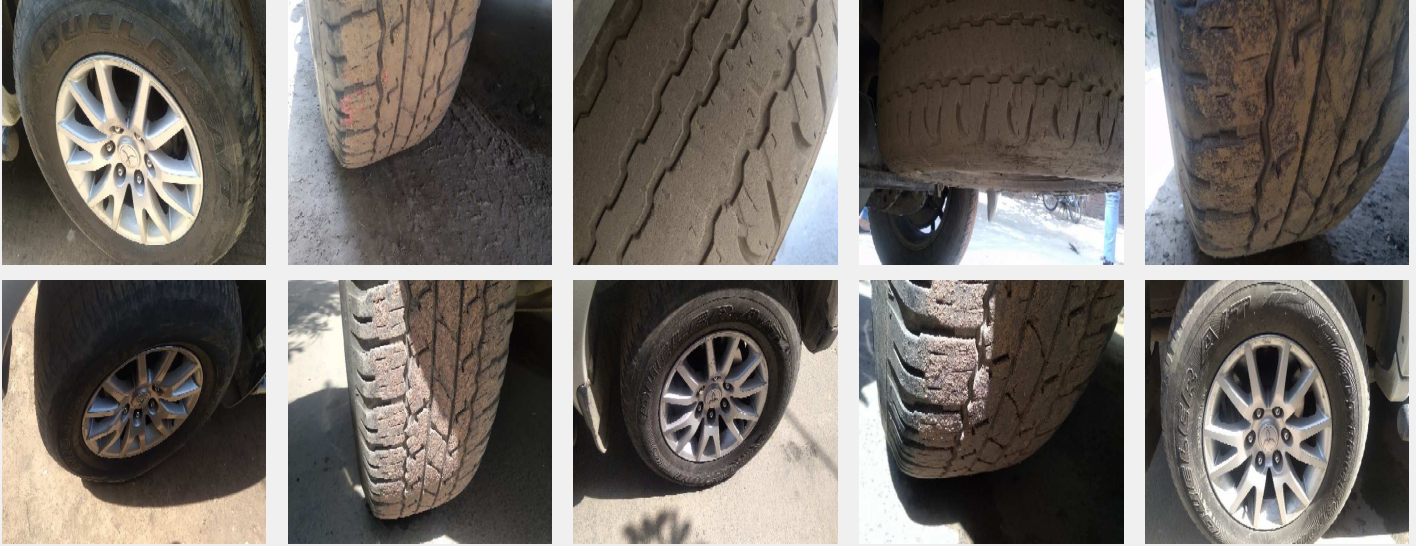
IMAGES

INSPECTION CHECKPOINTS	SCORE(X/10)	REMARKS/COMMENTS	OPTIONAL SPEND EST. (RS)
TYRES	7	GOOD CONDITION	0
SPARE TYRE (YES)	7	GOOD CONDITION	0
WHEEL ASSEMBLY (ALLOY RIM)	7	GOOD CONDITION	0

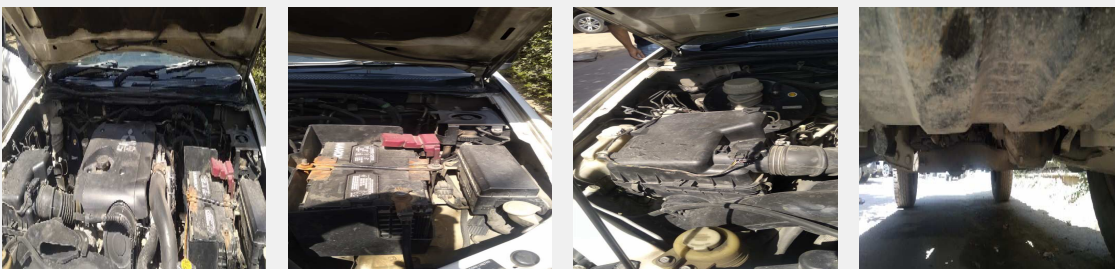
IMAGES

INSPECTION CHECKPOINTS	SCORE(X/10)	REMARKS/COMMENTS	OPTIONAL SPEND EST. (RS)
LH APRON	7	GOOD CONDITION	0
RH APRON	7	GOOD CONDITION	0
RADIATOR	7	GOOD CONDITION	0
WIRING	7	GOOD CONDITION	0
BATTERY	7	GOOD CONDITION	0
BRAKE FLUID LEVEL	7	MAX	0
ENGINE OIL	7	MAX	0
COOLANT LEVEL	7	MAX	0
BRAKE & COOLANT HOSE PIPES	7	GOOD CONDITION	0
UNDERCARRIAGE	7	GOOD CONDITION	0
EXHAUST SYSTEM	7	GOOD CONDITION	0

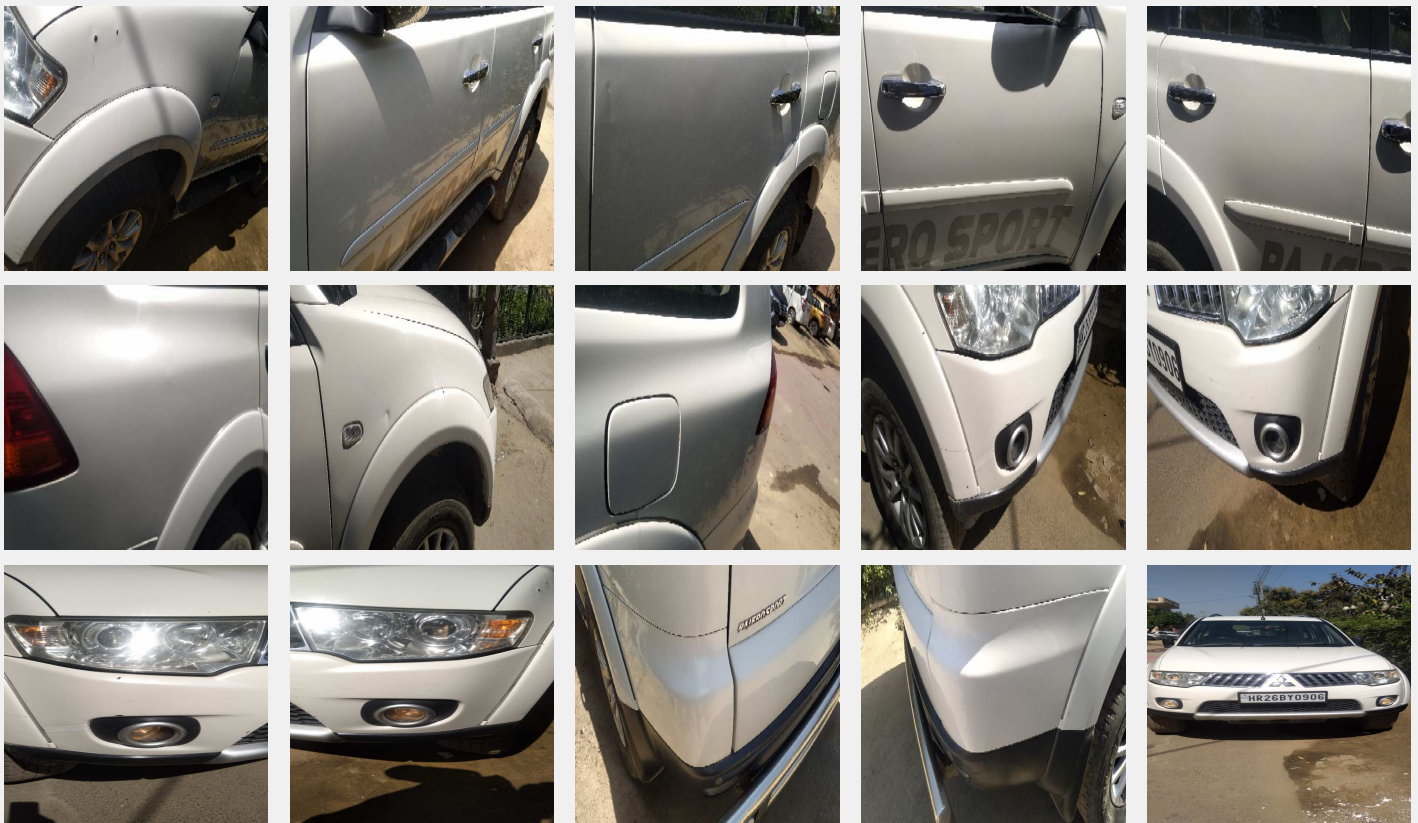
IMAGES

INSPECTION CHECKPOINTS	SCORE(X/10)	REMARKS/COMMENTS	OPTIONAL SPEND EST. (RS)
LICENSE PLATE	7	GOOD CONDITION	0
FRONT BUMPER	6	MINOR SCRATCHES	1000
HEAD LIGHTS	7	GOOD CONDITION	0
GRILLE	7	GOOD CONDITION	0
TURN SIGNAL	7	GOOD CONDITION	0
FOG LAMPS	7	GOOD CONDITION	0
HOOD	7	GOOD CONDITION	0
PILLAR	7	GOOD CONDITION	0
FRONT WINDSHIELD	7	GOOD VISIBILITY	0
SIDE VIEW MIRRORS	7	GOOD CONDITION	0
LH FENDER	6	MINOR SCRATCHES	800
LH FRONT DOOR	6	MINOR SCRATCHES AND DENT	1500
LH REAR DOOR	6	MINOR SCRATCHES AND DENT	1500
LH RUNNING BOARD	7	GOOD CONDITION	0
LH QUARTER PANEL	6	MINOR DENT AND SCRATCHES	1500
FUEL LID	7	GOOD CONDITION	0
REAR WINDSHIELD	7	GOOD VISIBILITY	0
REAR BUMPER	6	MINOR SCRATCHES	1000
TRUNK LID/TAIL GATE	7	GOOD CONDITION	0
LUGGAGE COMPARTMENT LIGHT	7	GOOD CONDITION	0
RH QUARTER PANEL	6	MINOR SCRATCHES	1000
RH RUNNING BOARD	7	GOOD CONDITION	0
RH REAR DOOR	6	MINOR SCRATCHES AND DENT	1500

INSPECTION CHECKPOINTS	SCORE(X/10)	REMARKS/COMMENTS	OPTIONAL SPEND EST. (RS)
RH FENDER	6	MINOR DENT AND SCRATCHES	1000
BODY RUST	7	GOOD CONDITION	0
ROOF (REGULAR)	7	GOOD CONDITION	0
PAINT CONDITION	7	GOOD CONDITION	0
TAIL LIGHT	5	RHS TAIL LAMP NEED TO REPLACE	4000

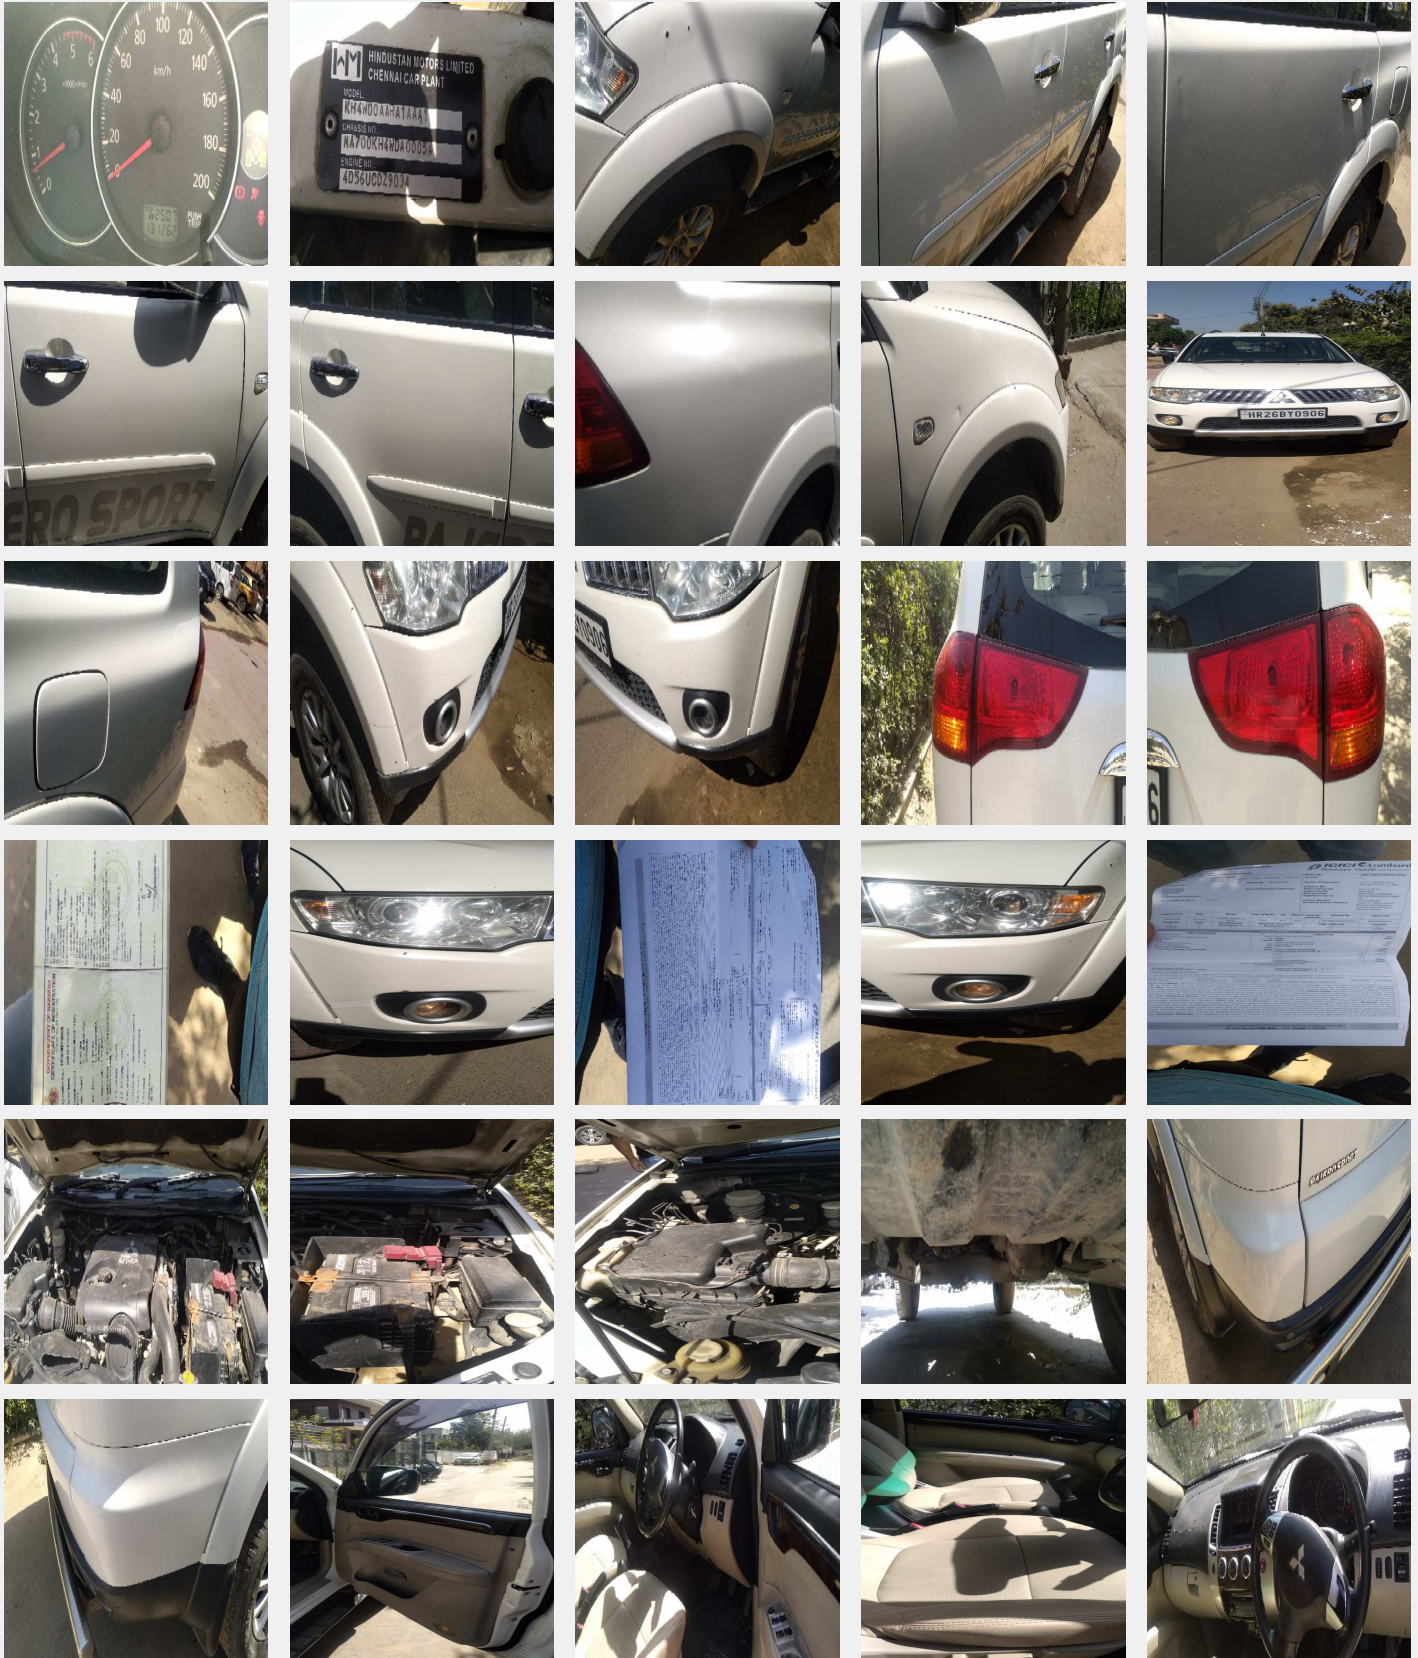
IMAGES

minor scratches and dent both bumpers already painted rhs quarterpanel already painted
