# ECO INSPECTION CERTIFICATE

Order ID : 51369

121 Points Vehicle Inspection Certificate

## Fiat Linea EMOTION 1.3, 2012

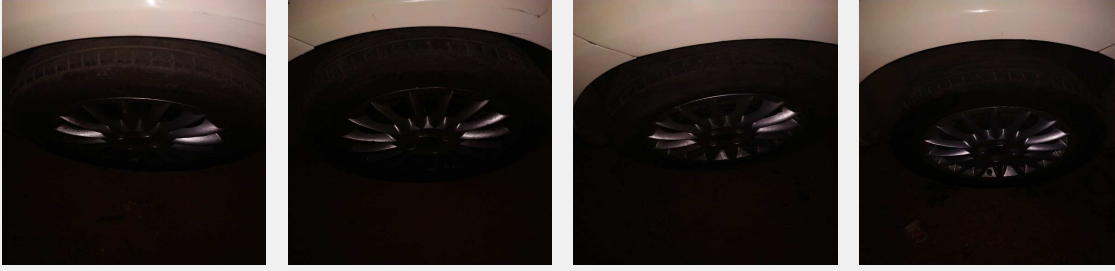
IMAGES

INSPECTION CHECKPOINTS	SCORE(X/10)	REMARKS/COMMENTS	OPTIONAL SPEND EST. (RS)
TYRES	7		0
SPARE TYRE (YES)	7		0
WHEEL ASSEMBLY (ALLOY RIM)	7		0

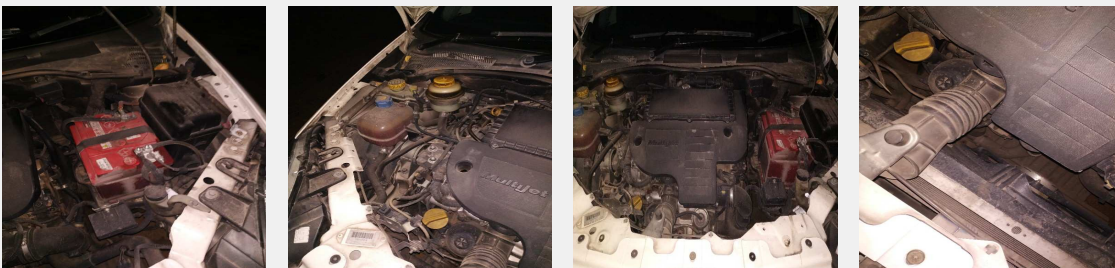
IMAGES

INSPECTION CHECKPOINTS	SCORE(X/10)	REMARKS/COMMENTS	OPTIONAL SPEND EST. (RS)
LH APRON	7		0
RH APRON	6		0
RADIATOR	6		0
WIRING	7		0
BATTERY	7		0
BRAKE FLUID LEVEL	7		0
ENGINE OIL	7		0
COOLANT LEVEL	7		0
BRAKE & COOLANT HOSE PIPES	7		0
UNDERCARRIAGE	7		0
EXHAUST SYSTEM	7		0

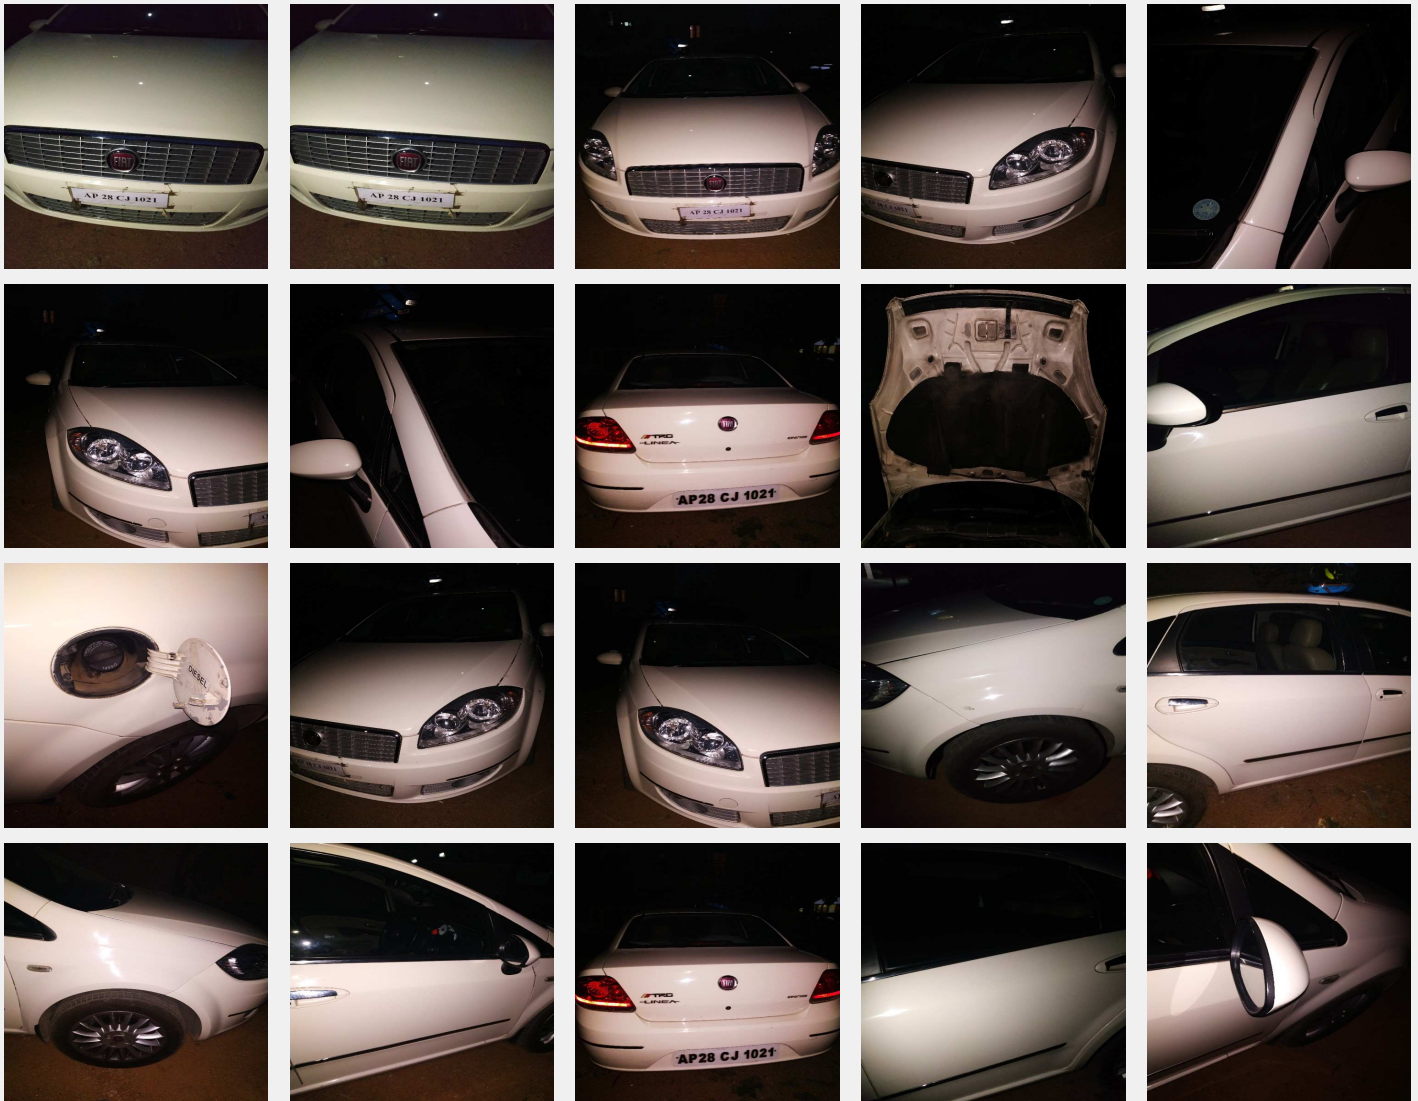
## IMAGES

INSPECTION CHECKPOINTS	SCORE(X/10)	REMARKS/COMMENTS	OPTIONAL SPEND EST. (RS)
RH FRONT DOOR	8		0
RH FENDER	8		0
BODY RUST	8		0
ROOF (REGULAR)	7		0
PAINT CONDITION	8		0
