ECO INSPECTION CERTIFICATE

121 Points Vehicle Inspection Certificate

Ford Figo DURATORQ DIESEL LXI 1.4, 2014

MAKE	FORD	TRANSMISSION TYPE	MANUAL
MODEL	FIGO	REGISTRATION NO.	DL4CAF8898
YEAR	2014	VIN/CHASIS NUMBER	MAJ1XXMRJ1BT7508
TRIM	DURATORQ DIESEL LXI 1.4	KMS RUN	949772
COLOR	BLACK	INSURANCE EXPIRY	2019-4-8
BODY TYPE	HATCHBACK	LOCATION	LUCKNOW
FUEL TYPE	DIESEL	ENGINE SOUND LINK	NIL

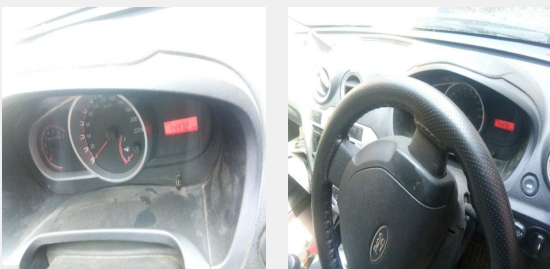
IMAGES

INSPECTION CHECKPOINTS	SCORE(X/10)	REMARKS/COMMENTS	OPTIONAL SPEND EST. (RS)
STEERING PERFORMANCE	7		0
BRAKE PERFORMANCE	6		0
CLUTCH PERFORMANCE	7		0
ENGINE NOISE	7		0
IGNITION SYSTEM	7		0
SUSPENSION PERFORMANCE	7		0
SUSPENSION FRONT SHOCKS	7		0
SUSPENSION REAR SHOCKS	7		0
TRANSMISSION ENGAGE	7		0
CRUISE CONTROL (YES)	7	U	0
REAR PARKING SENSORS (YES)	7		0
REAR VIEW CAMERA (YES)	7		0

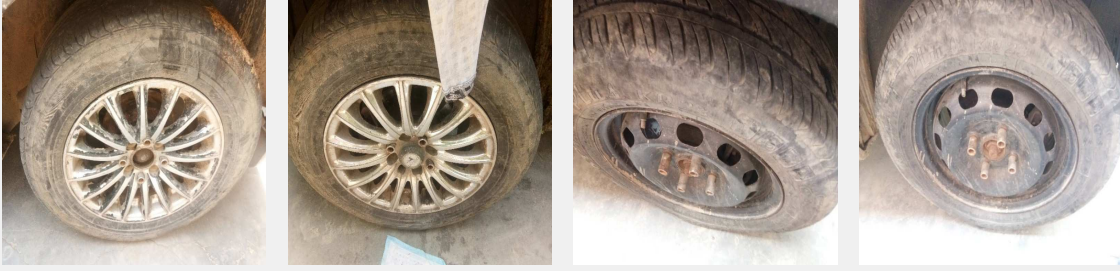
IMAGES

INSPECTION CHECKPOINTS	SCORE(X/10)	REMARKS/COMMENTS	OPTIONAL SPEND EST. (RS)
TYRES	7		0
SPARE TYRE (YES)	7		0
WHEEL ASSEMBLY (STEEL RIM)	7		0

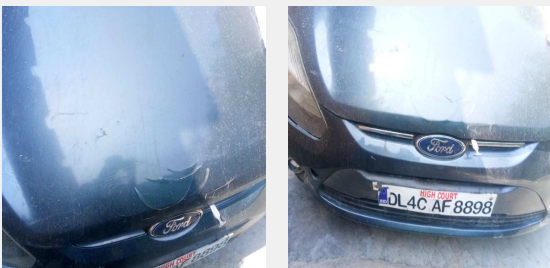
IMAGES

INSPECTION CHECKPOINTS	SCORE(X/10)	REMARKS/COMMENTS	OPTIONAL SPEND EST. (RS)
LH APRON	6		0
RH APRON	7		0
RADIATOR	7		0
WIRING	7		0
BATTERY	7		0
BRAKE FLUID LEVEL	7		0
ENGINE OIL	7		0
COOLANT LEVEL	7		0
BRAKE & COOLANT HOSE PIPES	7		0
UNDERCARRIAGE	7		0
EXHAUST SYSTEM	7		0
