ECO INSPECTION CERTIFICATE

Order ID : 53864

121 Points Vehicle Inspection Certificate

Tata Nano STD, 2010

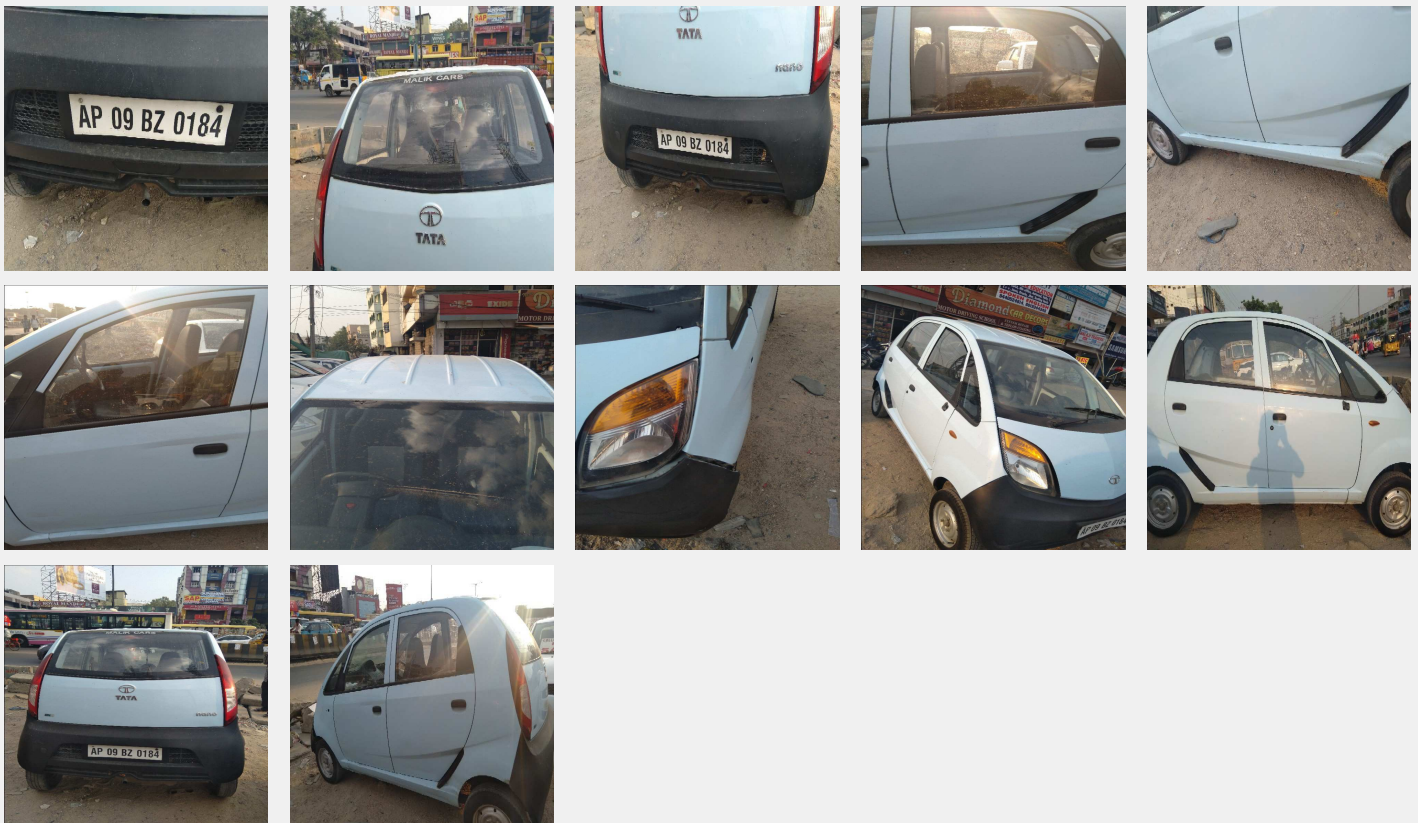
INSPECTION CHECKPOINTS	SCORE(X/10)	REMARKS/COMMENTS	OPTIONAL SPEND EST. (RS)
ROOF (REGULAR)	8		0
PAINT CONDITION	9		0
FRONT BUMPER	3	DAMAGED NEED TO BE CHANGED	2500
TAIL LIGHT	5	NEED TO BE CHANGED	2800
LUGGAGE COMPARTMENT LIGHT	0	NO LUGGAGE COMPARTMENT	1
