ECO INSPECTION CERTIFICATE

121 Points Vehicle Inspection Certificate

| Ordered By : Suhaib | Inspection Date : 2019-04-12 | Location : ALLAHABAD |

Volkswagen Polo GT TDI, 2014

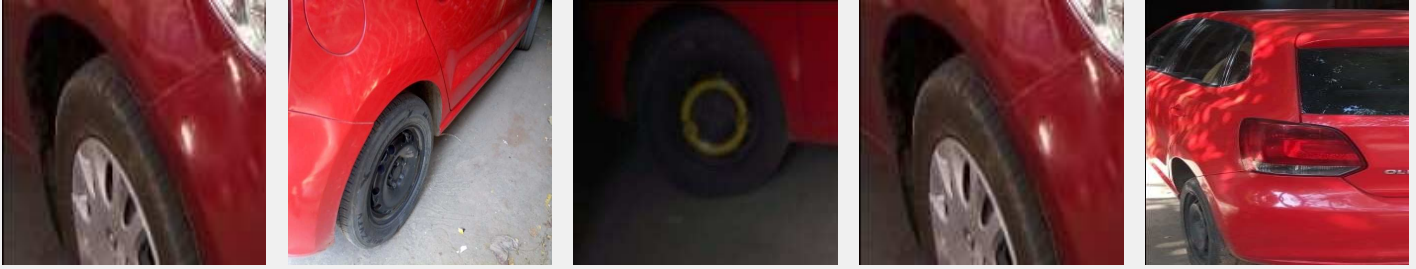
IMAGES

| INSPECTION CHECKPOINTS | SCORE(X/10) | REMARKS/COMMENTS | OPTIONAL SPEND EST. (RS) |
|---|---|---|---|
| TYRES | 7 | OK | 0 |
| SPARE TYRE (YES) | 3 | MISSING | 2000 |
| WHEEL ASSEMBLY (STEEL RIM) | 3 | FAIR | 4000 |
