ECO INSPECTION CERTIFICATE

Order ID : 56274

121 Points Vehicle Inspection Certificate

Ford Endeavour 3.0l 4x4 At, 2009

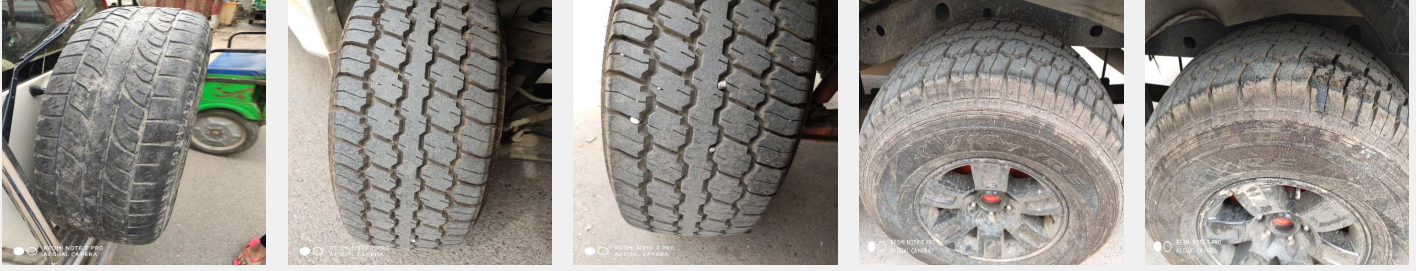
IMAGES

INSPECTION CHECKPOINTS	SCORE(X/10)	REMARKS/COMMENTS	OPTIONAL SPEND EST. (RS)
TYRES	8	GOOD CONDITION	0
SPARE TYRE (YES)	6	AVERAGE CONDITION	0
WHEEL ASSEMBLY (ALLOY RIM)	7	GOOD CONDITION	0

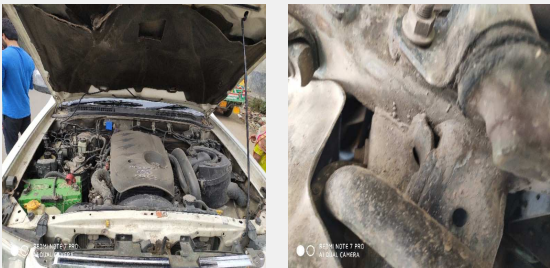
IMAGES

INSPECTION CHECKPOINTS	SCORE(X/10)	REMARKS/COMMENTS	OPTIONAL SPEND EST. (RS)
LH APRON	6	AVERAGE CONDITION	0
RH APRON	6	AVERAGE CONDITION	0
RADIATOR	6	AVERAGE CONDITION	0
WIRING	6	AVERAGE CONDITION	0
BATTERY	7	GOOD CONDITION	0
BRAKE FLUID LEVEL	7	GOOD CONDITION	0
ENGINE OIL	7	GOOD VISCOSITY	0
COOLANT LEVEL	7	MAXIMUM LEVEL	0
BRAKE & COOLANT HOSE PIPES	6	AVERAGE CONDITION	0
UNDERCARRIAGE	6	AVERAGE CONDITION	0
EXHAUST SYSTEM	6	AVERAGE CONDITION	0

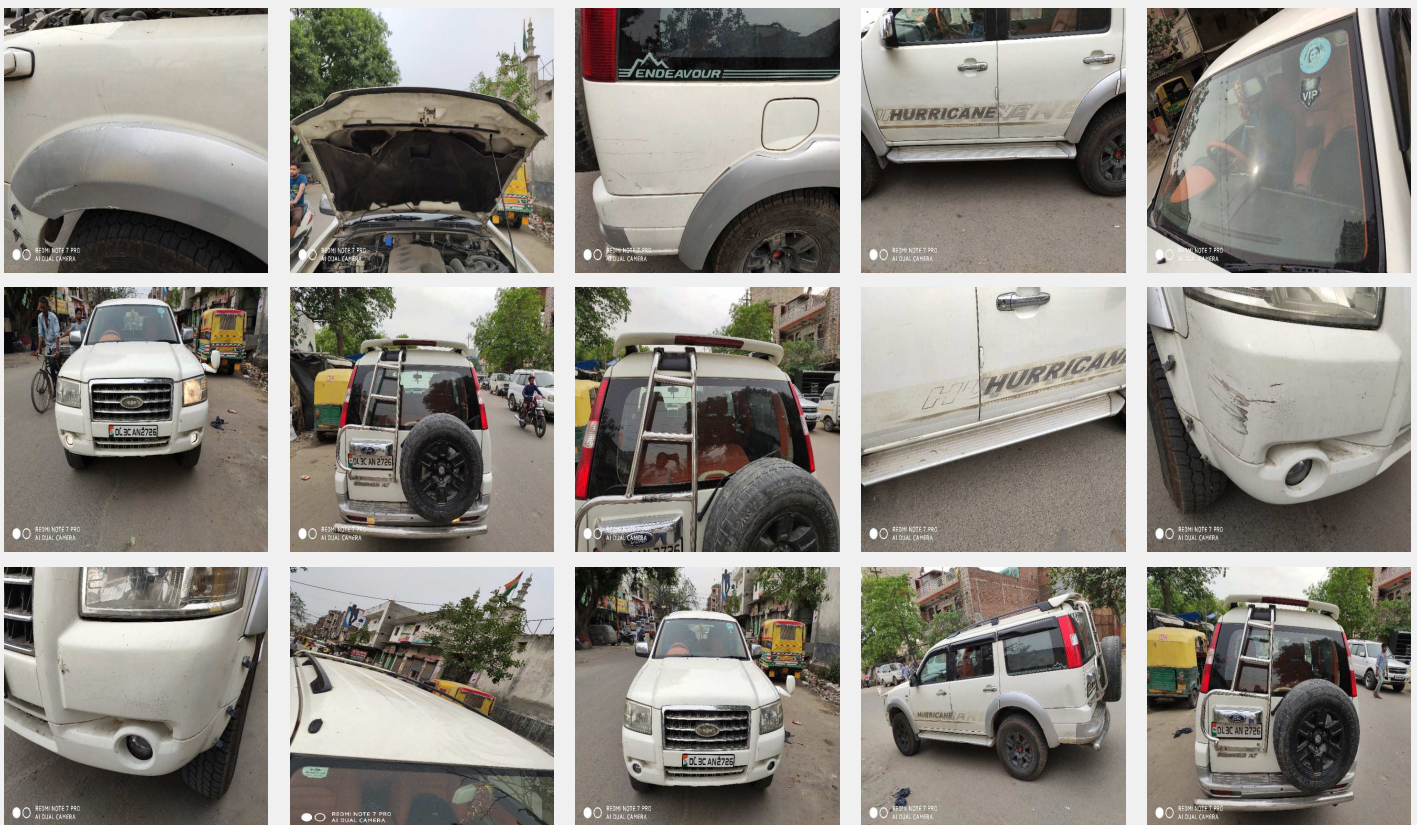
IMAGES

INSPECTION CHECKPOINTS	SCORE(X/10)	REMARKS/COMMENTS	OPTIONAL SPEND EST. (RS)
BODY RUST	6	AVERAGE CONDITION	0
ROOF (REGULAR)	6	AVERAGE CONDITION	0
PAINT CONDITION	6	AVERAGE CONDITION	0
HEAD LIGHTS	5	LEFT HEAD LIGHT NOT WORKING NEED TO CHECK AND REPAIR	300
LH QUARTER PANEL	5	DENT NEED TO BE REPAIR	1500

all scratches and dent need to be repair
