# ECO INSPECTION CERTIFICATE

121 Points Vehicle Inspection Certificate

## Mercedes-Benz E-Class 200K CLASSIC, 2005

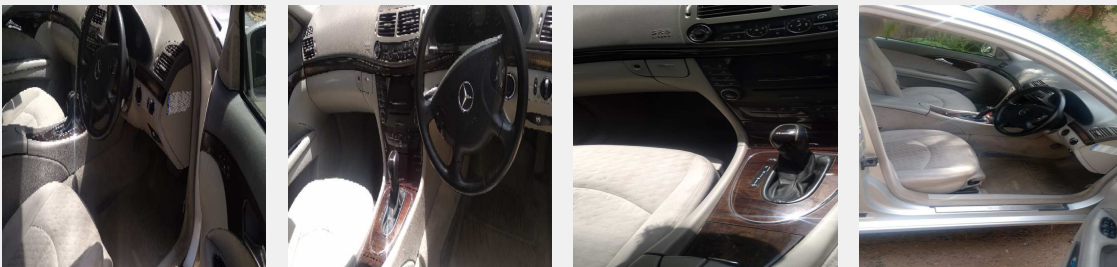
INSPECTION CHECKPOINTS	SCORE(X/10)	REMARKS/COMMENTS	OPTIONAL SPEND EST. (RS)
DOOR PANEL	7	GOOD CONDITION	0
DOOR HINGES	7	GOOD CONDITION	0
CARPET & FLOOR MAT	7	GOOD CONDITION	0
SEAT & SEAT BELT	7	GOOD CONDITION	0
DASHBOARD & INSTRUMENT PANEL	7	GOOD CONDITION	0
HORN	7	GOOD CONDITION	0
SPEAKERS & MUSIC SYSTEM	7	GOOD CONDITION	0
HANDBRAKE	7	GOOD CONDITION	0
STEERING-MOUNTED CONTROLS	7	GOOD CONDITION	0
PEDALS	7	GOOD CONDITION	0
CENTRAL LOCK	7	GOOD CONDITION	0
A/C VENTS & HEATER	7	GOOD CONDITION	0
CUP HOLDERS	7	GOOD CONDITION	0
NAVIGATION (NO)	10		0
ODOMETER	7	GOOD CONDITION	0
POWER WINDOWS (YES)	7	GOOD CONDITION	0
HAZARD LIGHT	7	GOOD CONDITION	0

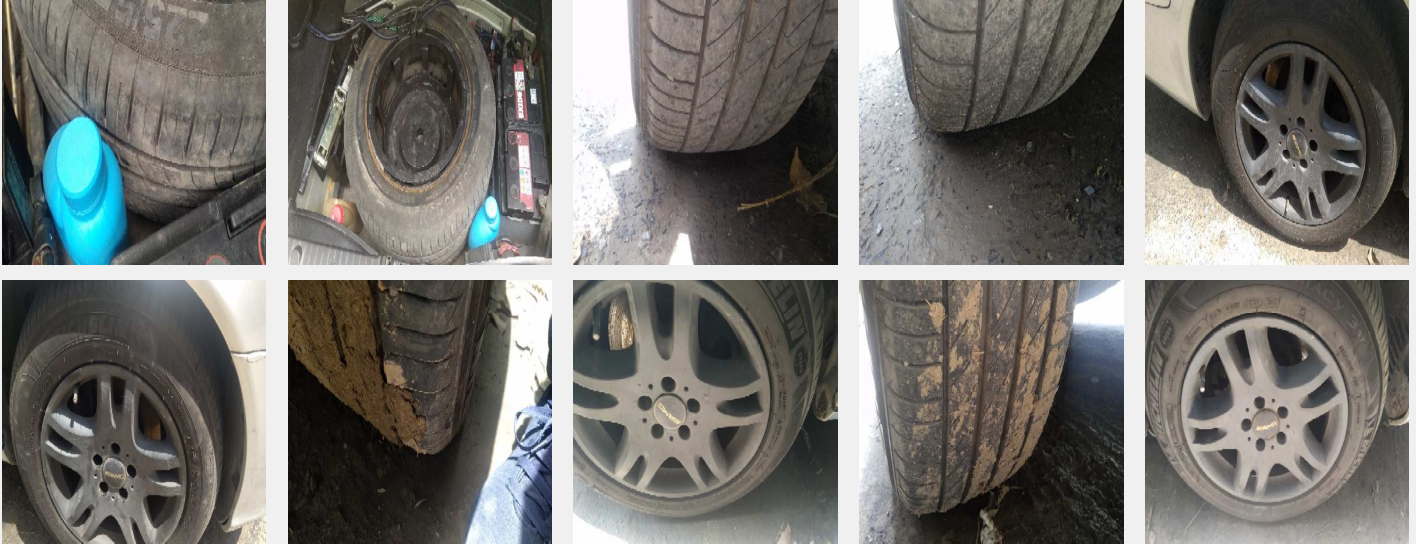
INSPECTION CHECKPOINTS	SCORE(X/10)	REMARKS/COMMENTS	OPTIONAL SPEND EST. (RS)
TYRES	7	GOOD CONDITION	0
SPARE TYRE (YES)	7	GOOD CONDITION	0
WHEEL ASSEMBLY (ALLOY RIM)	7	GOOD CONDITION	0

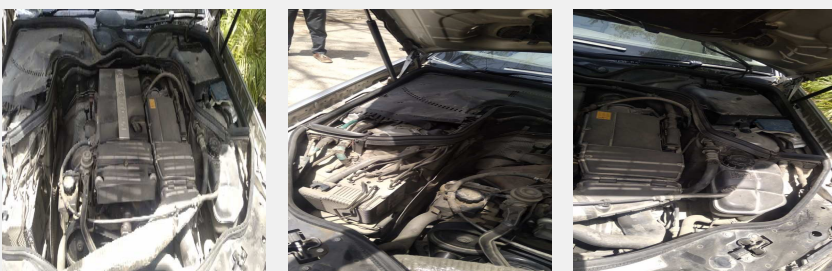
INSPECTION CHECKPOINTS	SCORE(X/10)	REMARKS/COMMENTS	OPTIONAL SPEND EST. (RS)
LH APRON	7	GOOD CONDITION	0
RH APRON	7	GOOD CONDITION	0
RADIATOR	7	GOOD CONDITION	0
WIRING	7	GOOD CONDITION	0
BATTERY	7	GOOD CONDITION	0
BRAKE FLUID LEVEL	7	MAX	0
ENGINE OIL	7	MAX	0
COOLANT LEVEL	7	MAX	0
BRAKE & COOLANT HOSE PIPES	7	GOOD CONDITION	0
UNDERCARRIAGE	7	GOOD CONDITION	0
EXHAUST SYSTEM	7	GOOD CONDITION	0

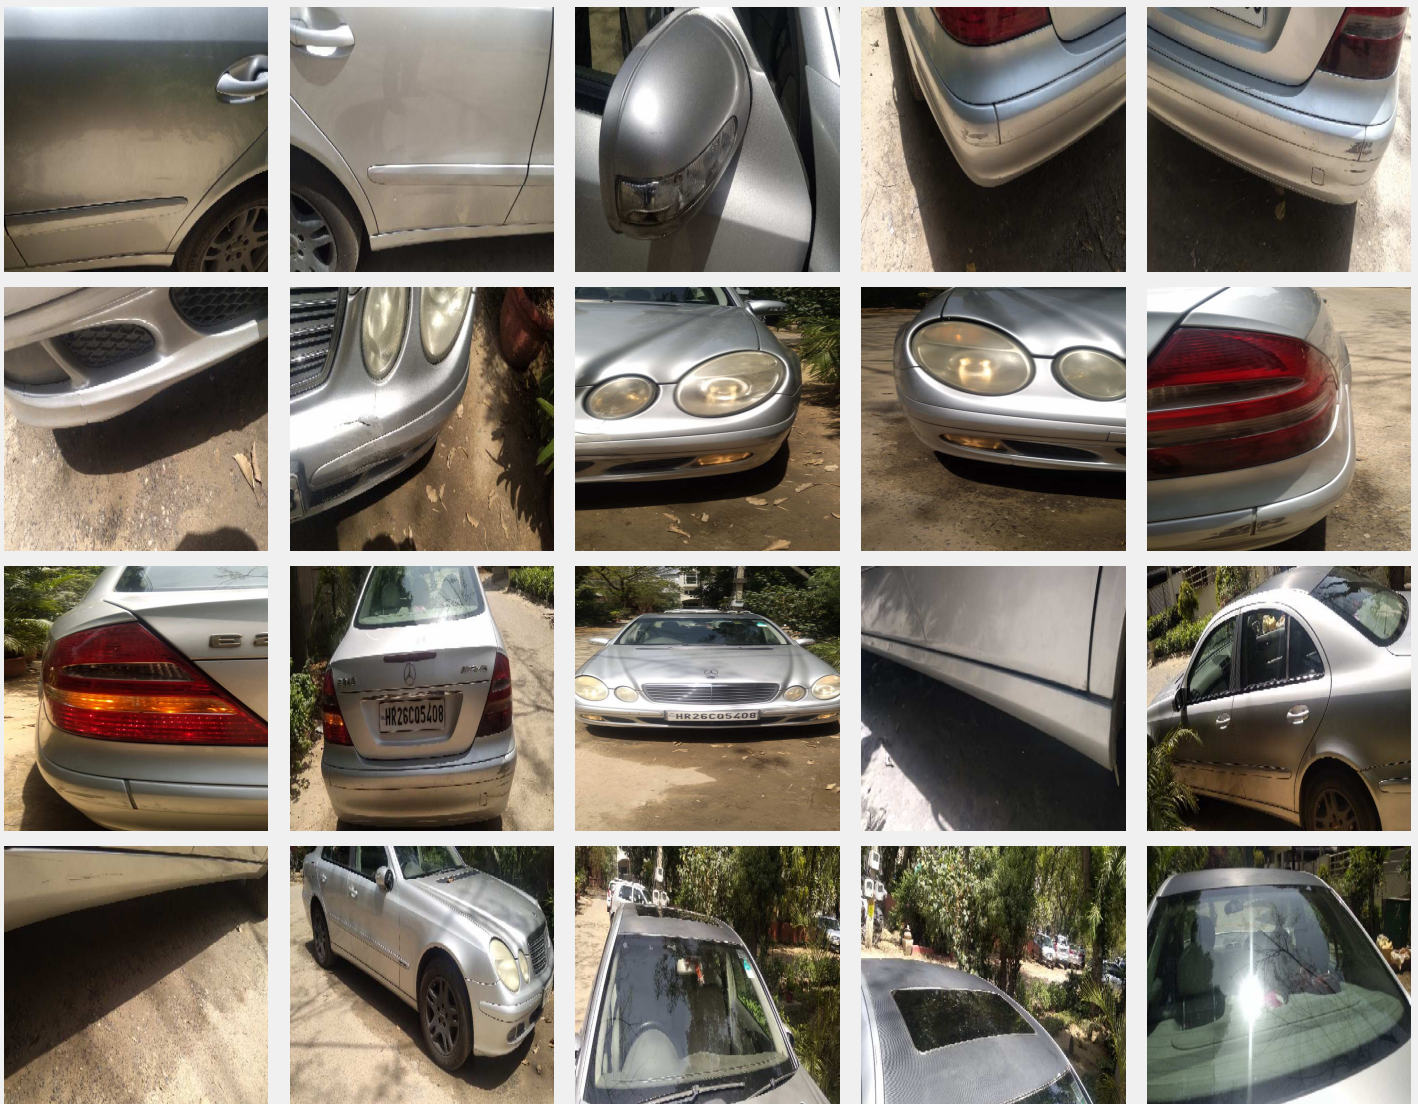
INSPECTION CHECKPOINTS	SCORE(X/10)	REMARKS/COMMENTS	OPTIONAL SPEND EST. (RS)
LICENSE PLATE	7	GOOD CONDITION	0
FRONT BUMPER	6	MINOR SCRATCHES AND CRACK	0
HEAD LIGHTS	7	GOOD CONDITION	0
GRILLE	7	GOOD CONDITION	0
TURN SIGNAL	7	GOOD CONDITION	0
FOG LAMPS	7	GOOD CONDITION	0
HOOD	7	GOOD CONDITION	0
PILLAR	7	GOOD CONDITION	0
FRONT WINDSHIELD	7	GOOD VISIBILITY	0
SIDE VIEW MIRRORS	6	MINOR CRACK	0
LH FENDER	7	GOOD CONDITION	0
LH FRONT DOOR	7	GOOD CONDITION	0
LH REAR DOOR	6	MINOR SCRATCHES	0
LH RUNNING BOARD	7	GOOD CONDITION	0
LH QUARTER PANEL	7	GOOD CONDITION	0
FUEL LID	7	GOOD CONDITION	0
REAR WINDSHIELD	7	GOOD VISIBILITY	0
REAR BUMPER	6	MINOR SCRATCHES	0
TAIL LIGHT	6	RHS NEED TO REPLACE	0
TRUNK LID/TAIL GATE	7	GOOD CONDITION	0
LUGGAGE COMPARTMENT LIGHT	7	GOOD CONDITION	0
RH QUARTER PANEL	7	GOOD CONDITION	0
RH RUNNING BOARD	7	GOOD CONDITION	0
RH REAR DOOR	6	MINOR SCRATCHES	0

INSPECTION CHECKPOINTS	SCORE(X/10)	REMARKS/COMMENTS	OPTIONAL SPEND EST. (RS)
RH FRONT DOOR	7	GOOD CONDITION	0
RH FENDER	7	GOOD CONDITION	0
BODY RUST	7	GOOD CONDITION	0
ROOF (SUN ROOF)	7	GOOD CONDITION	0
PAINT CONDITION	7	GOOD CONDITION	0

minor scratches car already painted
