ECO INSPECTION CERTIFICATE

Order ID : 61301

121 Points Vehicle Inspection Certificate

Tvs Apache 150CC, 2007

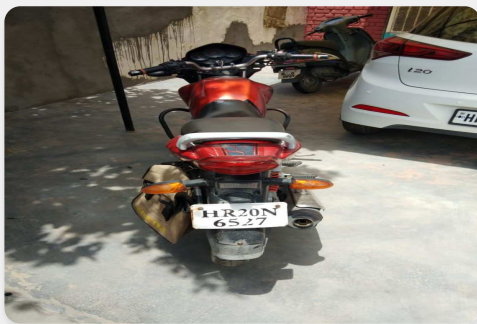
VEHICLE INFORMATION			
MAKE	TVS	ENGINE NUMBER	29920
MODEL	APACHE	REGISTRATION NO.	HR20N6527
YEAR	2007	VIN/CHASSIS NUMBER	20342
TRIM	150CC	ODOMETER READING	84916
COLOR	RED	INSURANCE EXPIRY	2019-5-2
FUEL TYPE	PETROL	ENGINE SOUND LINK	LISTEN ENGINE SOUND

KEY OBSERVATIONS			
FLOOD DAMAGE	NO	MAJOR ACCIDENT(S)	NO
TYRE LIFE REMAINING (KM)	8,000	RC COPY AVAILABLE	ORIGINAL
DENT	NO	INSURANCE COPY AVAILABLE	NO
		SERVICE LOGS AVAILABLE	NO
		BANK HYPOTHECATION	NO
		BANK NOC	NO
