ECO INSPECTION CERTIFICATE

121 Points Vehicle Inspection Certificate

Ordered By : Kalyan	Inspection Date : 2019-04-19	Location : SALT LAKE, SEC 2	Inspected By Labani Ray Naskar
-------------------------------	--	---------------------------------------	---

Mercedes-Benz Gla 200 CDI STYLE, 2016

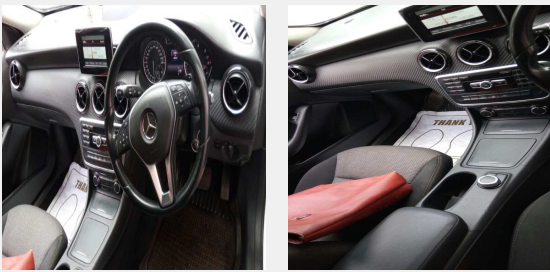
IMAGES

INSPECTION CHECKPOINTS	SCORE(X/10)	REMARKS/COMMENTS	OPTIONAL SPEND EST. (RS)
STEERING PERFORMANCE	6	GOOD CONDITION	0
BRAKE PERFORMANCE	6	GOOD CONDITION	0
CLUTCH PERFORMANCE	6	GOOD CONDITION	0
ENGINE NOISE	6	GOOD CONDITION	0
IGNITION SYSTEM	6	GOOD CONDITION	0
SUSPENSION PERFORMANCE	6	GOOD CONDITION	0
SUSPENSION FRONT SHOCKS	6	GOOD CONDITION	0
SUSPENSION REAR SHOCKS	6	GOOD CONDITION	0
TRANSMISSION ENGAGE	6	GOOD CONDITION	0
CRUISE CONTROL (YES)	6	GOOD CONDITION	0
REAR PARKING SENSORS (YES)	6	GOOD CONDITION	0
REAR VIEW CAMERA (YES)	6	GOOD CONDITION	0

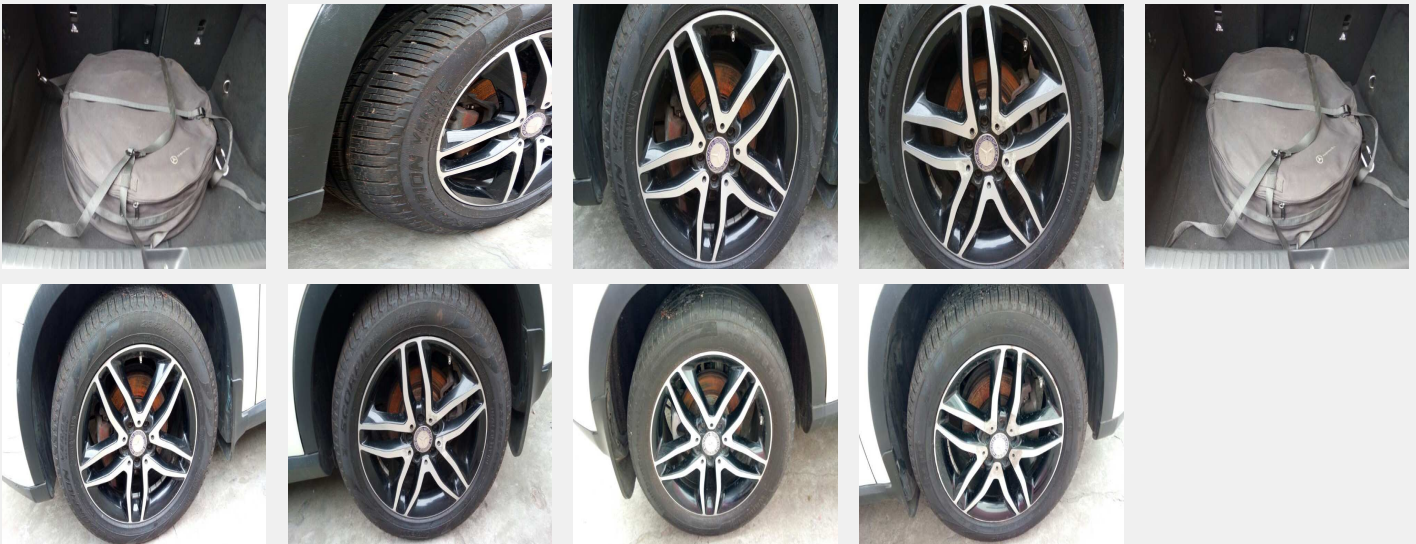
IMAGES

INSPECTION CHECKPOINTS	SCORE(X/10)	REMARKS/COMMENTS	OPTIONAL SPEND EST. (RS)
TYRES	6	GOOD CONDITION	0
SPARE TYRE (YES)	6	GOOD CONDITION	0
WHEEL ASSEMBLY (STEEL RIM)	6	GOOD CONDITION	0

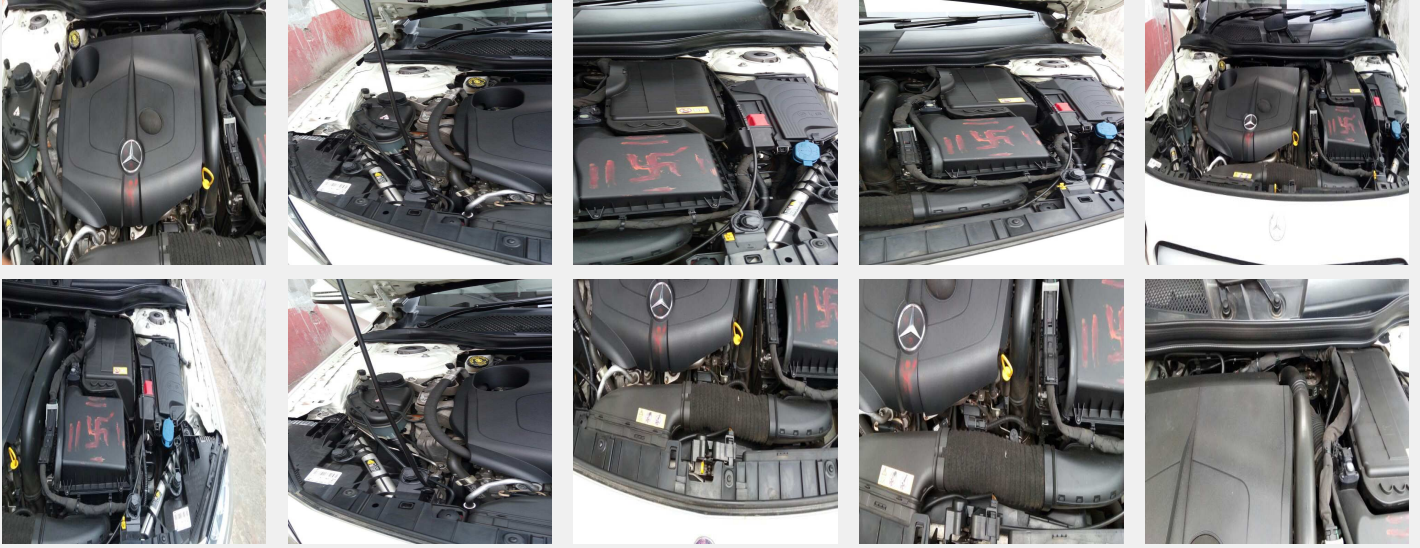
IMAGES

INSPECTION CHECKPOINTS	SCORE(X/10)	REMARKS/COMMENTS	OPTIONAL SPEND EST. (RS)
LH APRON	6	GOOD CONDITION	0
RH APRON	6	GOOD CONDITION	0
RADIATOR	6	GOOD CONDITION	0
WIRING	6	GOOD CONDITION	0
BATTERY	6	GOOD CONDITION	0
BRAKE FLUID LEVEL	6	GOOD CONDITION	0
ENGINE OIL	6	GOOD CONDITION	0
COOLANT LEVEL	6	GOOD CONDITION	0

BRAKE & COOLANT HOSE PIPES	6	GOOD CONDITION	0
UNDERCARRIAGE	6	GOOD CONDITION	0
EXHAUST SYSTEM	6	GOOD CONDITION	0

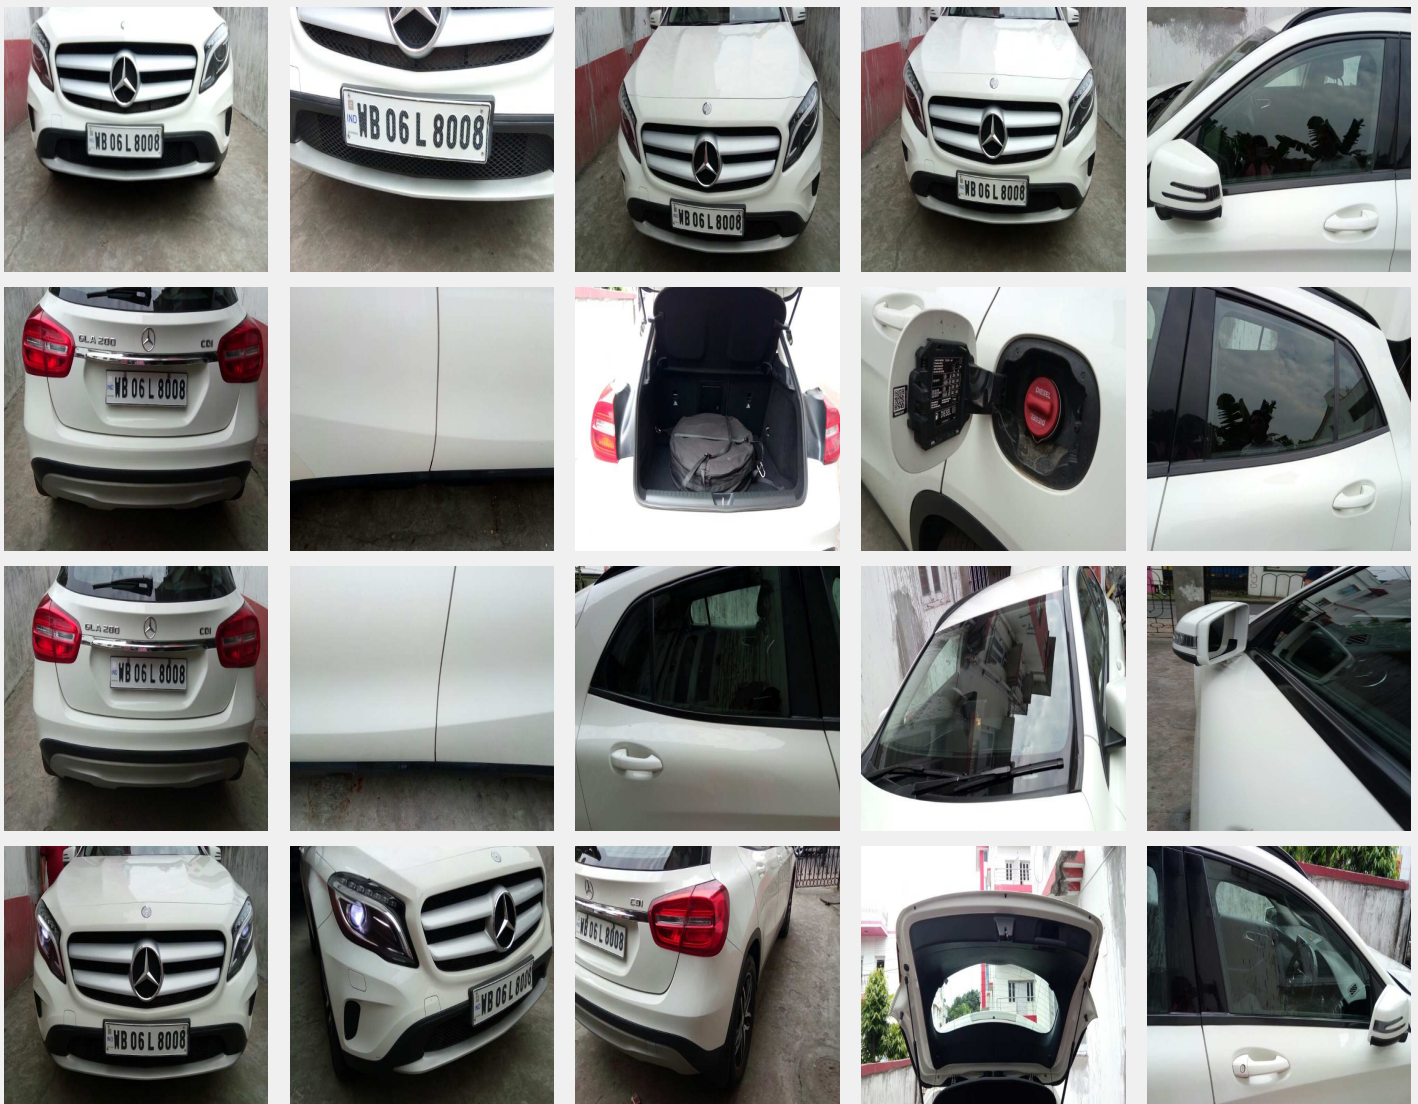
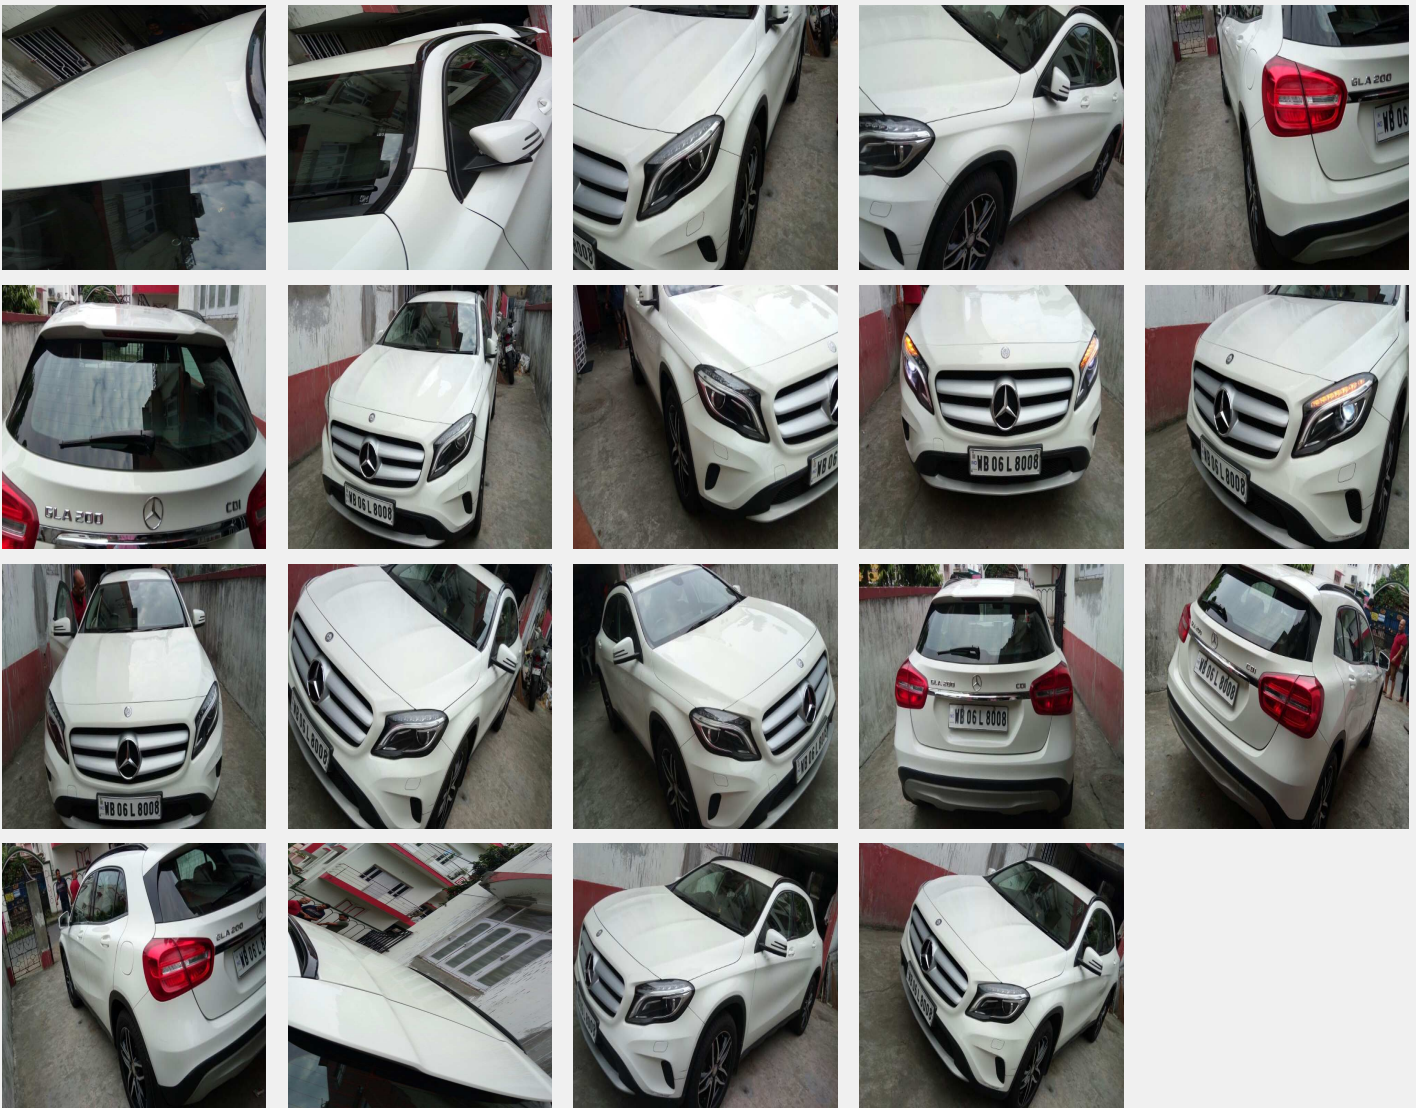
IMAGES

INSPECTION CHECKPOINTS	SCORE(X/10)	REMARKS/COMMENTS	OPTIONAL SPEND EST. (RS)
LICENSE PLATE	6	GOOD CONDITION	0
FRONT BUMPER	6	GOOD CONDITION	0
HEAD LIGHTS	6	GOOD CONDITION	0
GRILLE	6	GOOD CONDITION	0
TURN SIGNAL	6	GOOD CONDITION	0
FOG LAMPS	6	FOG LIGHT NOT AVAILABLE..	0
HOOD	6	GOOD CONDITION	0
PILLAR	6	GOOD CONDITION	0
FRONT WINDSHIELD	6	GOOD CONDITION	0
SIDE VIEW MIRRORS	6	GOOD CONDITION	0
LH FENDER	6	GOOD CONDITION	0
LH FRONT DOOR	6	GOOD CONDITION	0
LH REAR DOOR	6	GOOD CONDITION	0
LH RUNNING BOARD	6	GOOD CONDITION	0
LH QUARTER PANEL	6	GOOD CONDITION	0
FUEL LID	6	GOOD CONDITION	0
REAR WINDSHIELD	6	GOOD CONDITION	0
REAR BUMPER	6	GOOD CONDITION	0
TAIL LIGHT	6	GOOD CONDITION	0
TRUNK LID/TAIL GATE	6	GOOD CONDITION	0
LUGGAGE COMPARTMENT LIGHT	6	GOOD CONDITION	0
RH QUARTER PANEL	6	GOOD CONDITION	0
RH RUNNING BOARD	6	GOOD CONDITION	0
RH REAR DOOR	6	GOOD CONDITION	0

INSPECTION CHECKPOINTS	SCORE(X/10)	REMARKS/COMMENTS	OPTIONAL SPEND EST. (RS)
RH FRONT DOOR	6	GOOD CONDITION	0
RH FENDER	6	GOOD CONDITION	0
BODY RUST	6	GOOD CONDITION	0
ROOF (REGULAR)	6	GOOD CONDITION	0
PAINT CONDITION	6	GOOD CONDITION	0
