# ECO INSPECTION CERTIFICATE

Order ID : 68748

121 Points Vehicle Inspection Certificate

## Maruti Suzuki Alto LXI, 2004

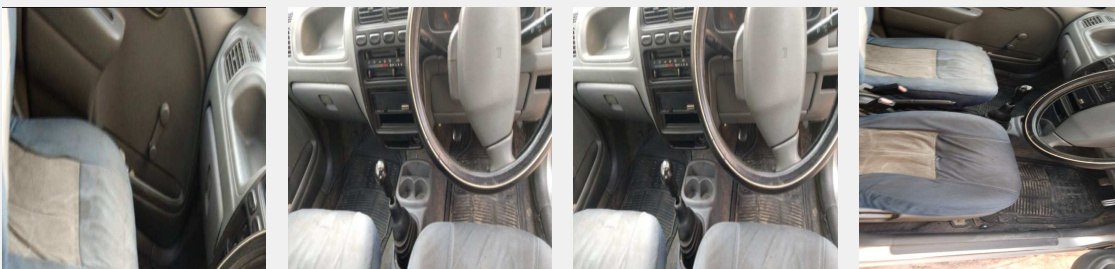
INSPECTION CHECKPOINTS	SCORE(X/10)	REMARKS/COMMENTS	OPTIONAL SPEND EST. (RS)
DOOR PANEL	7		0
DOOR HINGES	8		0
CARPET & FLOOR MAT	7		0
SEAT & SEAT BELT	8		0
DASHBOARD & INSTRUMENT PANEL	7		0
HORN	8		0
HANDBRAKE	8		0
STEERING-MOUNTED CONTROLS	7		0
PEDALS	8		0
A/C VENTS & HEATER	7		0
CUP HOLDERS	9		0
NAVIGATION (NO)	10		0
POWER WINDOWS (NO)	10		0
HAZARD LIGHT	7		0
SPEAKERS & MUSIC SYSTEM	1	MISSING	2000
CENTRAL LOCK	0	NOT FITTING	0
ODOMETER	1	NOT WORKING	2000

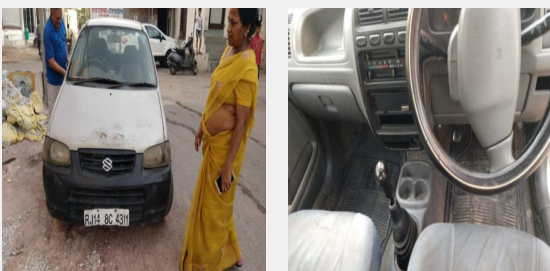
INSPECTION CHECKPOINTS	SCORE(X/10)	REMARKS/COMMENTS	OPTIONAL SPEND EST. (RS)
STEERING PERFORMANCE	8		0
BRAKE PERFORMANCE	7		0
CLUTCH PERFORMANCE	8		0
ENGINE NOISE	7		0
SUSPENSION PERFORMANCE	7		0
SUSPENSION FRONT SHOCKS	8		0
SUSPENSION REAR SHOCKS	6		0
CRUISE CONTROL (NO)	10		0
REAR PARKING SENSORS (NO)	10		0
REAR VIEW CAMERA (NO)	10		0
IGNITION SYSTEM	1	MISSING	0
TRANSMISSION ENGAGE	1	NOT WORKING	2000

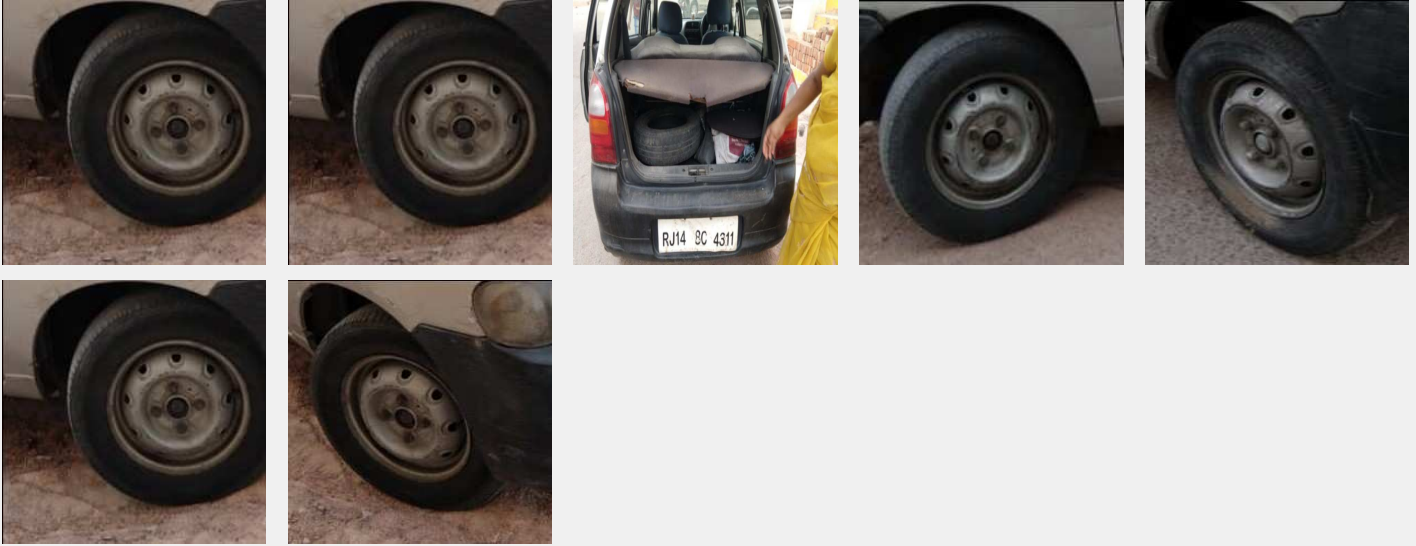
INSPECTION CHECKPOINTS	SCORE(X/10)	REMARKS/COMMENTS	OPTIONAL SPEND EST. (RS)
TYRES	7		0
SPARE TYRE (YES)	8		0
WHEEL ASSEMBLY (STEEL RIM)	8		0

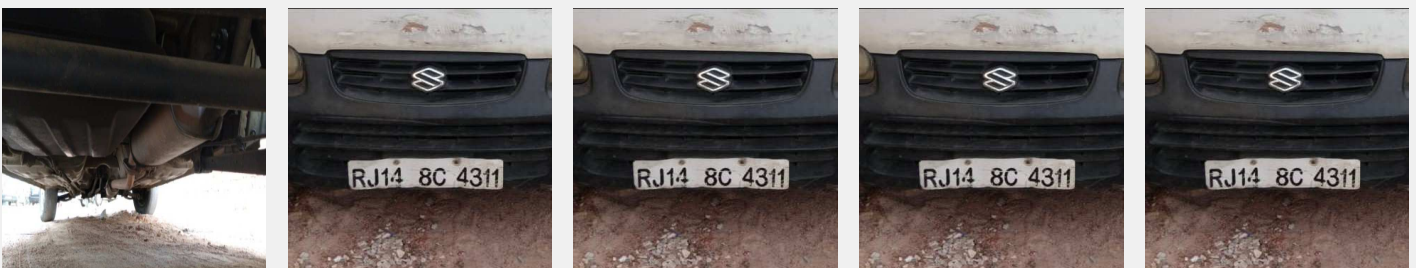
INSPECTION CHECKPOINTS	SCORE(X/10)	REMARKS/COMMENTS	OPTIONAL SPEND EST. (RS)
RH APRON	7	NOT OPENING	0
RADIATOR	6	NOT OPENING	0
WIRING	7	NOT OPENING	0
BATTERY	6	NOT OPENING	0
BRAKE FLUID LEVEL	7	NOT OPENING	0
ENGINE OIL	6	NOT OPENING	0
COOLANT LEVEL	7	NOT OPENING	0
BRAKE & COOLANT HOSE PIPES	7	NOT OPENING	0
UNDERCARRIAGE	7		0
EXHAUST SYSTEM	7		0
LH APRON	1	NOT OPENING	500

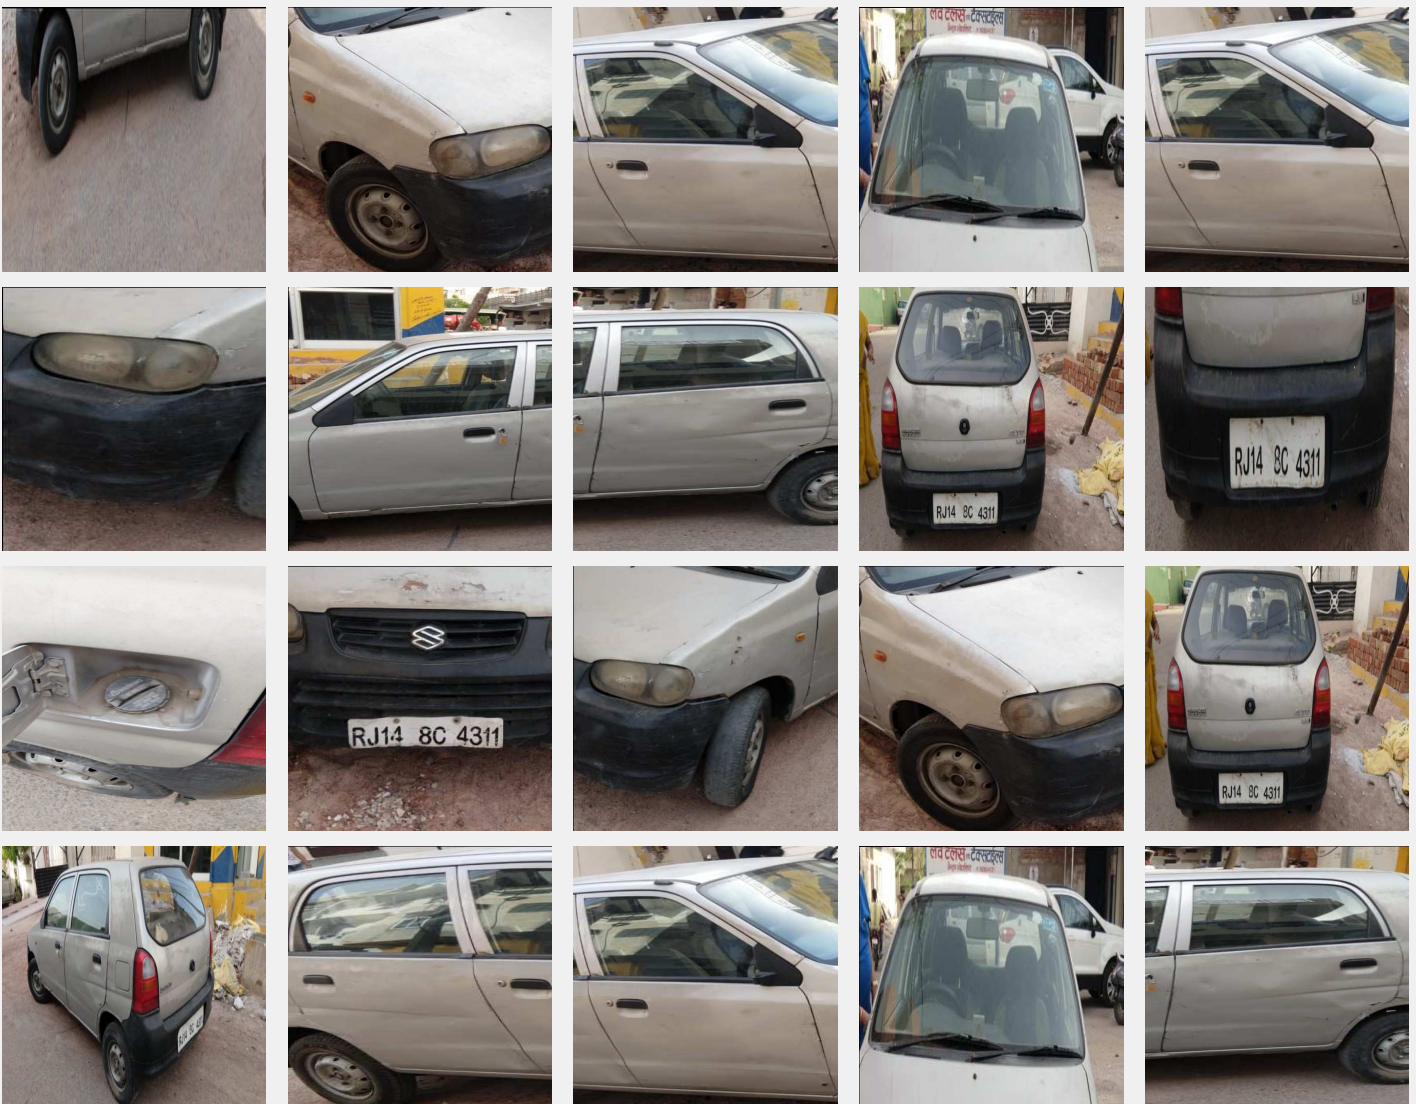
INSPECTION CHECKPOINTS	SCORE(X/10)	REMARKS/COMMENTS	OPTIONAL SPEND EST. (RS)
FRONT BUMPER	3	BROKEN	2000
HEAD LIGHTS	2	NOT CLEAR	2000
FOG LAMPS	0	NOT FITTING	0
HOOD	2	NOT OPENING	500
PAINT CONDITION	2	FAIR	10000
