ECO INSPECTION CERTIFICATE

121 Points Vehicle Inspection Certificate

Ordered By : Akash	Inspection Date : 2019-05-02	Location : CHINHAT	Inspected By

Ford Figo DURATORQ DIESEL LXI 1.4, 2011

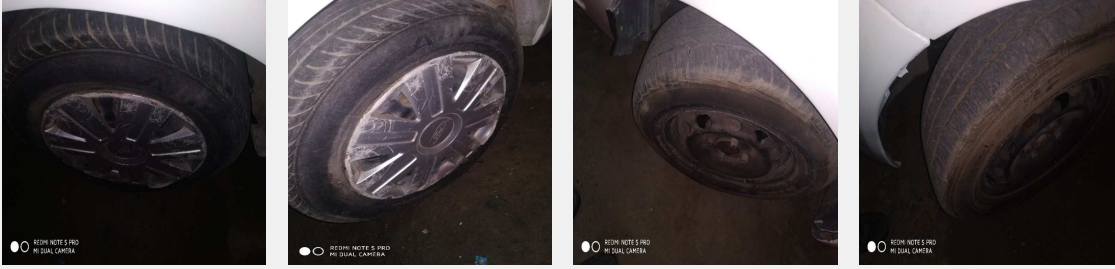
INSPECTION CHECKPOINTS	SCORE(X/10)	REMARKS/COMMENTS	OPTIONAL SPEND EST. (RS)
TYRES	6		0
SPARE TYRE (YES)	6		0
WHEEL ASSEMBLY (STEEL RIM)	6		0

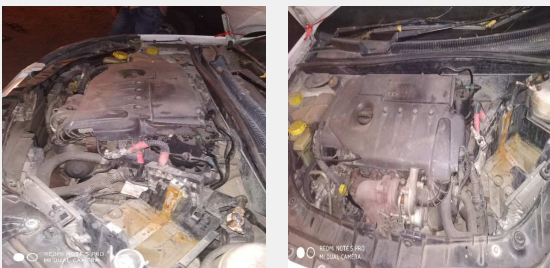
HOOD

INSPECTION CHECKPOINTS	SCORE(X/10)	REMARKS/COMMENTS	OPTIONAL SPEND EST. (RS)
LH APRON	6		0
RH APRON	6		0
RADIATOR	6		0
WIRING	7		0
BATTERY	6		0
BRAKE FLUID LEVEL	6		0
ENGINE OIL	6		0
COOLANT LEVEL	6		0
BRAKE & COOLANT HOSE PIPES	6		0
UNDERCARRIAGE	6		0
EXHAUST SYSTEM	6		0
