ECO INSPECTION CERTIFICATE

121 Points Vehicle Inspection Certificate

Ordered By : Madan	Inspection Date : 2019-05-01	Location : DELHI

Tata Manza Aura Abs Quadrajt Bs-iv, 2012

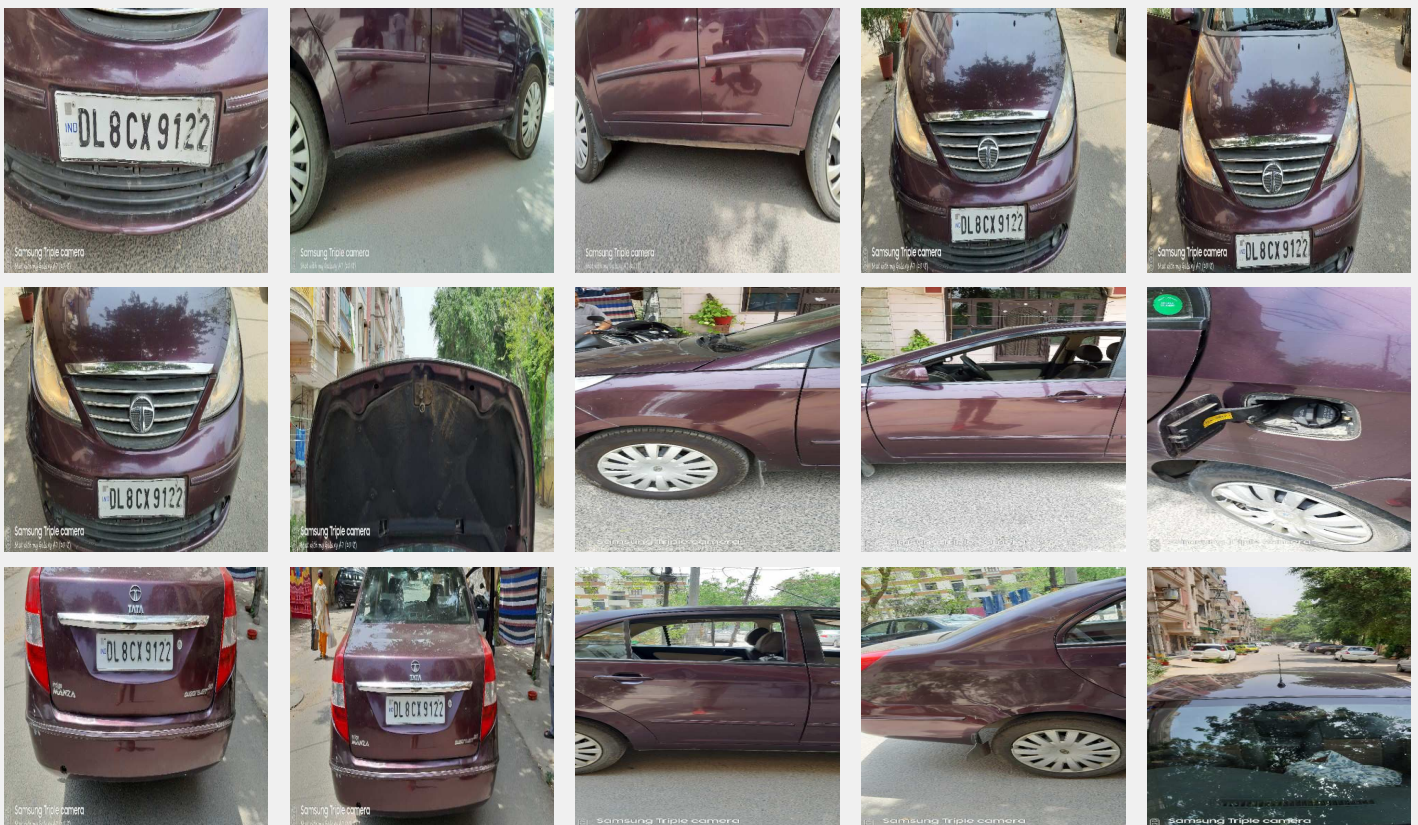
INSPECTION CHECKPOINTS	SCORE(X/10)	REMARKS/COMMENTS	OPTIONAL SPEND EST. (RS)
PAINT CONDITION	7	GOOD	0
FRONT BUMPER	5	SCRATCHES AND SOME PART BROKEN NEED TO REPAIR	3500
FOG LAMPS	0	NOT WORKING NEED TO CHANGE	2000
LH REAR DOOR	4	SCRATCHES NEED TO PAINT	3000
LH QUARTER PANEL	4	SCRATCHES NEED TO PAINT	2000

fog lamp is not working left hand rear door scratches minor scratches in body
