# ECO INSPECTION CERTIFICATE

Order ID : 69332

121 Points Vehicle Inspection Certificate

## Fiat Linea ACTIVE 1.3L ADVANCED MULTIJET DIESEL, 2009

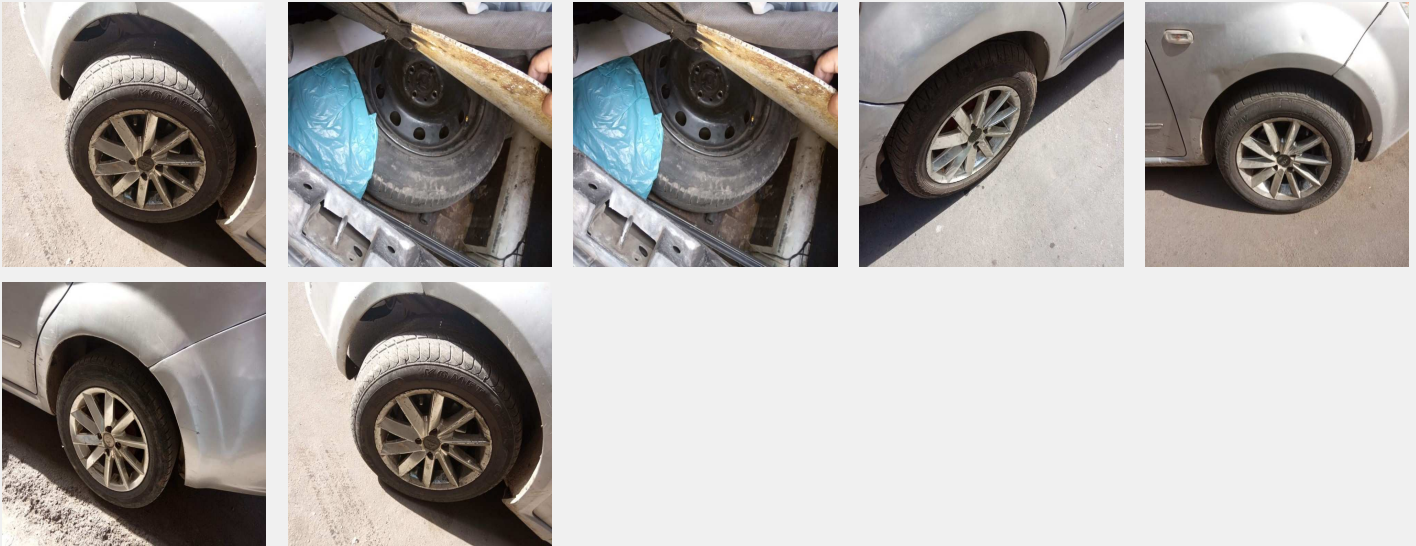
IMAGES

INSPECTION CHECKPOINTS	SCORE(X/10)	REMARKS/COMMENTS	OPTIONAL SPEND EST. (RS)
TYRES	8		0
SPARE TYRE (YES)	7		0
WHEEL ASSEMBLY (ALLOY RIM)	8		0

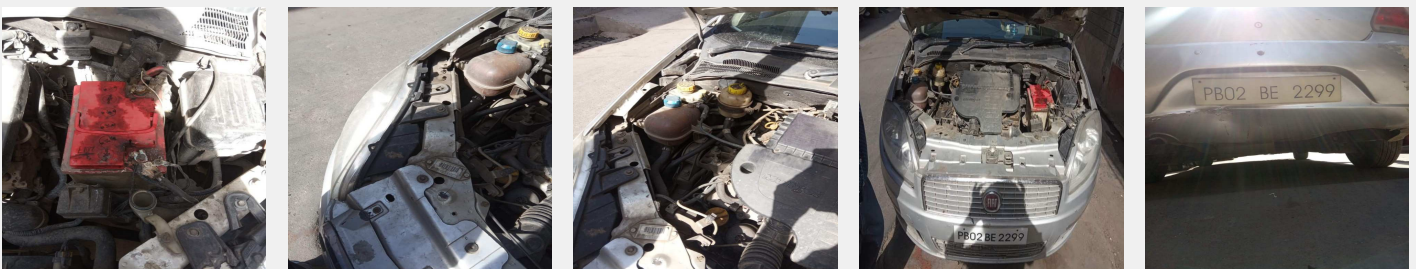
IMAGES

INSPECTION CHECKPOINTS	SCORE(X/10)	REMARKS/COMMENTS	OPTIONAL SPEND EST. (RS)
LH APRON	8		0
RH APRON	9		0
RADIATOR	8		0
WIRING	8		0
BATTERY	9		0
BRAKE FLUID LEVEL	9		0
ENGINE OIL	7		0
COOLANT LEVEL	8		0
BRAKE & COOLANT HOSE PIPES	7		0
UNDERCARRIAGE	9		0
EXHAUST SYSTEM	8		0

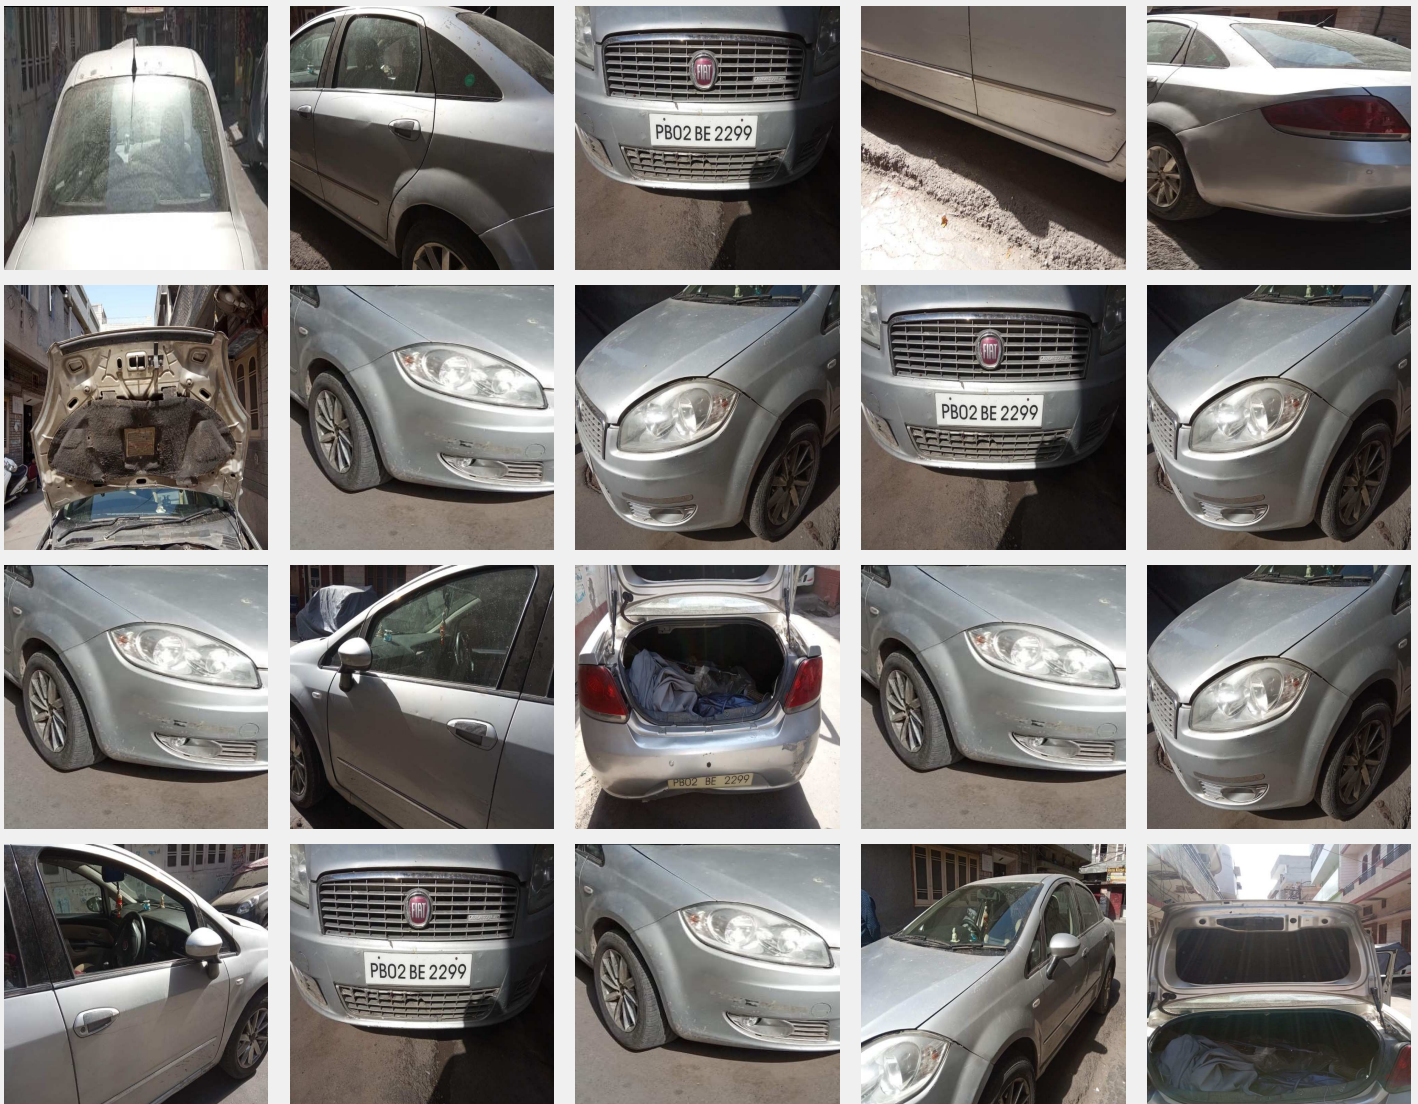
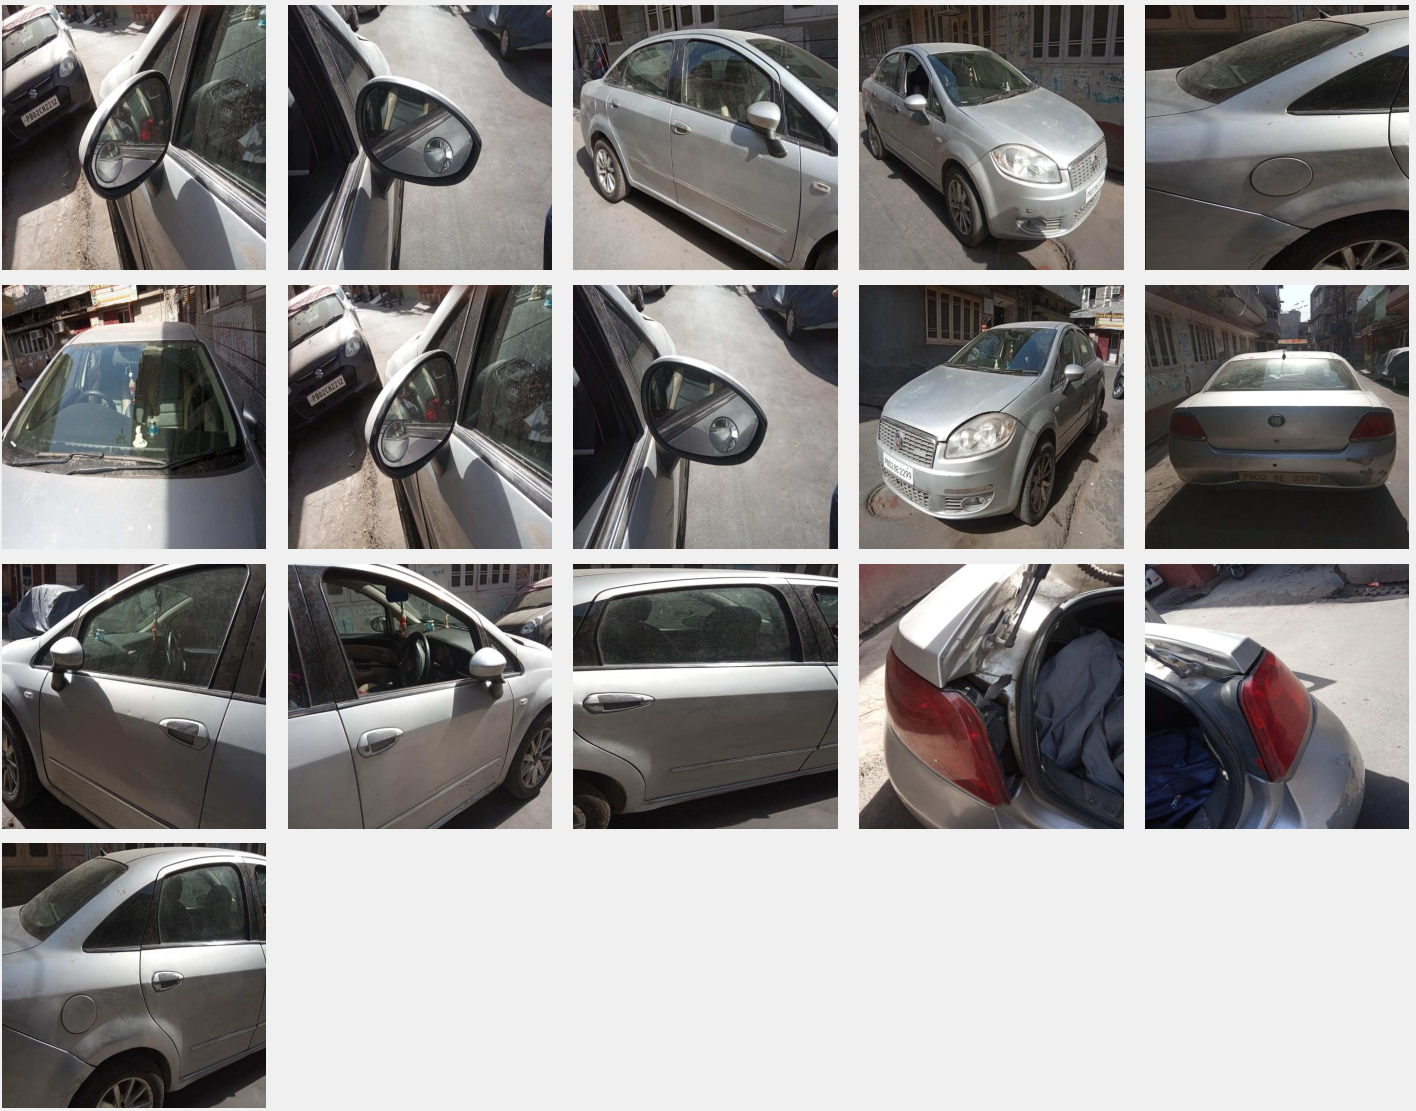
## IMAGES

INSPECTION CHECKPOINTS	SCORE(X/10)	REMARKS/COMMENTS	OPTIONAL SPEND EST. (RS)
RH FENDER	9		0
BODY RUST	8		0
ROOF (REGULAR)	9		0
REAR BUMPER	2	BROKEN	2000
PAINT CONDITION	3	SCRACH	5000
