# ECO INSPECTION CERTIFICATE

Order ID : 71894

121 Points Vehicle Inspection Certificate

## Hyundai Accent GLE, 2008

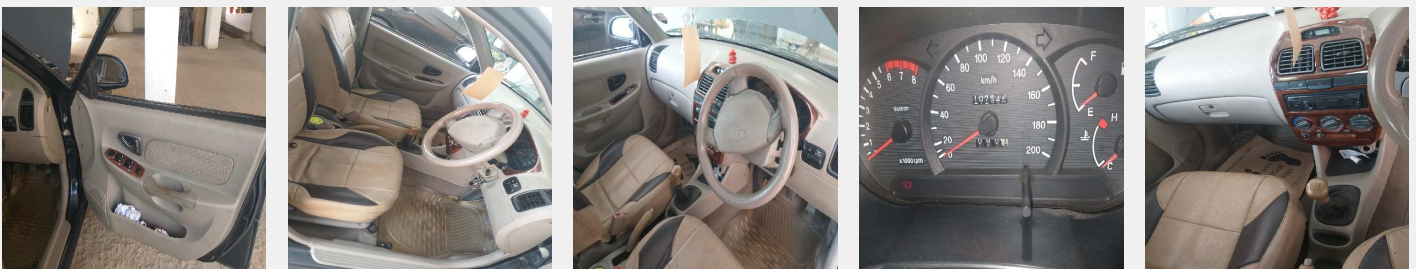
INSPECTION CHECKPOINTS	SCORE(X/10)	REMARKS/COMMENTS	OPTIONAL SPEND EST. (RS)
DOOR PANEL	7	GOOD	0
DOOR HINGES	7	GOOD	0
CARPET & FLOOR MAT	7	GOOD	0
SEAT & SEAT BELT	7	GOOD	0
DASHBOARD & INSTRUMENT PANEL	7	GOOD	0
HORN	7	GOOD	0
SPEAKERS & MUSIC SYSTEM	7	GOOD	0
HANDBRAKE	7	GOOD	0
PEDALS	7	GOOD	0
CENTRAL LOCK	7	GOOD	0
A/C VENTS & HEATER	7	GOOD	0
CUP HOLDERS	7	GOOD	0
NAVIGATION (NO)	10		0
ODOMETER	7	GOOD	0
POWER WINDOWS (YES)	7	GOOD	0
HAZARD LIGHT	7	GOOD	0
STEERING-MOUNTED CONTROLS	0	NOT AVAILABLE	0

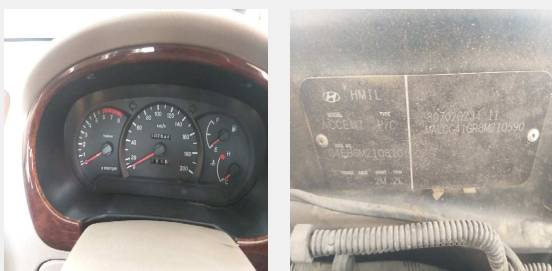
INSPECTION CHECKPOINTS	SCORE(X/10)	REMARKS/COMMENTS	OPTIONAL SPEND EST. (RS)
STEERING PERFORMANCE	7	GOOD	0
BRAKE PERFORMANCE	7	GOOD	0
CLUTCH PERFORMANCE	7	GOOD	0
ENGINE NOISE	7	GOOD	0
IGNITION SYSTEM	7	GOOD	0
SUSPENSION PERFORMANCE	7	GOOD	0
SUSPENSION FRONT SHOCKS	7	GOOD	0
SUSPENSION REAR SHOCKS	7	GOOD	0
TRANSMISSION ENGAGE	7	GOOD	0
CRUISE CONTROL (NO)	10		0
REAR PARKING SENSORS (NO)	10		0
REAR VIEW CAMERA (NO)	10		0

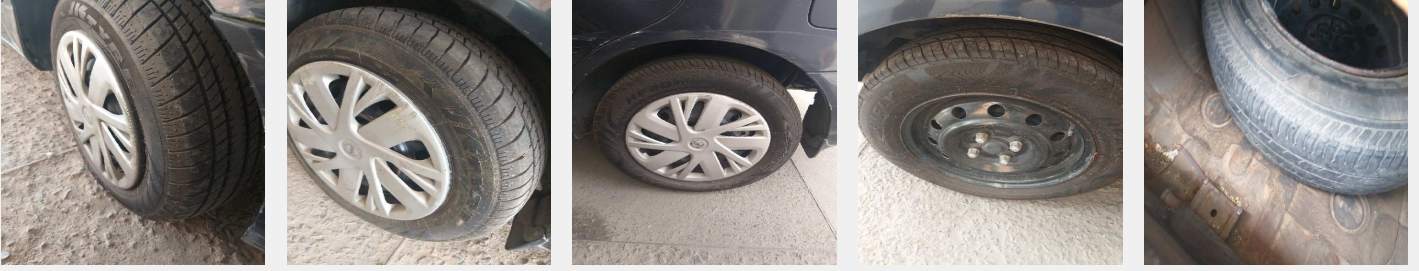
INSPECTION CHECKPOINTS	SCORE(X/10)	REMARKS/COMMENTS	OPTIONAL SPEND EST. (RS)
TYRES	8	GOOD	0
SPARE TYRE (YES)	8	GOOD	0
WHEEL ASSEMBLY (STEEL RIM)	7	GOOD	0

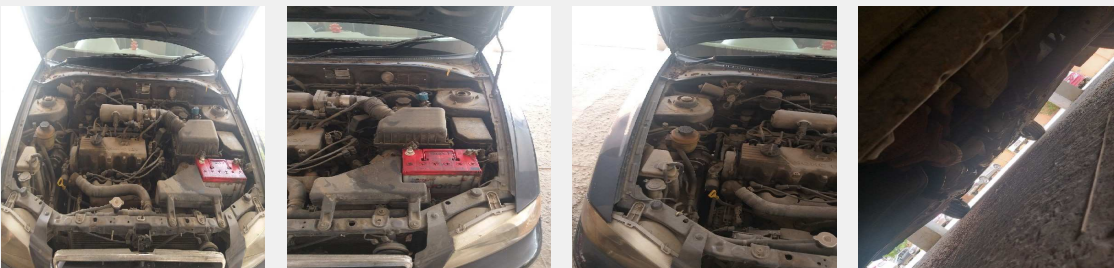
INSPECTION CHECKPOINTS	SCORE(X/10)	REMARKS/COMMENTS	OPTIONAL SPEND EST. (RS)
LH APRON	7	GOOD	0
RH APRON	7	GOOD	0
RADIATOR	7	GOOD	0
WIRING	7	GOOD	0
BATTERY	7	GOOD	0
BRAKE FLUID LEVEL	7	MAXIMUM	0
ENGINE OIL	7	MAXIMUM	0
COOLANT LEVEL	7	MAXIMUM	0
BRAKE & COOLANT HOSE PIPES	7	GOOD	0
UNDERCARRIAGE	7	GOOD	0
EXHAUST SYSTEM	7	GOOD	0

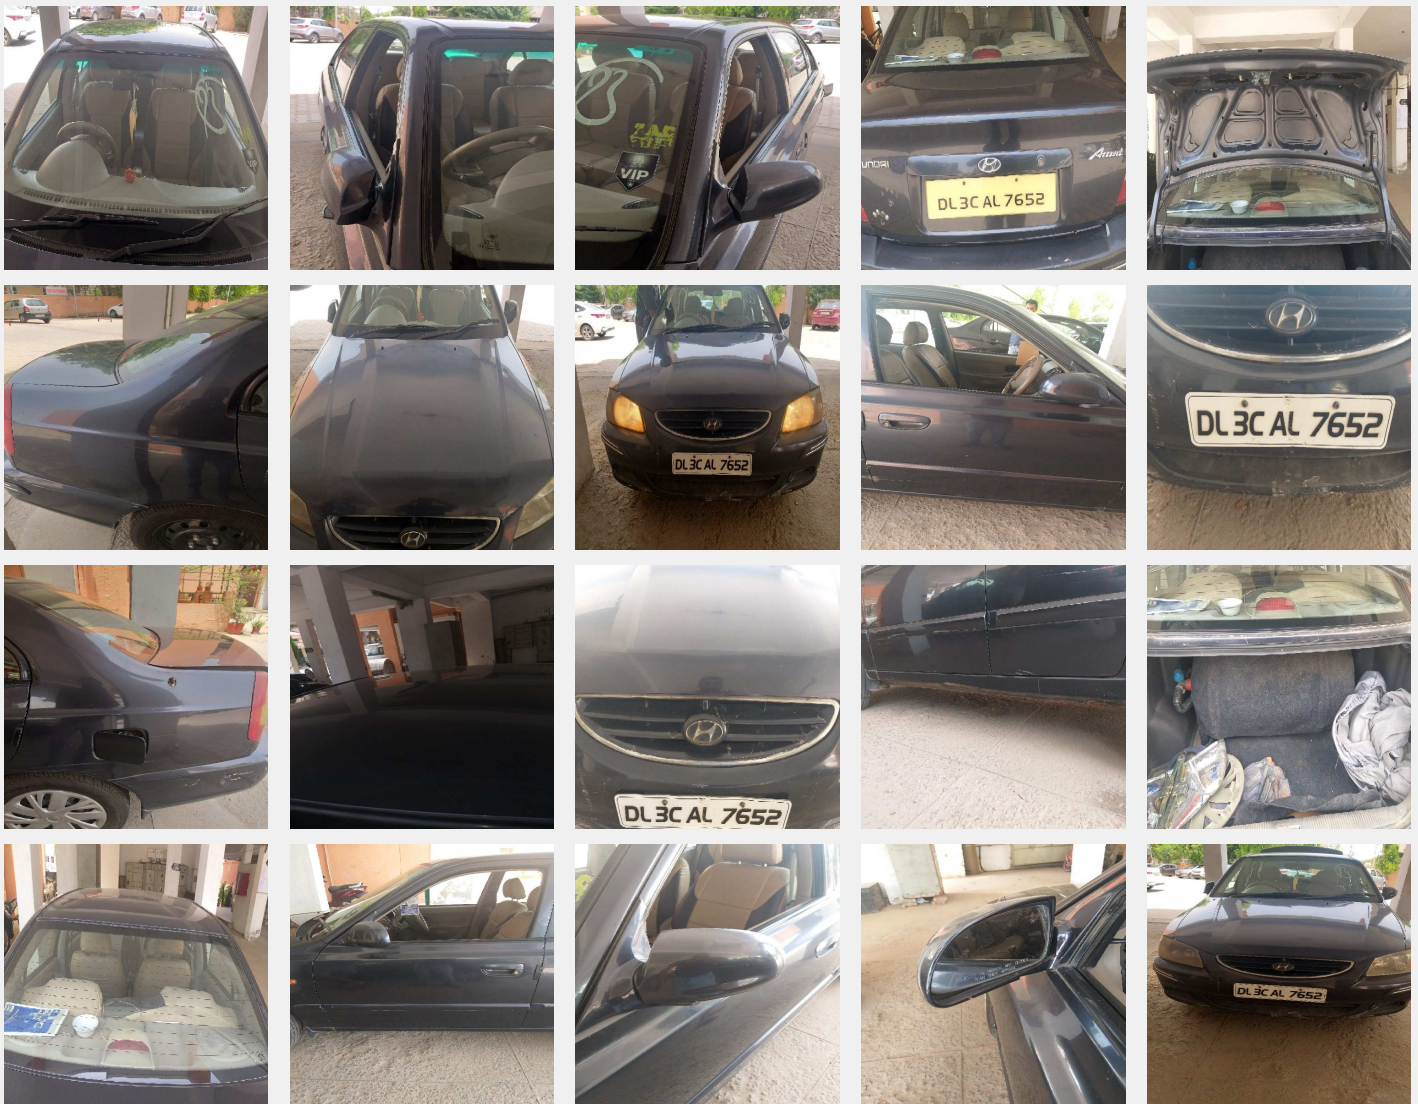
INSPECTION CHECKPOINTS	SCORE(X/10)	REMARKS/COMMENTS	OPTIONAL SPEND EST. (RS)
LICENSE PLATE	7	GOOD	0
HEAD LIGHTS	6	FAIR CONDITION AND WORKING PROPERLY	0
GRILLE	7	GOOD	0
TURN SIGNAL	7	GOOD	0
HOOD	7	GOOD	0
PILLAR	7	GOOD	0
FRONT WINDSHIELD	7	GOOD VISIBILITY	0
SIDE VIEW MIRRORS	7	GOOD	0
LH FRONT DOOR	7	GOOD	0
LH RUNNING BOARD	7	GOOD	0
LH QUARTER PANEL	6	MINOR SCRATCHES	500
FUEL LID	7	GOOD	0
REAR WINDSHIELD	7	GOOD VISIBILITY	0
TRUNK LID/TAIL GATE	7	GOOD	0
LUGGAGE COMPARTMENT LIGHT	7	GOOD	0
RH QUARTER PANEL	7	GOOD	0
RH FRONT DOOR	6	MINOR SCRATCHES	500
BODY RUST	7	GOOD	0
ROOF (REGULAR)	7	GOOD	0
PAINT CONDITION	7	GOOD	0
FRONT BUMPER	5	NEED TO BE REAPING	2500
FOG LAMPS	0	NOT AVAILABLE	0
LH FENDER	5	MINOR SCRATCHES AND NEED TO BE REAPING	2500
LH REAR DOOR	5	MINOR SCRATCHES AND NEED TO BE REAPING	500

INSPECTION CHECKPOINTS	SCORE(X/10)	REMARKS/COMMENTS	OPTIONAL SPEND EST. (RS)
REAR BUMPER	5	NEED TO BE REAPING	2500
TAIL LIGHT	4	FAIR CONDITION NEEDS TO BE CHANG BOTH	3500
RH RUNNING BOARD	5	NEED TO BE REAPING	500
RH REAR DOOR	5	NEED TO BE REAPING	3500
RH FENDER	5	NEED TO BE REAPING	2500

minor scratches and dent
