ECO INSPECTION CERTIFICATE

121 Points Vehicle Inspection Certificate

Inspection Date :
2019-05-22

Chevrolet Aveo 1.4 CNG, 2011

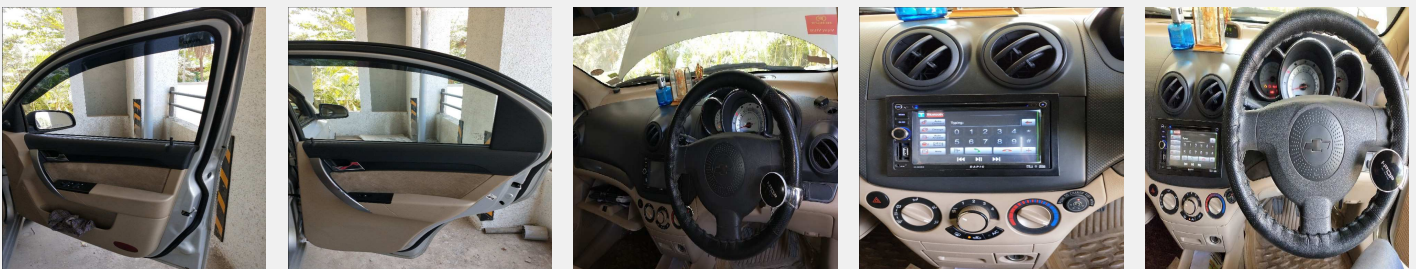
INSPECTION CHECKPOINTS	SCORE(X/10)	REMARKS/COMMENTS	OPTIONAL SPEND EST. (RS)
DOOR PANEL	6	GOOD CONDITION	0
DOOR HINGES	6	ACCEPTABLE	0
CARPET & FLOOR MAT	6	ACCEPTABLE CONDITION	0
SEAT & SEAT BELT	6	GOOD WORKING	0
DASHBOARD & INSTRUMENT PANEL	6	GOOD WORKING CONDITION	0
HORN	6	GOOD SOUND	0
SPEAKERS & MUSIC SYSTEM	6	GOOD WORKING	0
HANDBRAKE	6	WORKING PROPERLY	0
PEDALS	6	GOOD WORKING	0
CENTRAL LOCK	6	WORKING GOOD	0
A/C VENTS & HEATER	6	GOOD COOLING	0
CUP HOLDERS	6	NO DAMAGE	0
NAVIGATION (NO)	10		0
ODOMETER	6	GOOD WORKING	0
POWER WINDOWS (YES)	6	WORKING GOOD	0
HAZARD LIGHT	6	WORKING GOOD	0
STEERING-MOUNTED CONTROLS	0	NOT AVAILABLE	0

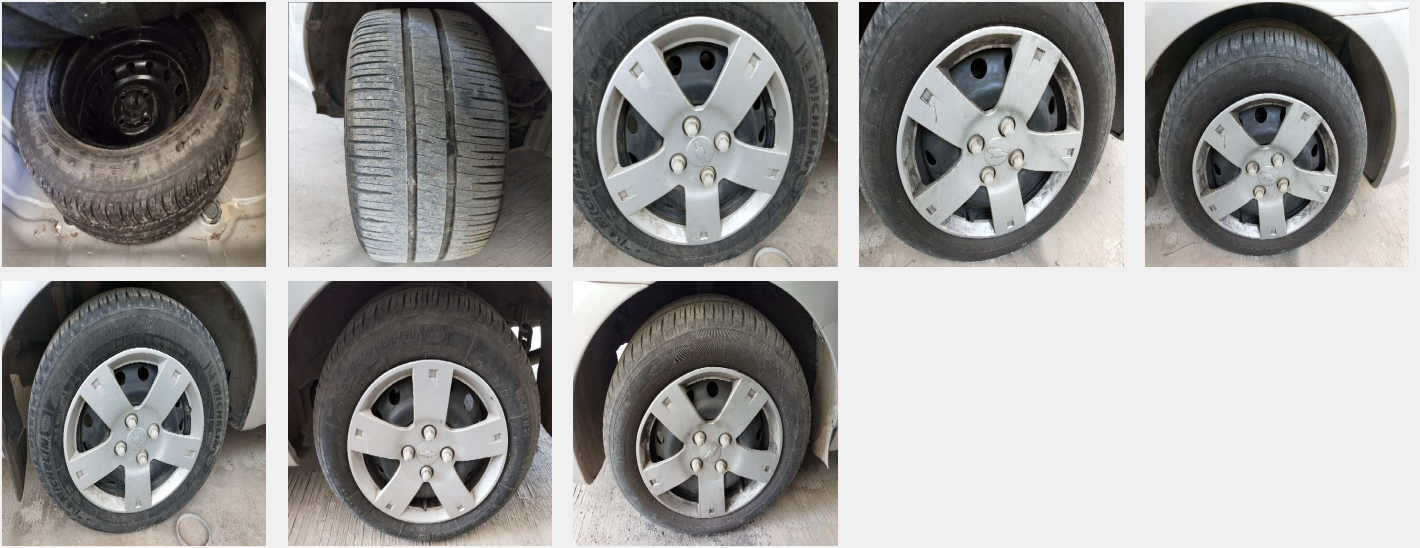
INSPECTION CHECKPOINTS	SCORE(X/10)	REMARKS/COMMENTS	OPTIONAL SPEND EST. (RS)
TYRES	6	NORMAL WEAR AND TEAR	0

SPARE TYRE (YES)	6	GOOD CONDITION	0
WHEEL ASSEMBLY (STEEL RIM)	6	GOOD CONDITION	0

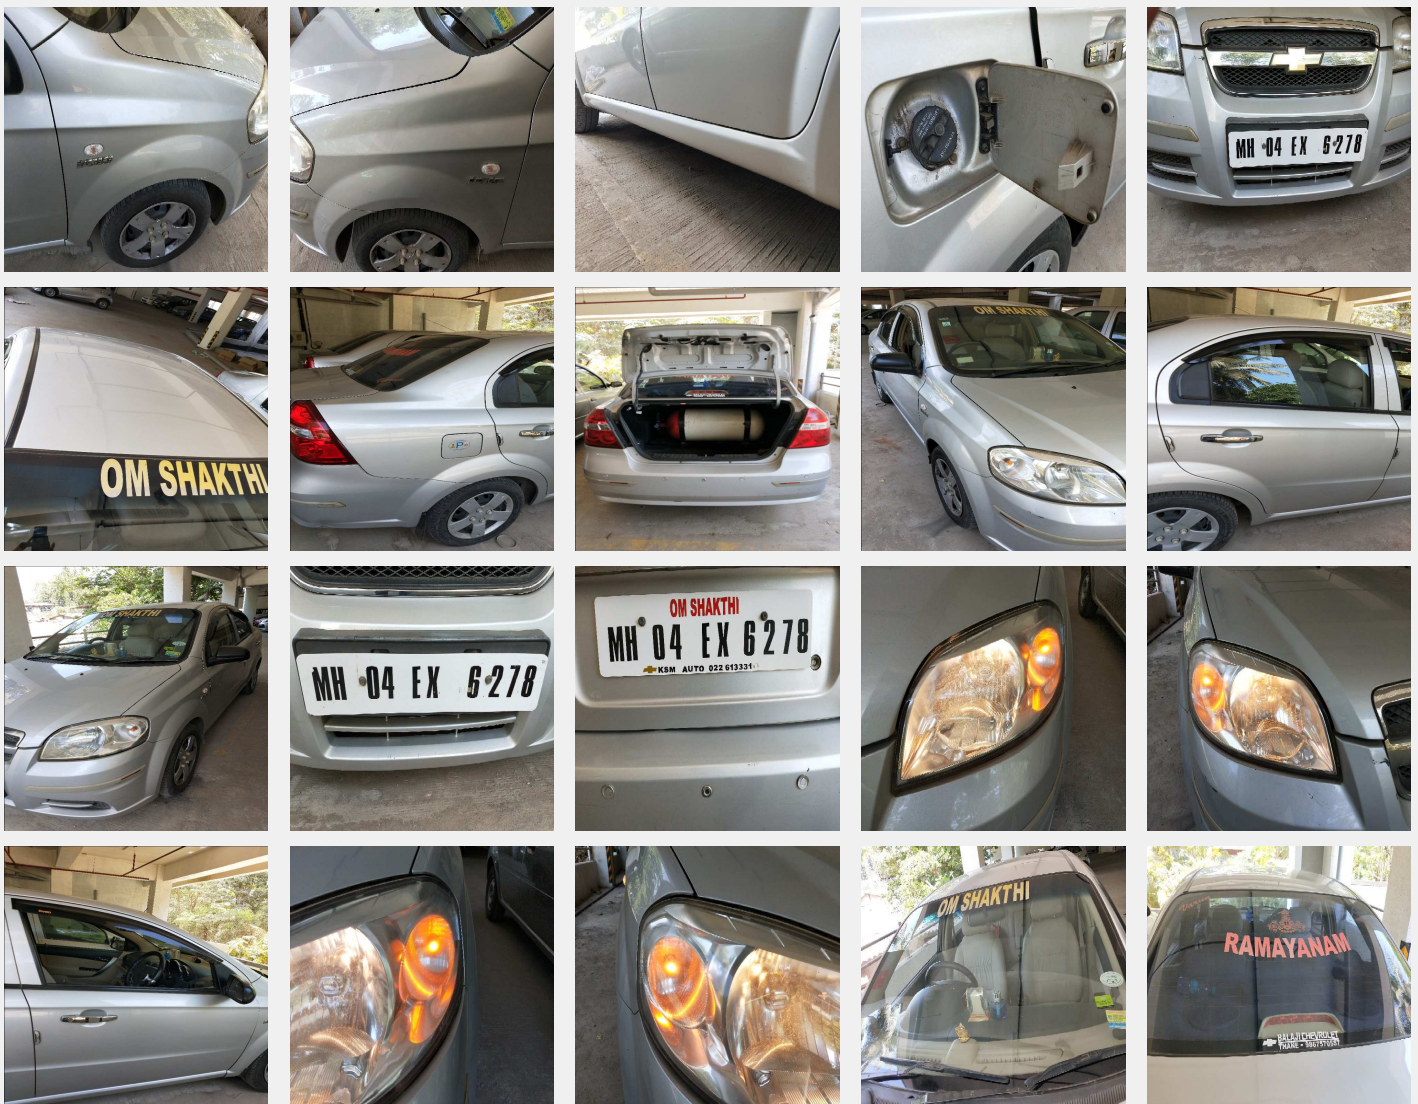
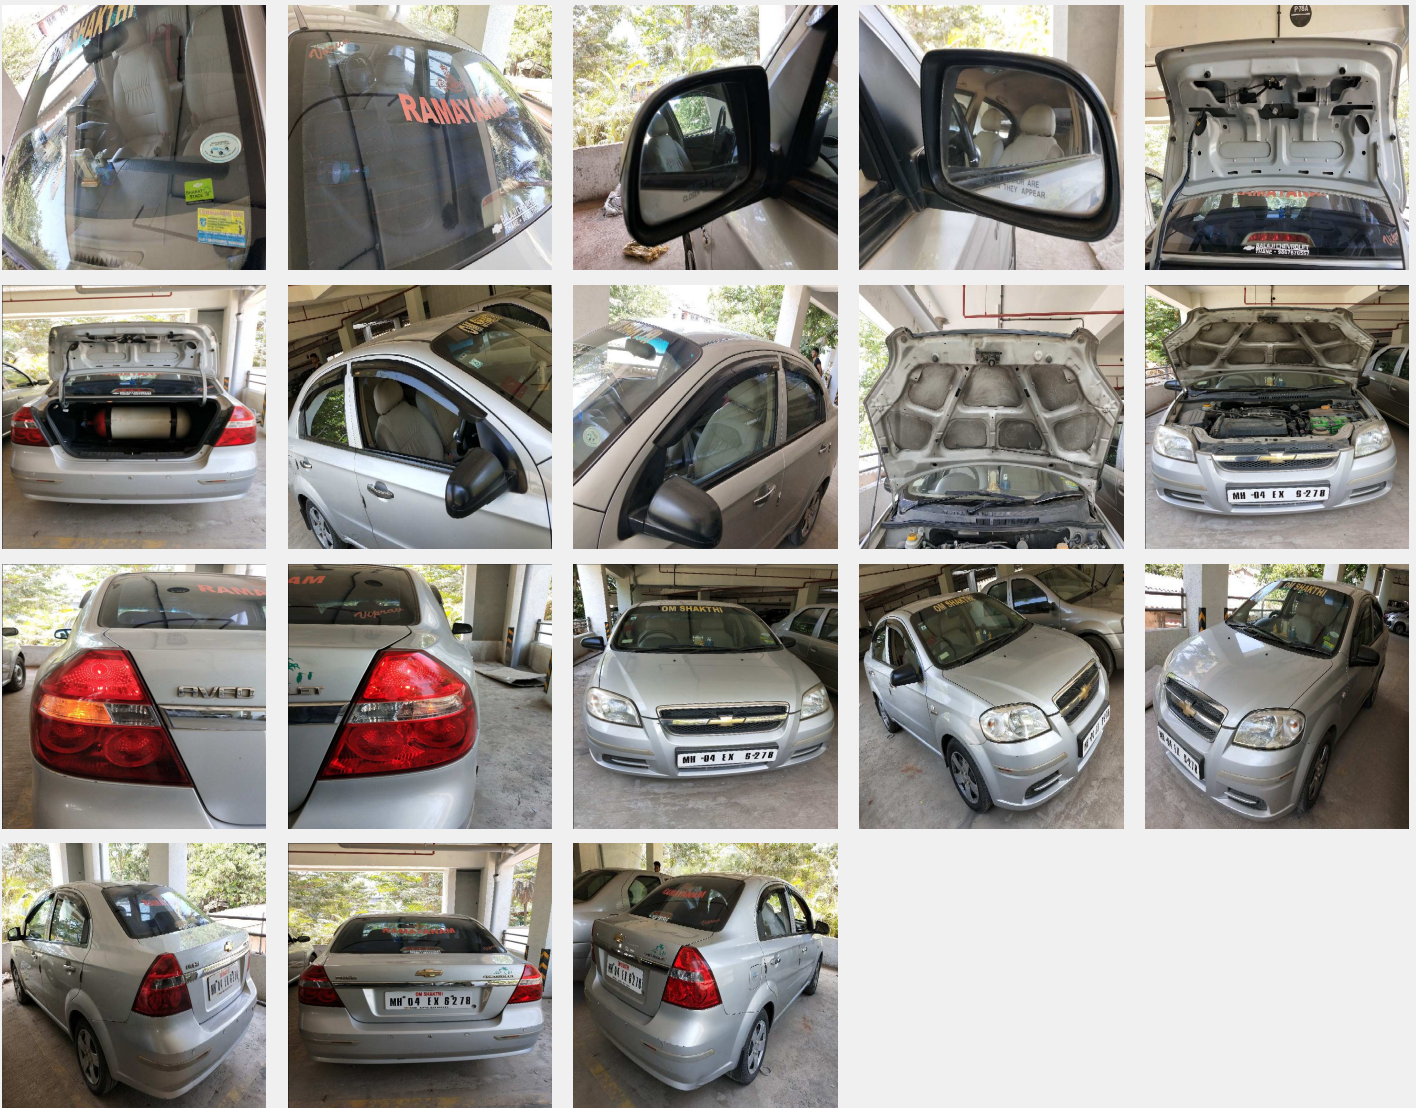
INSPECTION CHECKPOINTS	SCORE(X/10)	REMARKS/COMMENTS	OPTIONAL SPEND EST. (RS)
LH FRONT DOOR	5	MINOR DENT FOUND	1500
LH REAR DOOR	5	MINOR SCRATCHES FOUND	1500
LH QUARTER PANEL	5	MINOR SCRATCHES FOUND	2000
REAR BUMPER	5	NEED TO PAINT	2000
RH RUNNING BOARD	5	MINOR SCRATCH FOUND	1000

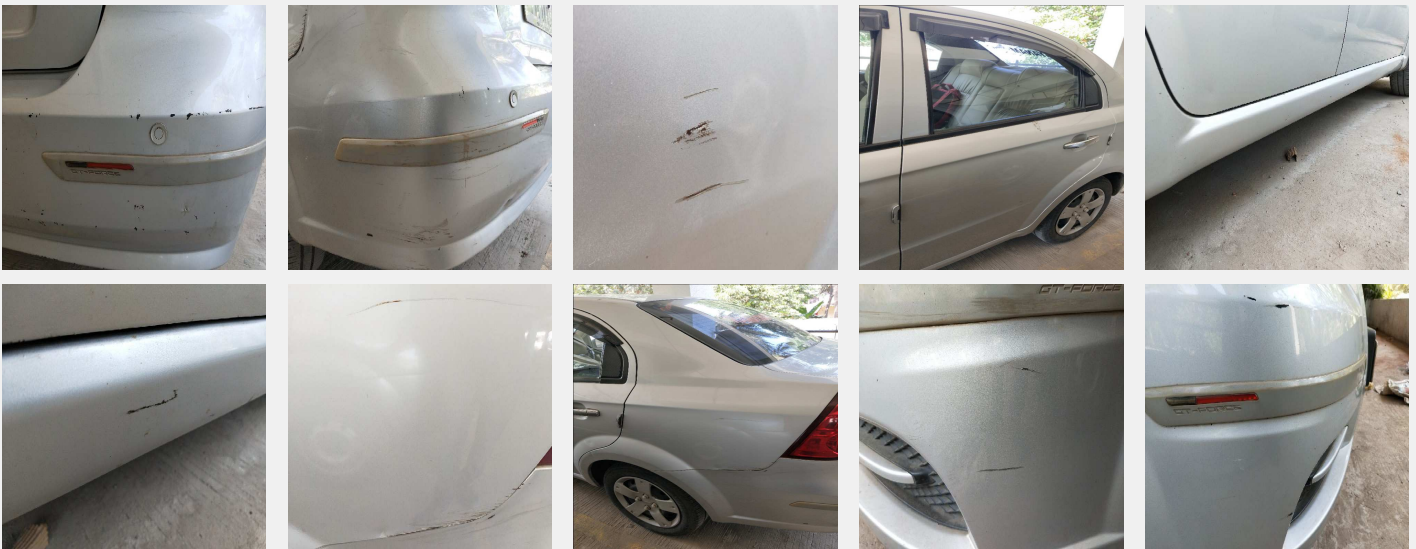
**NEED ATTENTION**

INSPECTION CHECKPOINTS	SCORE(X/10)	REMARKS/COMMENTS	OPTIONAL SPEND EST. (RS)
LICENSE PLATE	6	GOOD CONDITION	0
HEAD LIGHTS	6	GOOD WORKING	0
GRILLE	6	ACCEPTABLE	0
TURN SIGNAL	6	GOOD WORKING	0
HOOD	6	GOOD CONDITION	0
PILLAR	6	GOOD CONDITION	0
FRONT WINDSHIELD	6	GOOD VISIBILITY	0
SIDE VIEW MIRRORS	6	GOOD CONDITION	0
LH FENDER	6	GOOD CONDITION	0
LH RUNNING BOARD	6	GOOD CONDITION	0
FUEL LID	6	GOOD CONDITION	0
REAR WINDSHIELD	6	CLEAR VISIBILITY	0
TAIL LIGHT	6	GOOD WORKING	0
TRUNK LID/TAIL GATE	6	GOOD CONDITION	0
LUGGAGE COMPARTMENT LIGHT	6	NORMAL SPACE	0
RH QUARTER PANEL	6	GOOD CONDITION	0
RH REAR DOOR	6	GOOD CONDITION	0
RH FRONT DOOR	6	GOOD CONDITION	0
RH FENDER	6	GOOD CONDITION	0
BODY RUST	6	NO RUST FOUND	0
ROOF (REGULAR)	6	GOOD CONDITION	0
PAINT CONDITION	6	GOOD CONDITION	0
FRONT BUMPER	5	MINOR SCRATCHES FOUND	1500
FOG LAMPS	0	NOT AVAILABLE	0
