# ECO INSPECTION CERTIFICATE

Order ID : 75681

121 Points Vehicle Inspection Certificate

## Maruti Suzuki Esteem VXi BS II, 2005

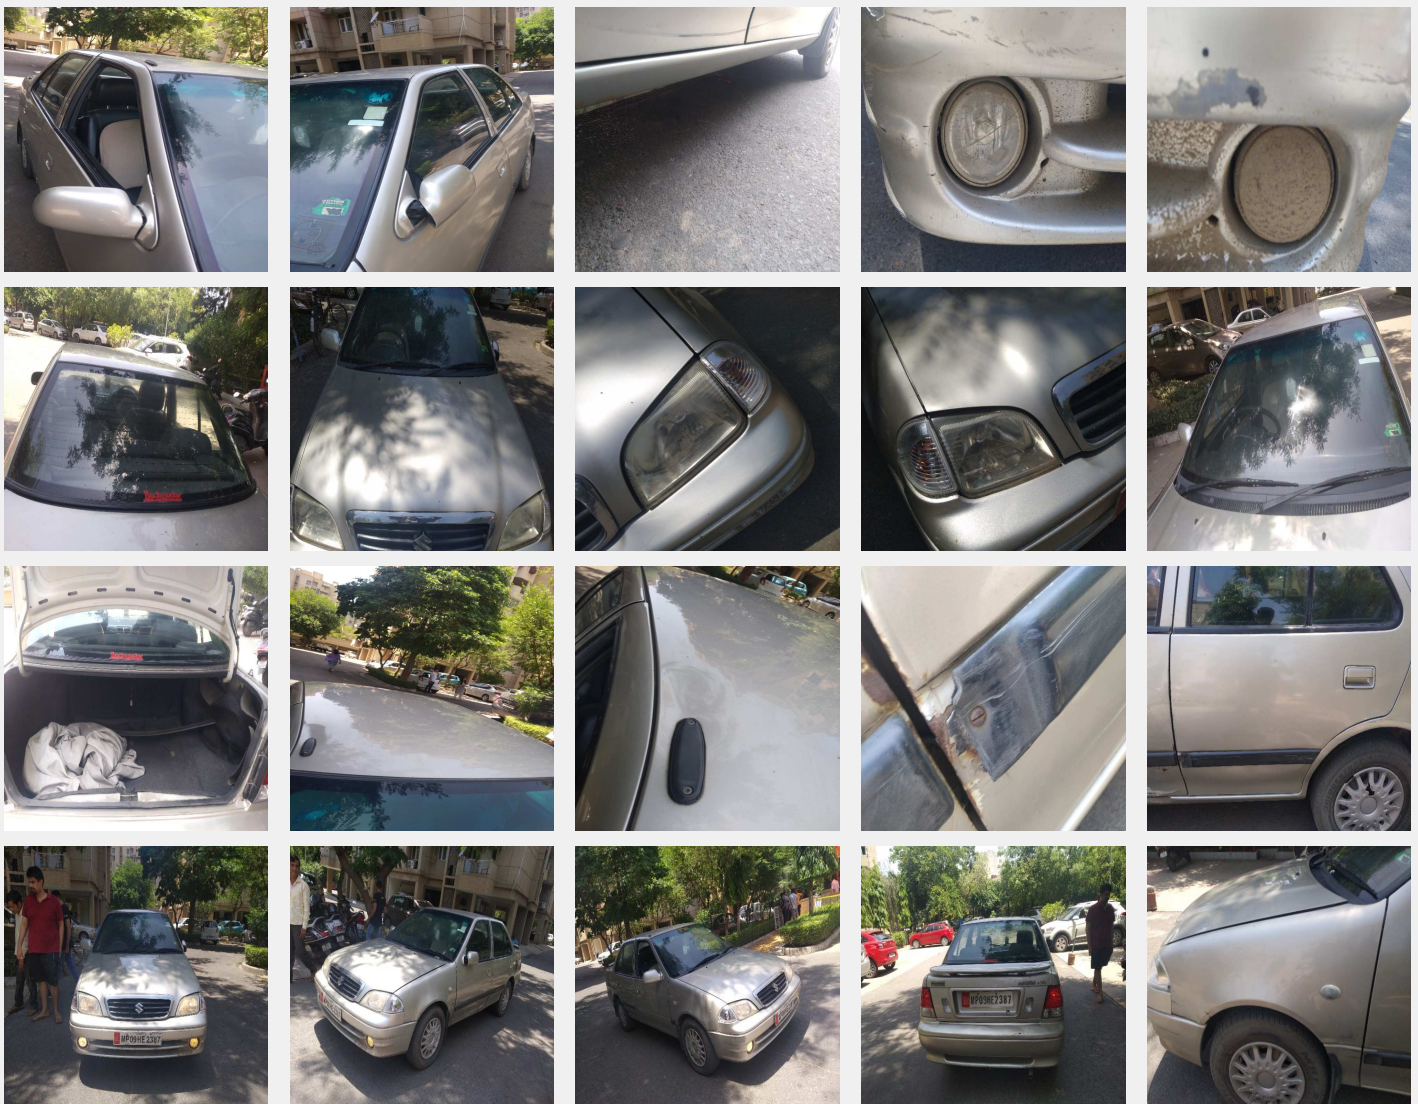
## IMAGES

| INSPECTION CHECKPOINTS | SCORE(X/10) | REMARKS/COMMENTS | OPTIONAL SPEND EST. (RS) |
|---|---|---|---|
| RH QUARTER PANEL | 4 | NEED TO REPAIR | 1500 |
| RH REAR DOOR | 3 | NEED TO REPAIR | 2500 |
| RH FRONT DOOR | 4 | NEED TO REPAIR | 2500 |
| RH FENDER | 3 | NEED TO REPAIR | 1500 |
| BODY RUST | 3 | BODY RUST | 5000 |

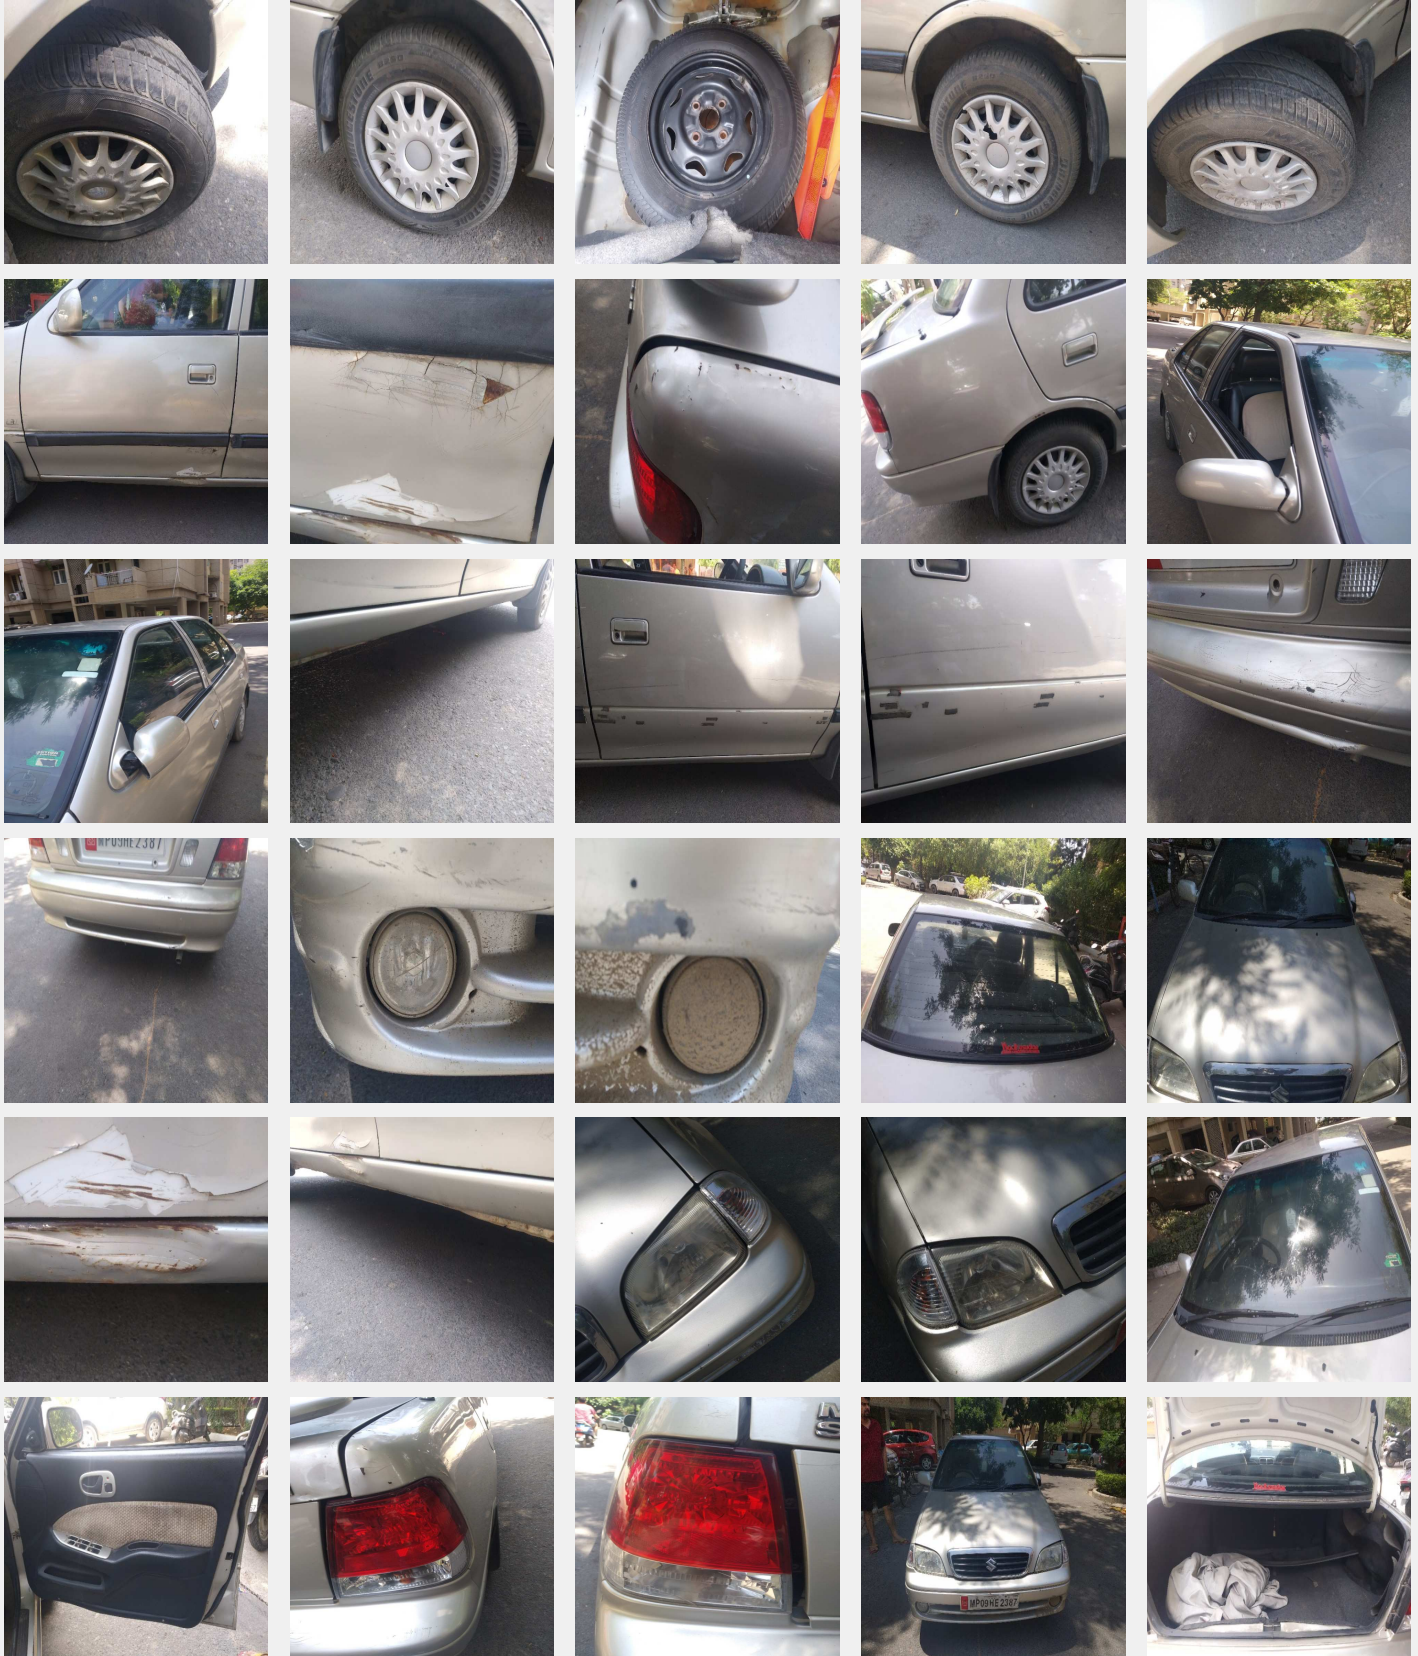
IMAGES

odometer not working car fully painted seat covers cracking body rust minor scratches and minor dent
