ECO INSPECTION CERTIFICATE

121 Points Vehicle Inspection Certificate

Skoda Rapid AMBITION 1.6 TDI CR MT PLUS, 2013

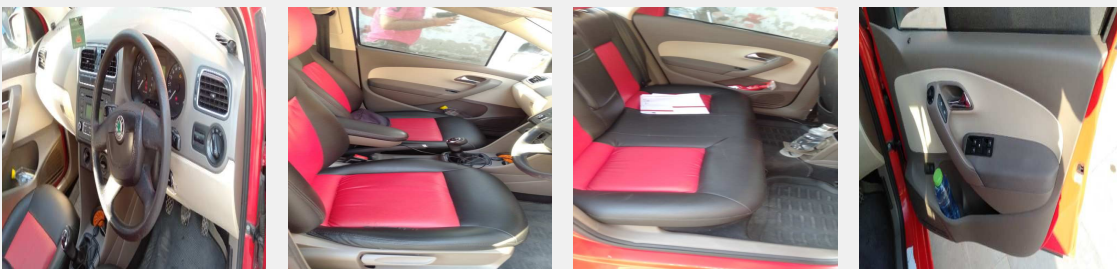
INSPECTION CHECKPOINTS	SCORE(X/10)	REMARKS/COMMENTS	OPTIONAL SPEND EST. (RS)
DOOR PANEL	8	GOOD	0
DOOR HINGES	7	GOOD	0
CARPET & FLOOR MAT	7	GOOD	0
SEAT & SEAT BELT	7	GOOD	0
DASHBOARD & INSTRUMENT PANEL	7	GOOD	0
HORN	7	GOOD	0
SPEAKERS & MUSIC SYSTEM	8	GOOD	0
HANDBRAKE	7	GOOD	0
PEDALS	7	GOOD	0
CENTRAL LOCK	7	GOOD	0
A/C VENTS & HEATER	7	GOOD	0
CUP HOLDERS	7	GOOD	0
NAVIGATION (NO)	10		0
ODOMETER	7	GOOD	0
POWER WINDOWS (YES)	7	GOOD	0
HAZARD LIGHT	7	GOOD	0
STEERING-MOUNTED CONTROLS	0	NA	0

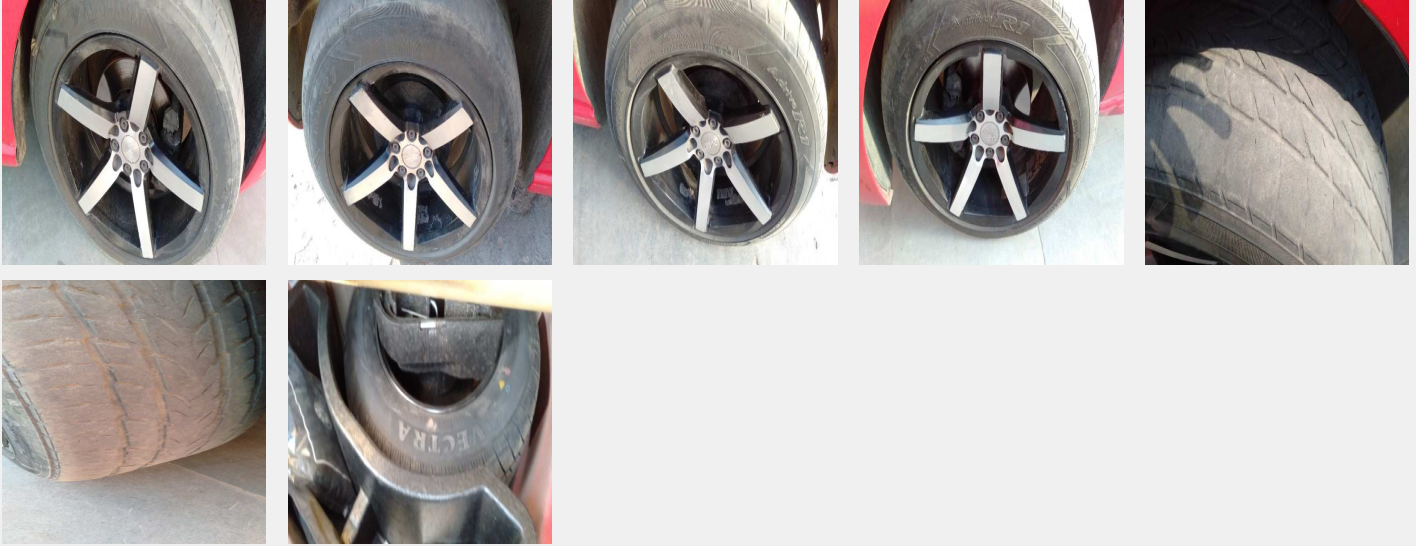
INSPECTION CHECKPOINTS	SCORE(X/10)	REMARKS/COMMENTS	OPTIONAL SPEND EST. (RS)
TYRES	7	GOOD	0
SPARE TYRE (YES)	8	GOOD	0
WHEEL ASSEMBLY (ALLOY RIM)	7	GOOD	0

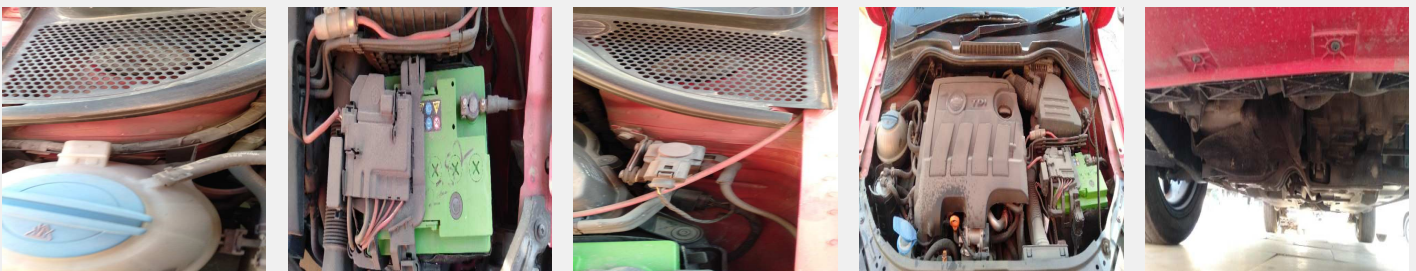
INSPECTION CHECKPOINTS	SCORE(X/10)	REMARKS/COMMENTS	OPTIONAL SPEND EST. (RS)
LH APRON	7	GOOD	0
RH APRON	7	GOOD	0
RADIATOR	7	GOOD	0
WIRING	7	GOOD	0
BATTERY	7	GOOD	0
BRAKE FLUID LEVEL	7	GOOD	0
ENGINE OIL	7	GOOD	0
COOLANT LEVEL	7	GOOD	0
BRAKE & COOLANT HOSE PIPES	7	GOOD	0
UNDERCARRIAGE	7	GOOD	0
EXHAUST SYSTEM	7	GOOD	0

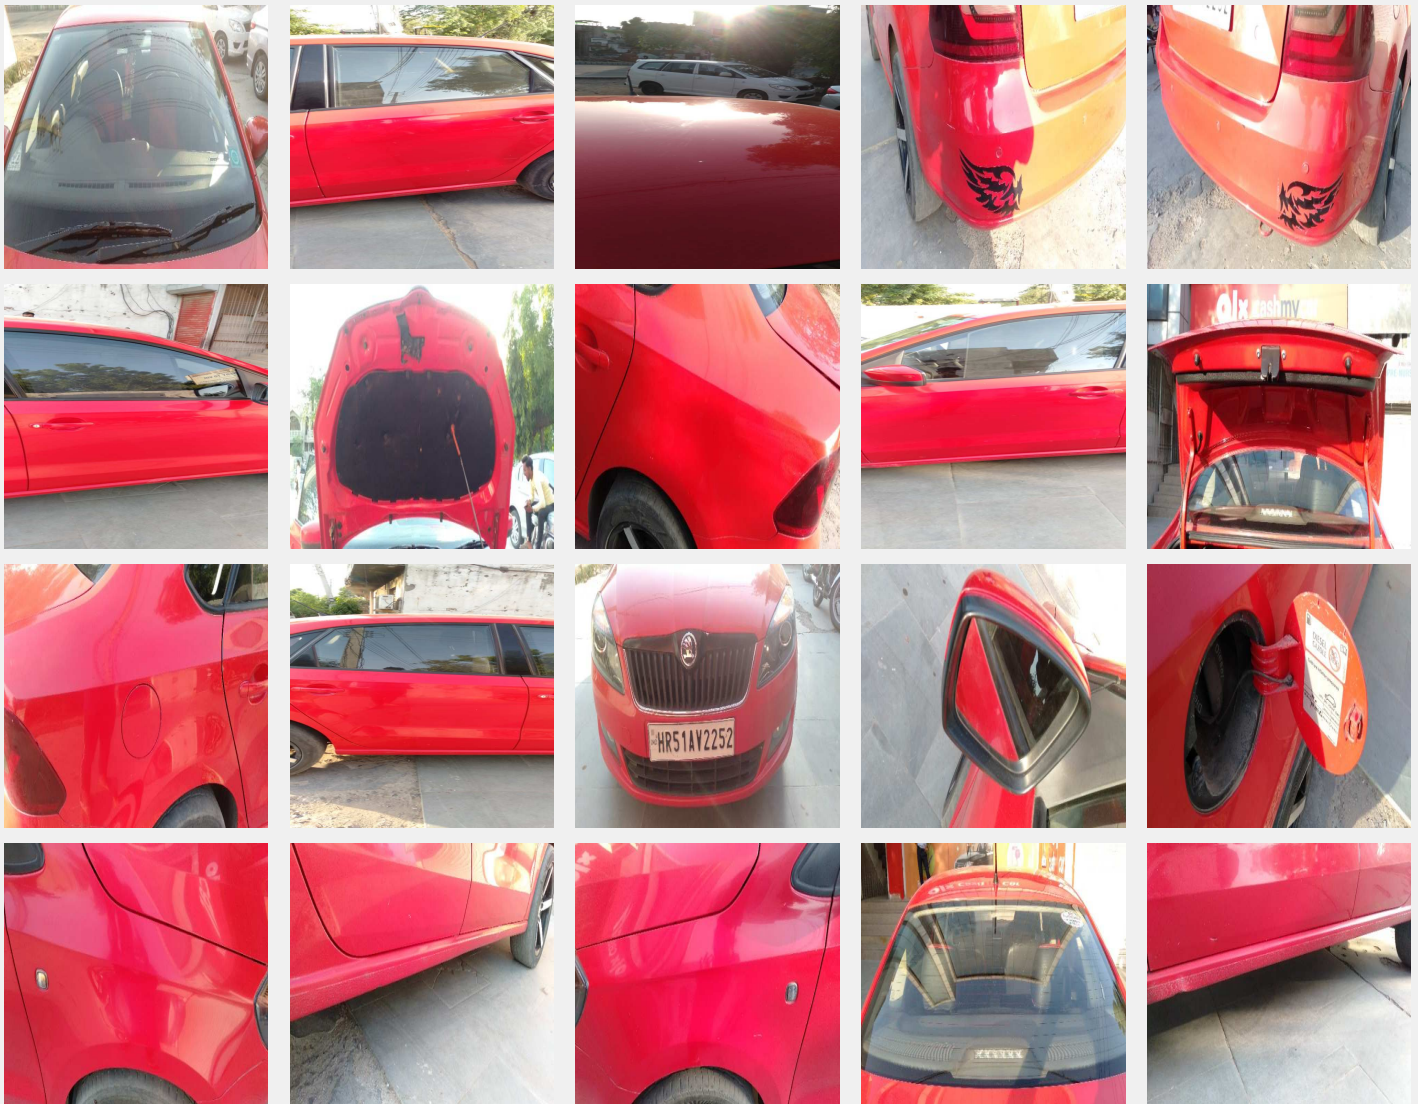
INSPECTION CHECKPOINTS	SCORE(X/10)	REMARKS/COMMENTS	OPTIONAL SPEND EST. (RS)
BODY RUST	7	GOOD	0
ROOF (REGULAR)	7	GOOD	0
PAINT CONDITION	8	GOOD	0
TAIL LIGHT	3	RIGHT SIDE BROKEN TAIL LIGHT	2000
LUGGAGE COMPARTMENT LIGHT	0	NA	0
