ECO INSPECTION CERTIFICATE

Order ID : 77836

121 Points Vehicle Inspection Certificate

Maruti Suzuki 800 STD BS II, 2001

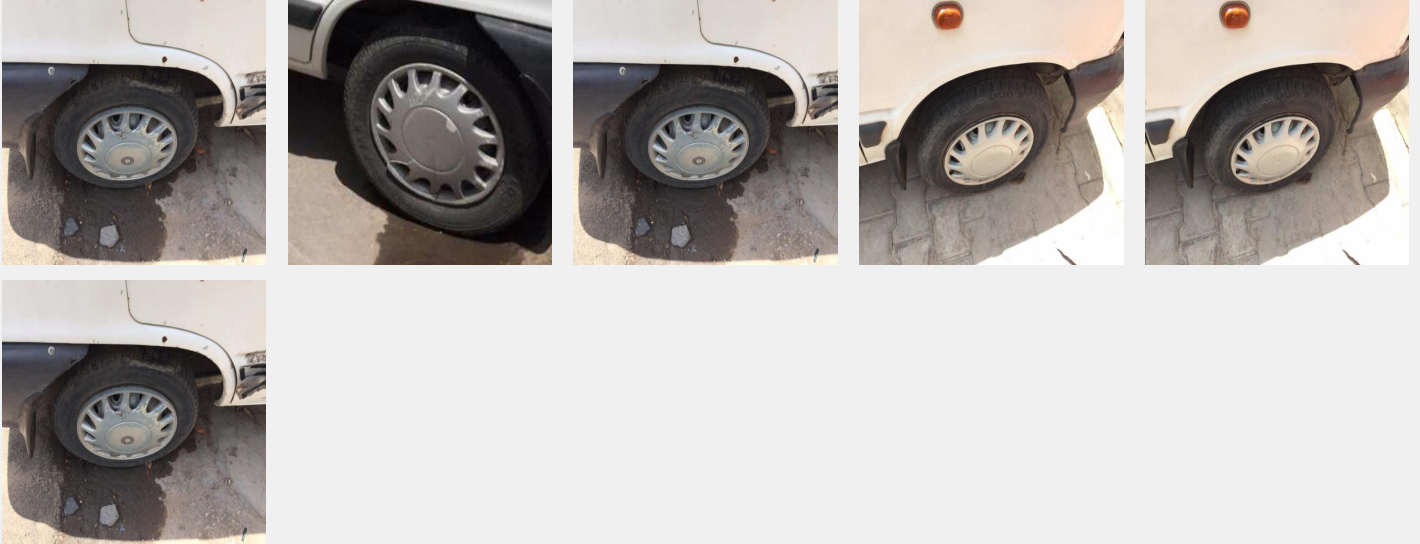
INSPECTION CHECKPOINTS	SCORE(X/10)	REMARKS/COMMENTS	OPTIONAL SPEND EST. (RS)
TYRES	6		0
SPARE TYRE (NO)	10		0
WHEEL ASSEMBLY (STEEL RIM)	7		0

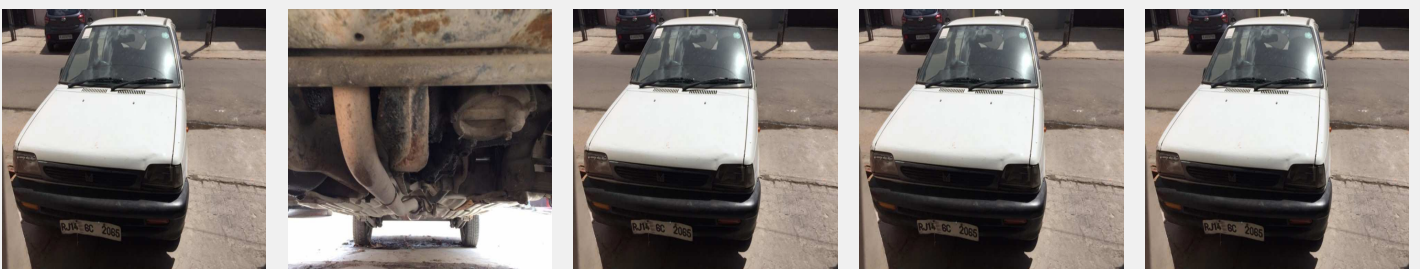
HOOD

INSPECTION CHECKPOINTS	SCORE(X/10)	REMARKS/COMMENTS	OPTIONAL SPEND EST. (RS)
LH APRON	7	KEY IS MISSING	0
RH APRON	6	KEY MISSING	0
RADIATOR	8		0
WIRING	7	KEY MISSING	0
BATTERY	7	KEY MISSING	0
BRAKE FLUID LEVEL	7		0
ENGINE OIL	8		0
COOLANT LEVEL	7		0
BRAKE & COOLANT HOSE PIPES	8		0
UNDERCARRIAGE	7		0
EXHAUST SYSTEM	8		0

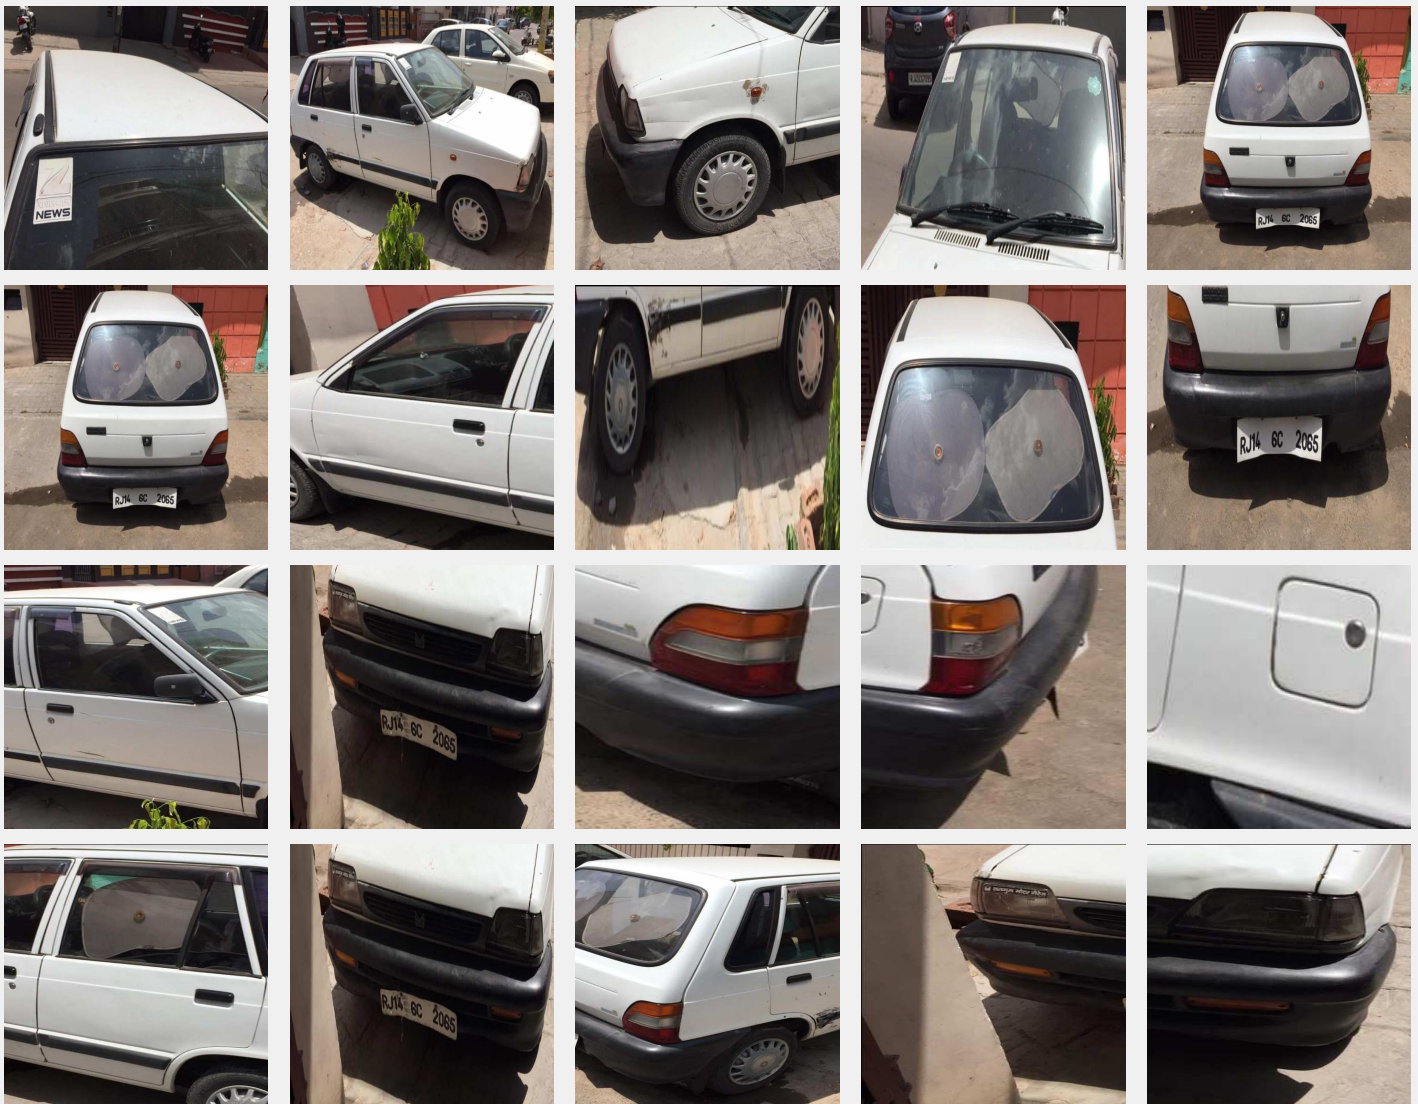
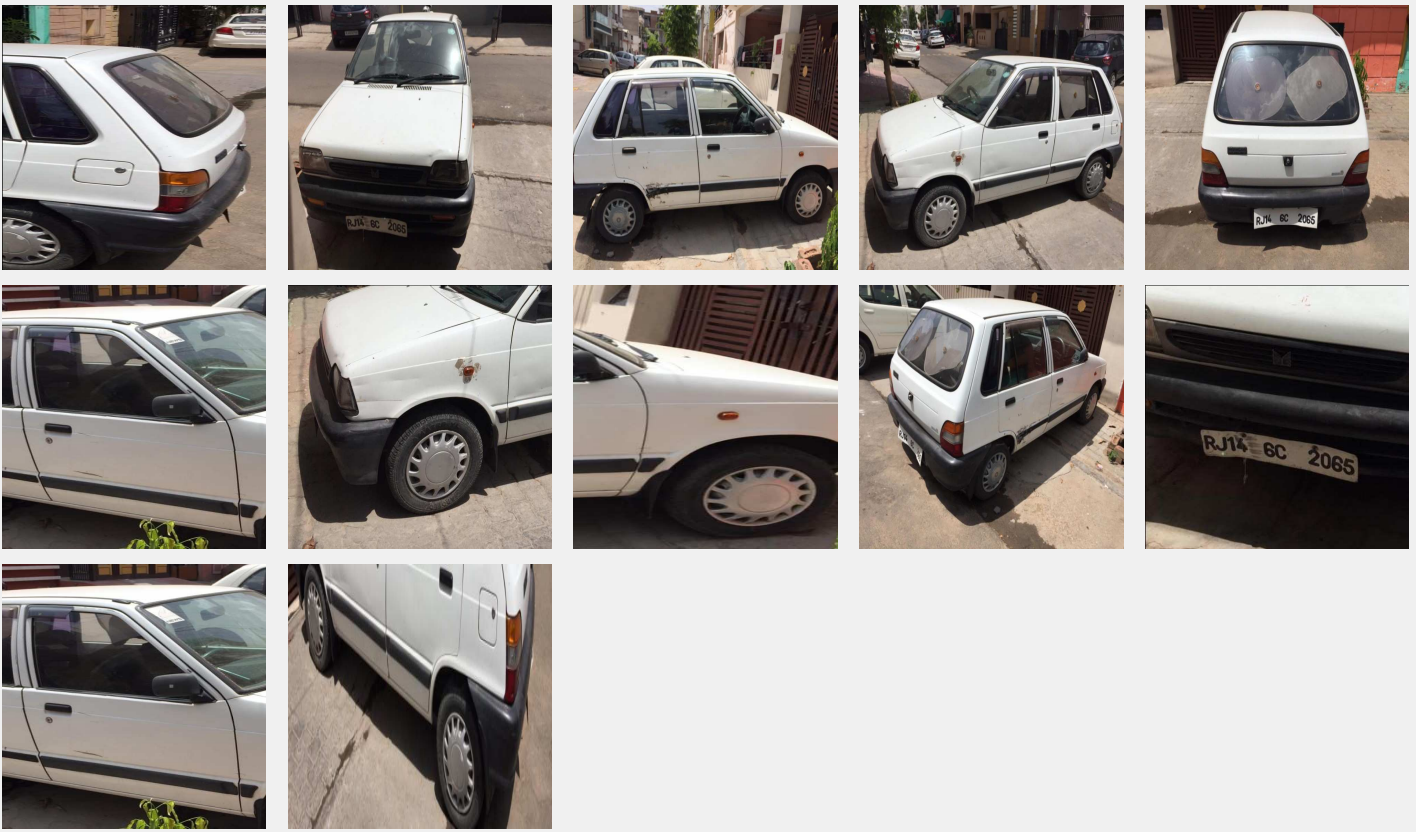
EXTERIOR (CONTINUED)

INSPECTION CHECKPOINTS	SCORE(X/10)	REMARKS/COMMENTS	OPTIONAL SPEND EST. (RS)
PAINT CONDITION	7		0
FOG LAMPS	0	NOT FITTING	0
HOOD	3	DENT	4000
SIDE VIEW MIRRORS	3	LEFT MISSING	1000
RH REAR DOOR	3	BROKEN	500
