ECO INSPECTION CERTIFICATE

121 Points Vehicle Inspection Certificate

Ordered By : Gopagani	Inspection Date : 2019-06-01	Location : HYDERABAD	Inspected By Verified Technician 108+ vehicle inspected 1+ years experience Tata Uday Kumar
--------------------------	---------------------------------	-------------------------	---

Hyundai Accent GLE, 2001

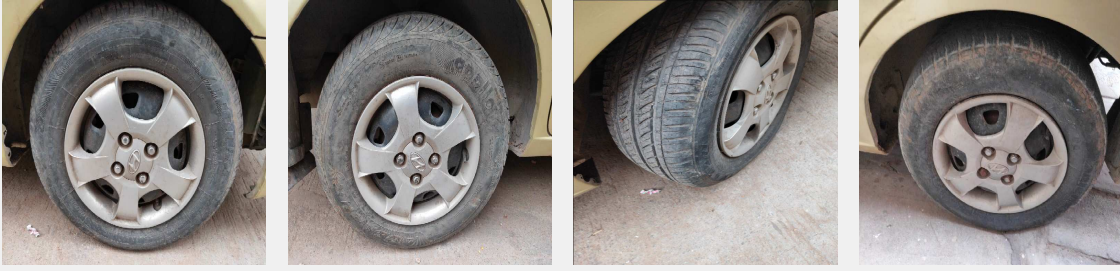
IMAGES

INSPECTION CHECKPOINTS	SCORE(X/10)	REMARKS/COMMENTS	OPTIONAL SPEND EST. (RS)
TYRES	7		0
SPARE TYRE (NO)	10		0
WHEEL ASSEMBLY (ALLOY RIM)	7		0

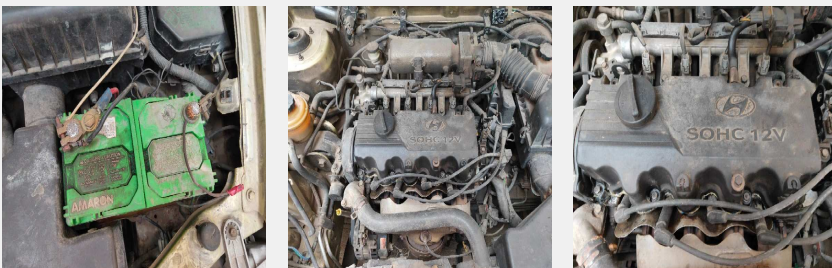
IMAGES

INSPECTION CHECKPOINTS	SCORE(X/10)	REMARKS/COMMENTS	OPTIONAL SPEND EST. (RS)
LH APRON	8		0
RH APRON	8		0
RADIATOR	8		0
WIRING	8		0
BATTERY	8		0
BRAKE FLUID LEVEL	8		0
ENGINE OIL	8		0
COOLANT LEVEL	9		0
BRAKE & COOLANT HOSE PIPES	8		0
UNDERCARRIAGE	8		0
EXHAUST SYSTEM	8		0

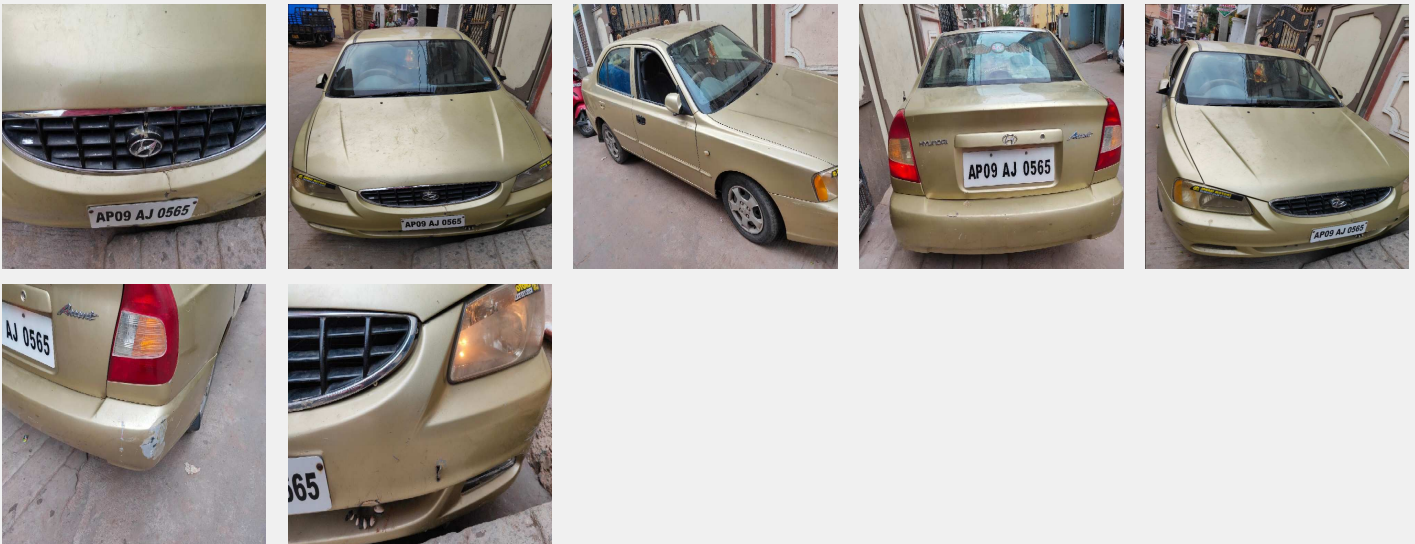
IMAGES

INSPECTION CHECKPOINTS	SCORE(X/10)	REMARKS/COMMENTS	OPTIONAL SPEND EST. (RS)
RH FRONT DOOR	8		0
RH FENDER	8		0
BODY RUST	8		0
ROOF (REGULAR)	8		0
PAINT CONDITION	7	NEED PAINT IN SOME PANELS	0

Need some repairs and painting
