ECO INSPECTION CERTIFICATE

Order ID : 81064

121 Points Vehicle Inspection Certificate

Chevrolet Spark LS 1.0 MUZIC, 2007

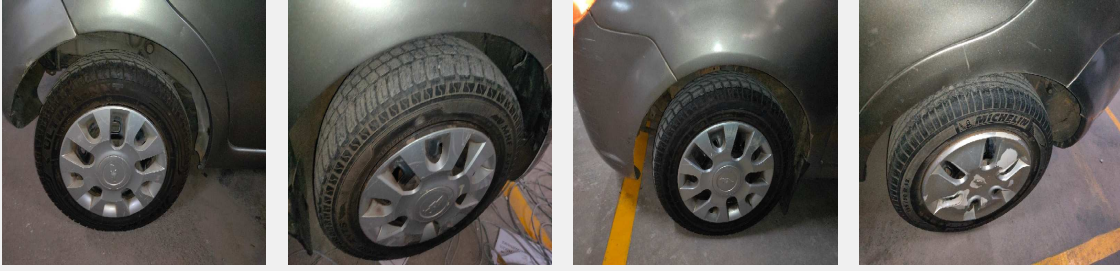
IMAGES

| INSPECTION CHECKPOINTS | SCORE(X/10) | REMARKS/COMMENTS | OPTIONAL SPEND EST. (RS) |
|---|---|---|---|
| TYRES | 8 | | 0 |
| WHEEL ASSEMBLY (ALLOY RIM) | 8 | | 0 |
