ECO INSPECTION CERTIFICATE

Order ID : 81481

121 Points Vehicle Inspection Certificate

Audi A4 2.0 TDI, 2009

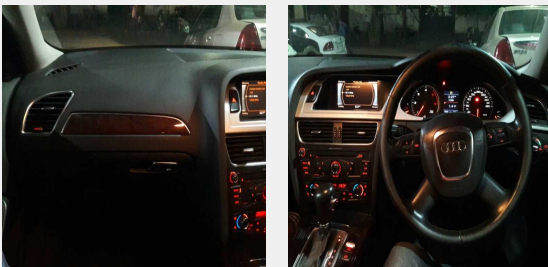
IMAGES

INSPECTION CHECKPOINTS	SCORE(X/10)	REMARKS/COMMENTS	OPTIONAL SPEND EST. (RS)
DOOR PANEL	6		0
DOOR HINGES	6		0
CARPET & FLOOR MAT	6		0
SEAT & SEAT BELT	6		0
DASHBOARD & INSTRUMENT PANEL	6		0
HORN	6		0
SPEAKERS & MUSIC SYSTEM	6		0
HANDBRAKE	6		0
STEERING-MOUNTED CONTROLS	6		0
PEDALS	6		0
CENTRAL LOCK	6		0
A/C VENTS & HEATER	7		0
CUP HOLDERS	6		0
NAVIGATION (YES)	6		0
ODOMETER	6		0
POWER WINDOWS (YES)	6		0
HAZARD LIGHT	6		0

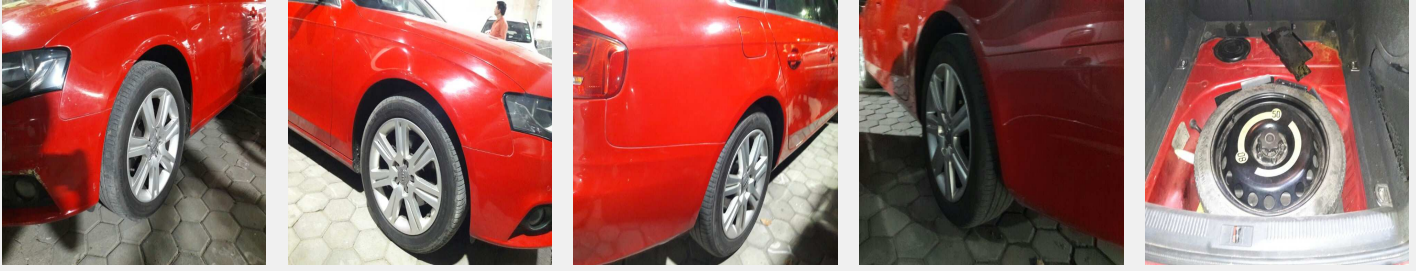
IMAGES

INSPECTION CHECKPOINTS	SCORE(X/10)	REMARKS/COMMENTS	OPTIONAL SPEND EST. (RS)
TYRES	6		0
SPARE TYRE (YES)	6		0
WHEEL ASSEMBLY (STEEL RIM)	6		0

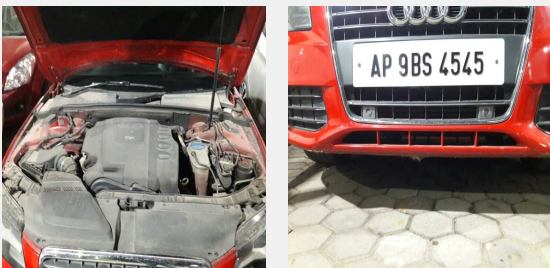
IMAGES

INSPECTION CHECKPOINTS	SCORE(X/10)	REMARKS/COMMENTS	OPTIONAL SPEND EST. (RS)
LH APRON	6		0
RH APRON	6		0
RADIATOR	6		0
WIRING	6		0
BATTERY	6		0
BRAKE FLUID LEVEL	6		0
ENGINE OIL	6		0
COOLANT LEVEL	6		0
BRAKE & COOLANT HOSE PIPES	6		0
UNDERCARRIAGE	6		0
EXHAUST SYSTEM	6		0
