# ECO INSPECTION CERTIFICATE

Order ID : 95843

121 Points Vehicle Inspection Certificate

## Maruti Suzuki Ignis Zeta 1.2 Amt, 2018

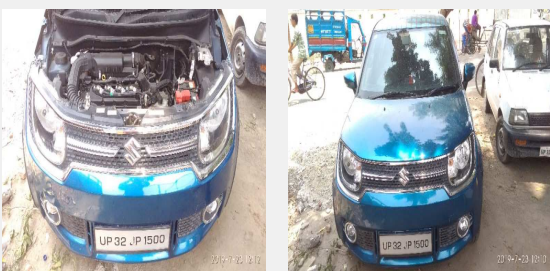
## IMAGES

INSPECTION CHECKPOINTS	SCORE(X/10)	REMARKS/COMMENTS	OPTIONAL SPEND EST. (RS)
STEERING PERFORMANCE	8		0
BRAKE PERFORMANCE	8		0
CLUTCH PERFORMANCE	8	OK	0
ENGINE NOISE	9	OK	0
IGNITION SYSTEM	8	OK	0
SUSPENSION PERFORMANCE	8	OK	0
SUSPENSION FRONT SHOCKS	9	OK	0
SUSPENSION REAR SHOCKS	9	OK	0
TRANSMISSION ENGAGE	8	OK	0
CRUISE CONTROL (YES)	7	OK	0
REAR PARKING SENSORS (YES)	8	OK	0
REAR VIEW CAMERA (YES)	7	OK	0

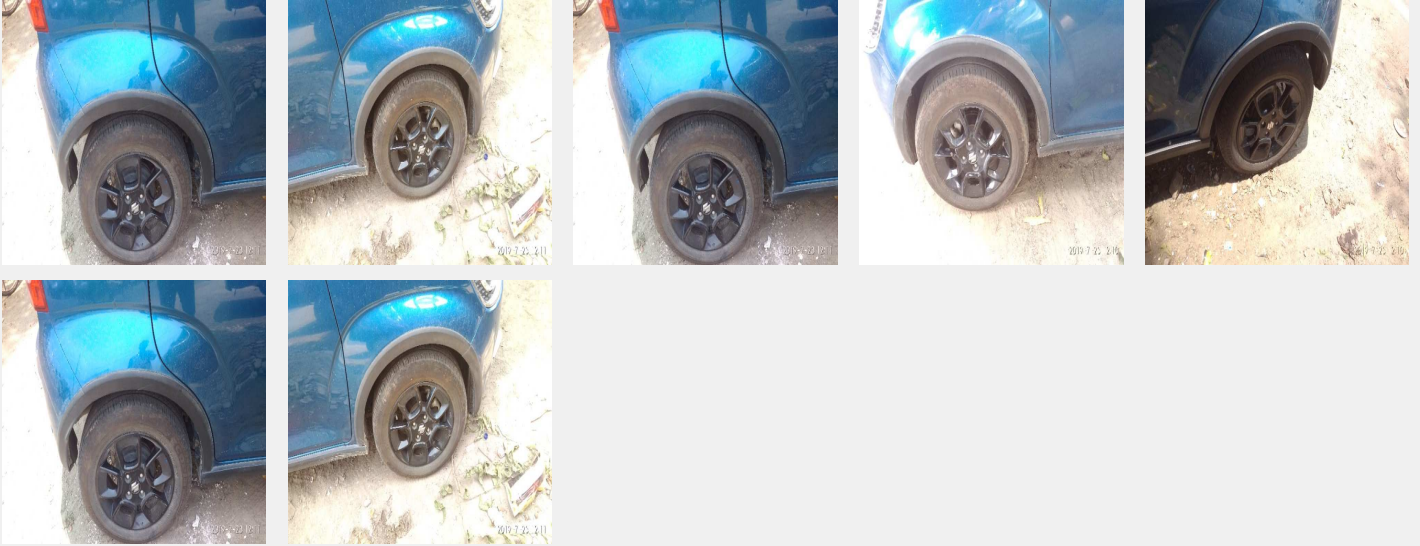
IMAGES

INSPECTION CHECKPOINTS	SCORE(X/10)	REMARKS/COMMENTS	OPTIONAL SPEND EST. (RS)
TYRES	8	OK	0
SPARE TYRE (YES)	8		0
WHEEL ASSEMBLY (STEEL RIM)	8		0

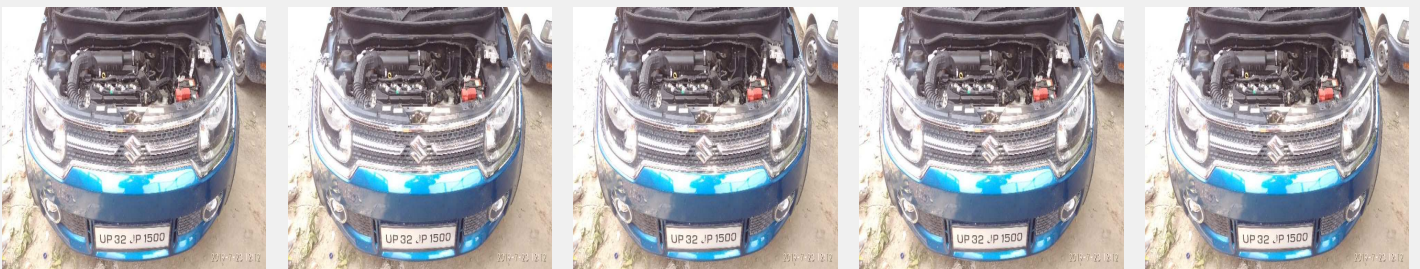
IMAGES

INSPECTION CHECKPOINTS	SCORE(X/10)	REMARKS/COMMENTS	OPTIONAL SPEND EST. (RS)
LH APRON	8	OK	0
RH APRON	8		0
RADIATOR	9		0
WIRING	8	OK	0
BATTERY	8		0
BRAKE FLUID LEVEL	8	OK	0
ENGINE OIL	8	OK	0
COOLANT LEVEL	8	OK	0
BRAKE & COOLANT HOSE PIPES	8	OK	0
UNDERCARRIAGE	8	OK	0
EXHAUST SYSTEM	8	OK	0

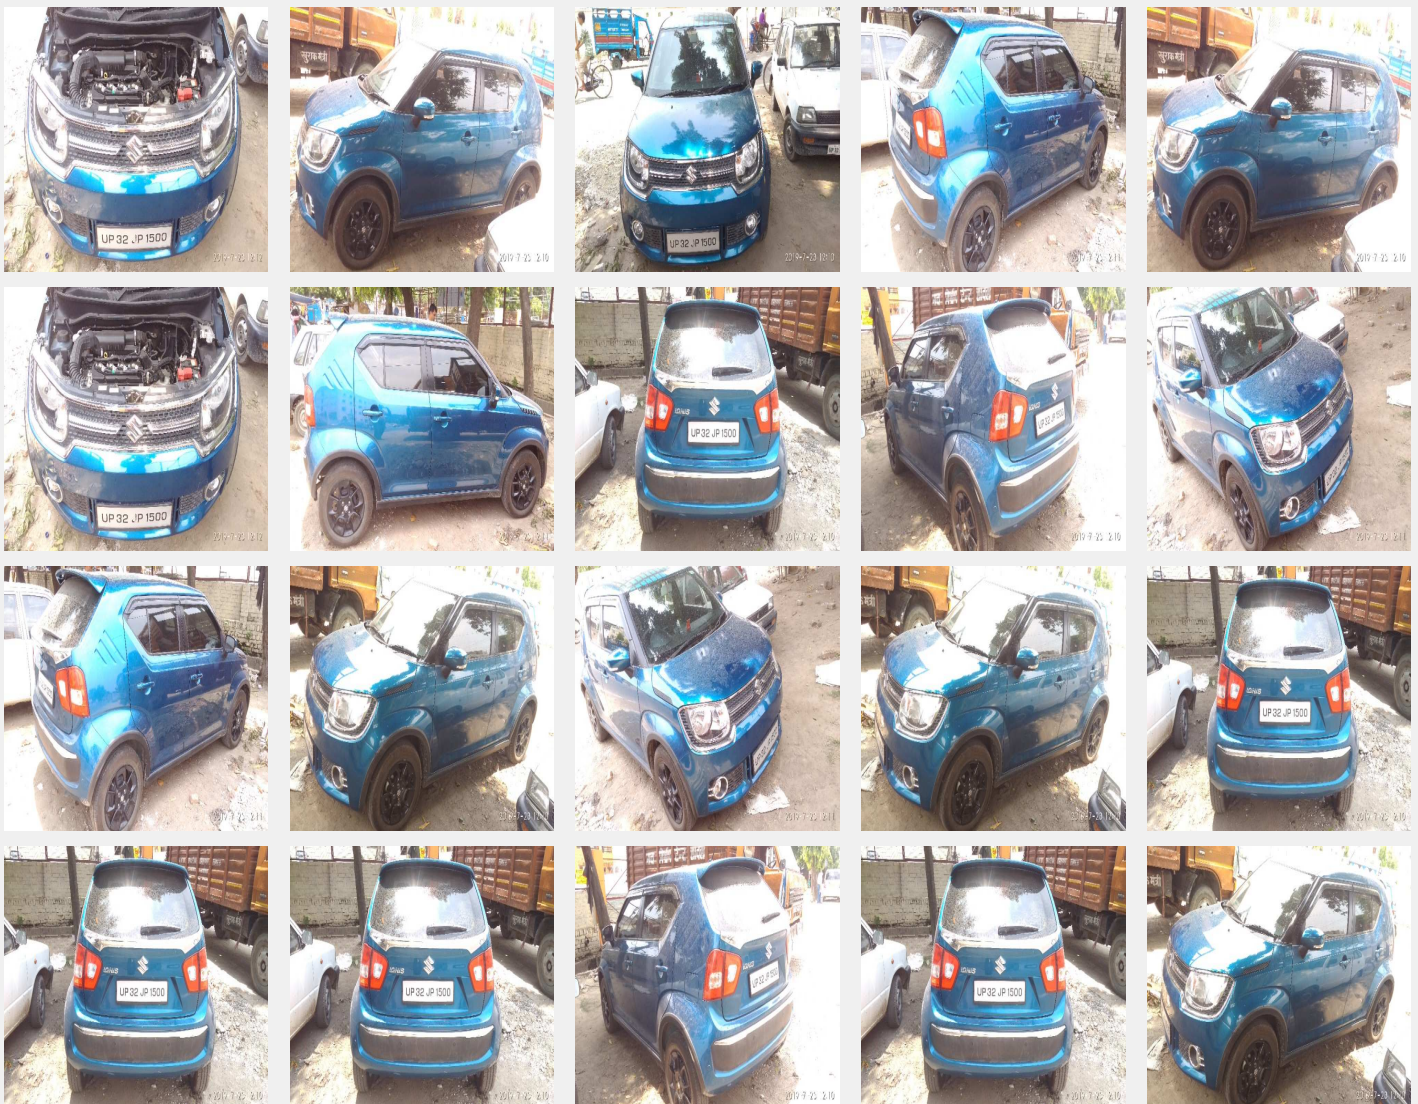
## IMAGES

INSPECTION CHECKPOINTS	SCORE(X/10)	REMARKS/COMMENTS	OPTIONAL SPEND EST. (RS)
RH FRONT DOOR	8		0
RH FENDER	8		0
BODY RUST	8		0
ROOF (REGULAR)	8	OK	0
PAINT CONDITION	8		0
