# ECO INSPECTION CERTIFICATE

121 Points Vehicle Inspection Certificate

Inspection Date : 2019-07-26

## Toyota Innova Crysta 2.8 G 7 STR, 2016

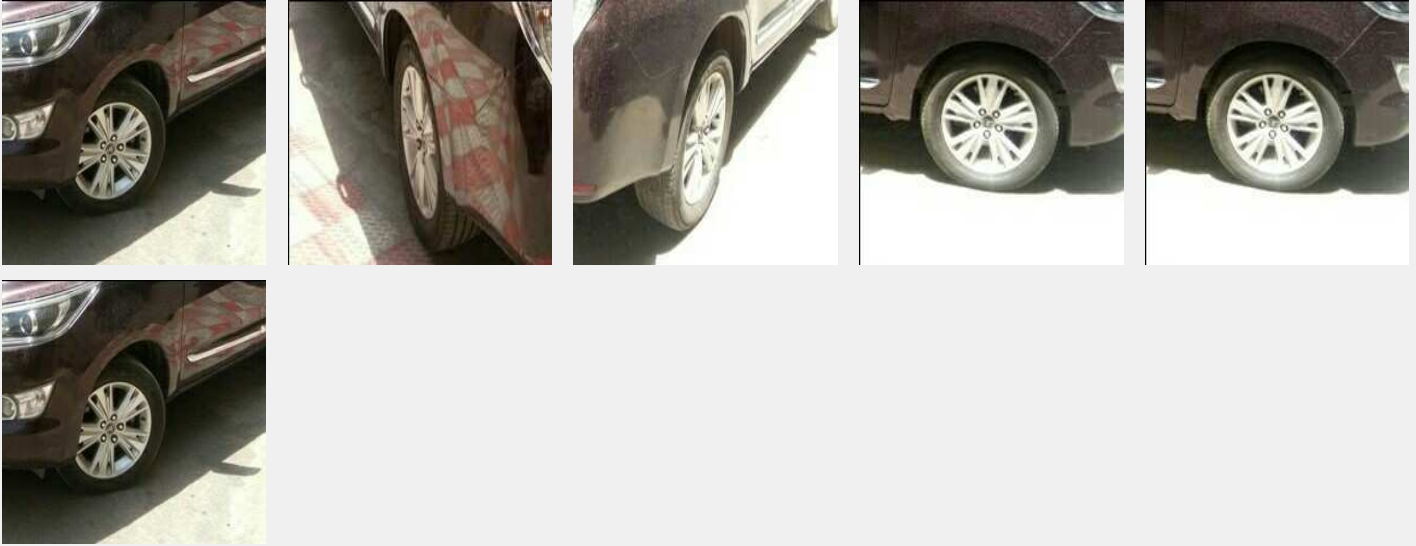
IMAGES

INSPECTION CHECKPOINTS	SCORE(X/10)	REMARKS/COMMENTS	OPTIONAL SPEND EST. (RS)
TYRES	6		0
SPARE TYRE (NO)	10		0
WHEEL ASSEMBLY (ALLOY RIM)	6		0

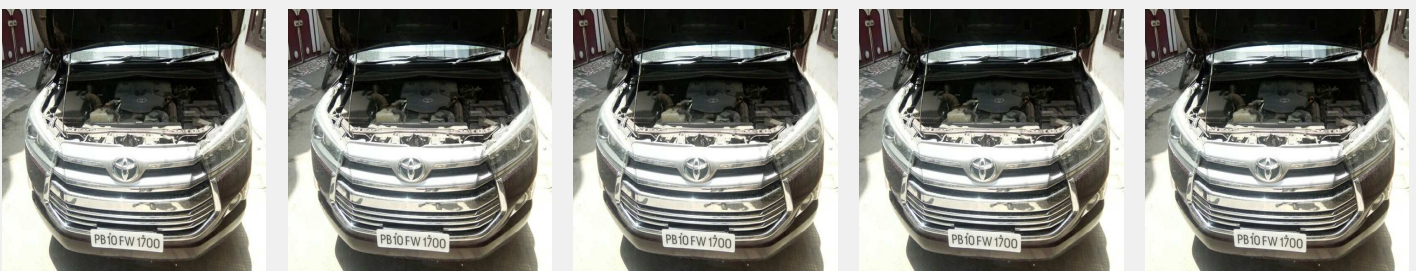
IMAGES

INSPECTION CHECKPOINTS	SCORE(X/10)	REMARKS/COMMENTS	OPTIONAL SPEND EST. (RS)
LH APRON	6		0
RH APRON	6		0
RADIATOR	6		0
WIRING	6		0
BATTERY	6		0
BRAKE FLUID LEVEL	6		0
ENGINE OIL	6		0
COOLANT LEVEL	6		0
BRAKE & COOLANT HOSE PIPES	6		0
UNDERCARRIAGE	6		0
EXHAUST SYSTEM	6		0

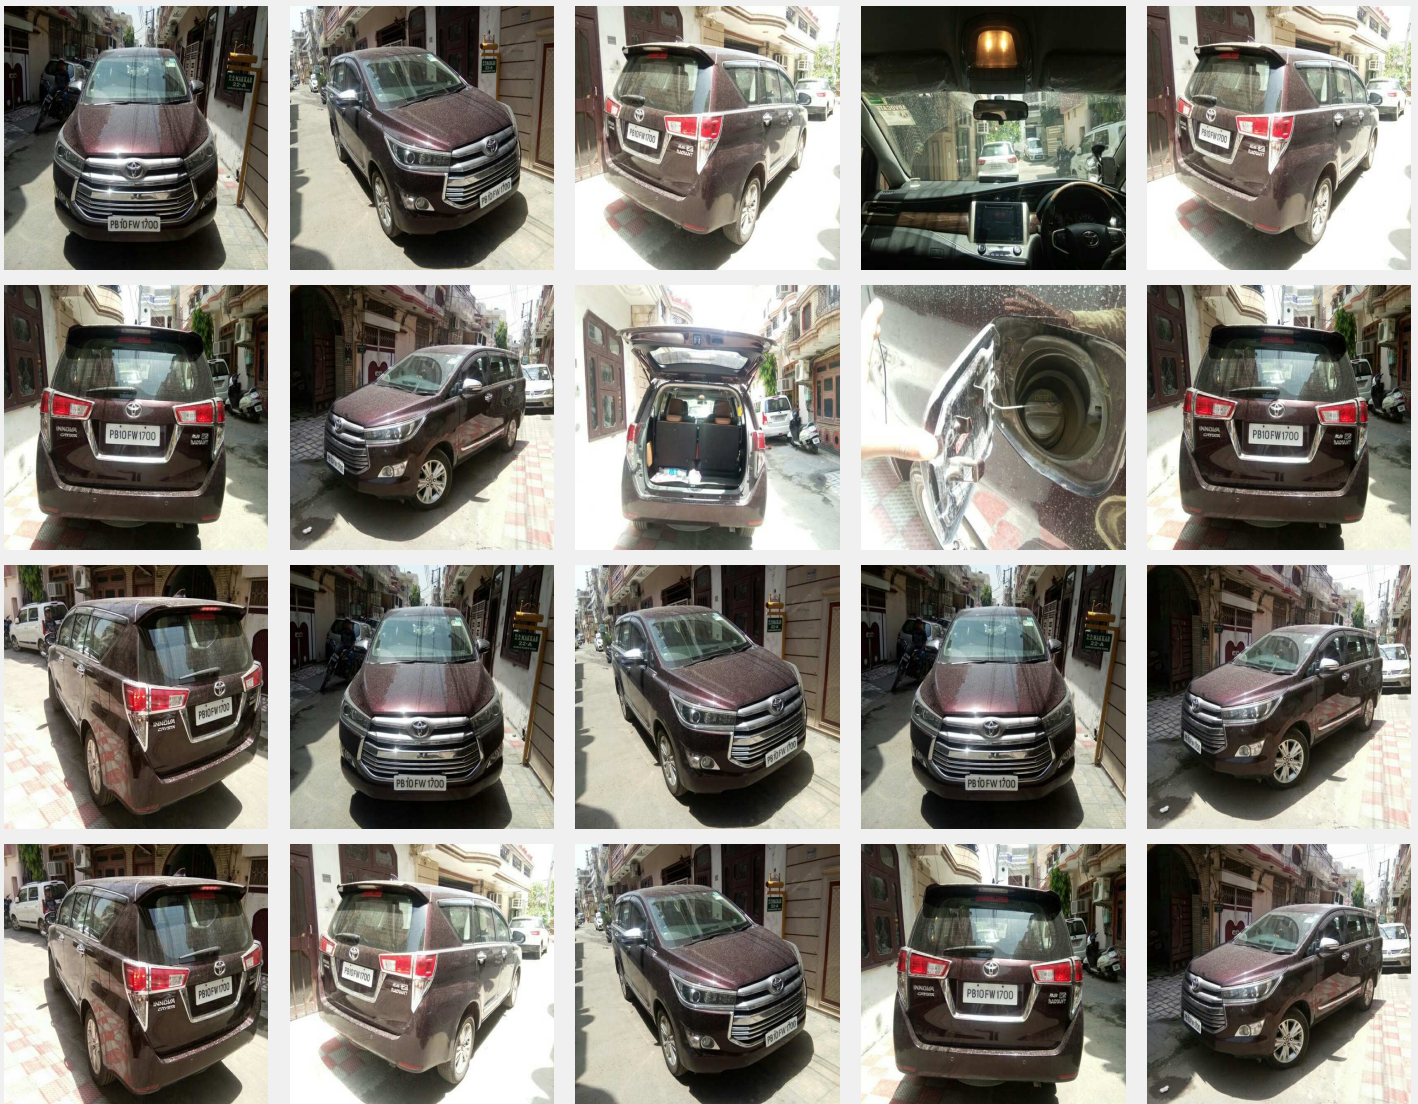
## IMAGES

INSPECTION CHECKPOINTS	SCORE(X/10)	REMARKS/COMMENTS	OPTIONAL SPEND EST. (RS)
RH FRONT DOOR	6		0
RH FENDER	6		0
ROOF (REGULAR)	6		0
PAINT CONDITION	6		0
BODY RUST	0	NO	0
