ECO INSPECTION CERTIFICATE

121 Points Vehicle Inspection Certificate

Ordered By : Hemant	Inspection Date : 2019-05-26	Location : KAMAL NAGAR	Inspected By

Volkswagen Ameo HIGHLINE 1.2L (P), 2016

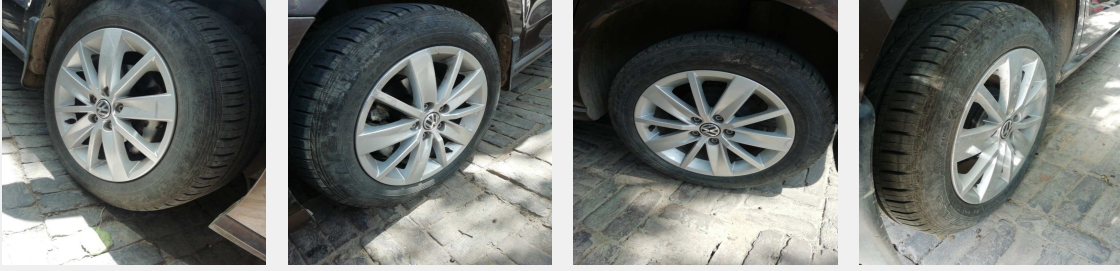
IMAGES

INSPECTION CHECKPOINTS	SCORE(X/10)	REMARKS/COMMENTS	OPTIONAL SPEND EST. (RS)
TYRES	9		0
SPARE TYRE (YES)	9		0
WHEEL ASSEMBLY (STEEL RIM)	9		0

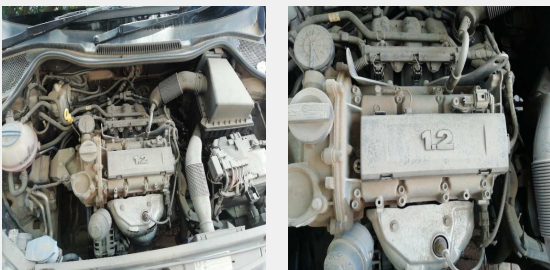
IMAGES

INSPECTION CHECKPOINTS	SCORE(X/10)	REMARKS/COMMENTS	OPTIONAL SPEND EST. (RS)
LH APRON	9		0
RH APRON	9		0
RADIATOR	9		0
WIRING	9		0
BATTERY	9		0
BRAKE FLUID LEVEL	8		0
ENGINE OIL	9		0
COOLANT LEVEL	9		0
BRAKE & COOLANT HOSE PIPES	9		0
UNDERCARRIAGE	9		0
EXHAUST SYSTEM	8		0

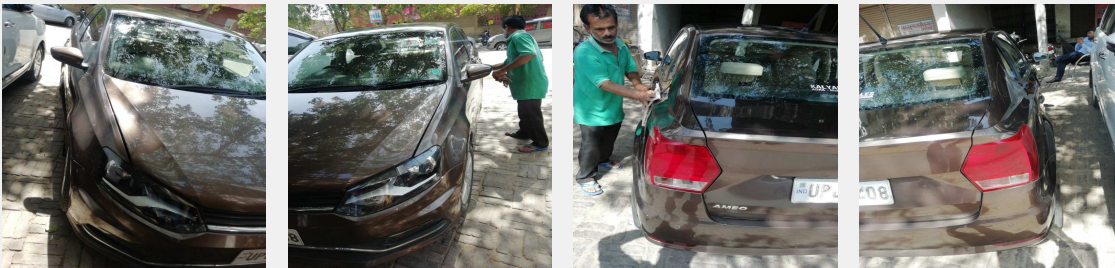
IMAGES

INSPECTION CHECKPOINTS	SCORE(X/10)	REMARKS/COMMENTS	OPTIONAL SPEND EST. (RS)
RH FRONT DOOR	9		0
RH FENDER	9		0
BODY RUST	9		0
ROOF (REGULAR)	9		0
PAINT CONDITION	9		0
