ECO INSPECTION CERTIFICATE

Order ID : 113782

121 Points Vehicle Inspection Certificate

Maruti Suzuki Wagon R 1.0 Lxi Cng Opt, 2015

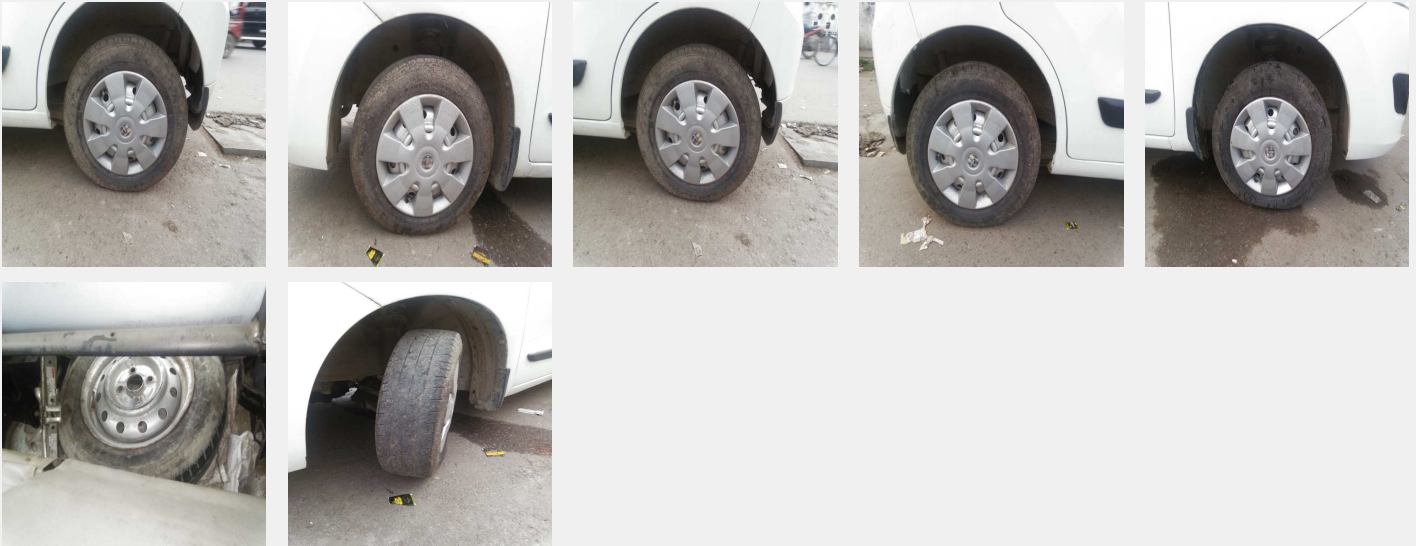
IMAGES

INSPECTION CHECKPOINTS	SCORE(X/10)	REMARKS/COMMENTS	OPTIONAL SPEND EST. (RS)
TYRES	6	TIRES ARE IN AVERAGE CONDITION	0
SPARE TYRE (YES)	6	SPARE TYRE IS IN AVERAGE CONDITION	0
WHEEL ASSEMBLY (STEEL RIM)	8	MAJOR PROBLEM IN WHEEL ALIGNMENT.	0

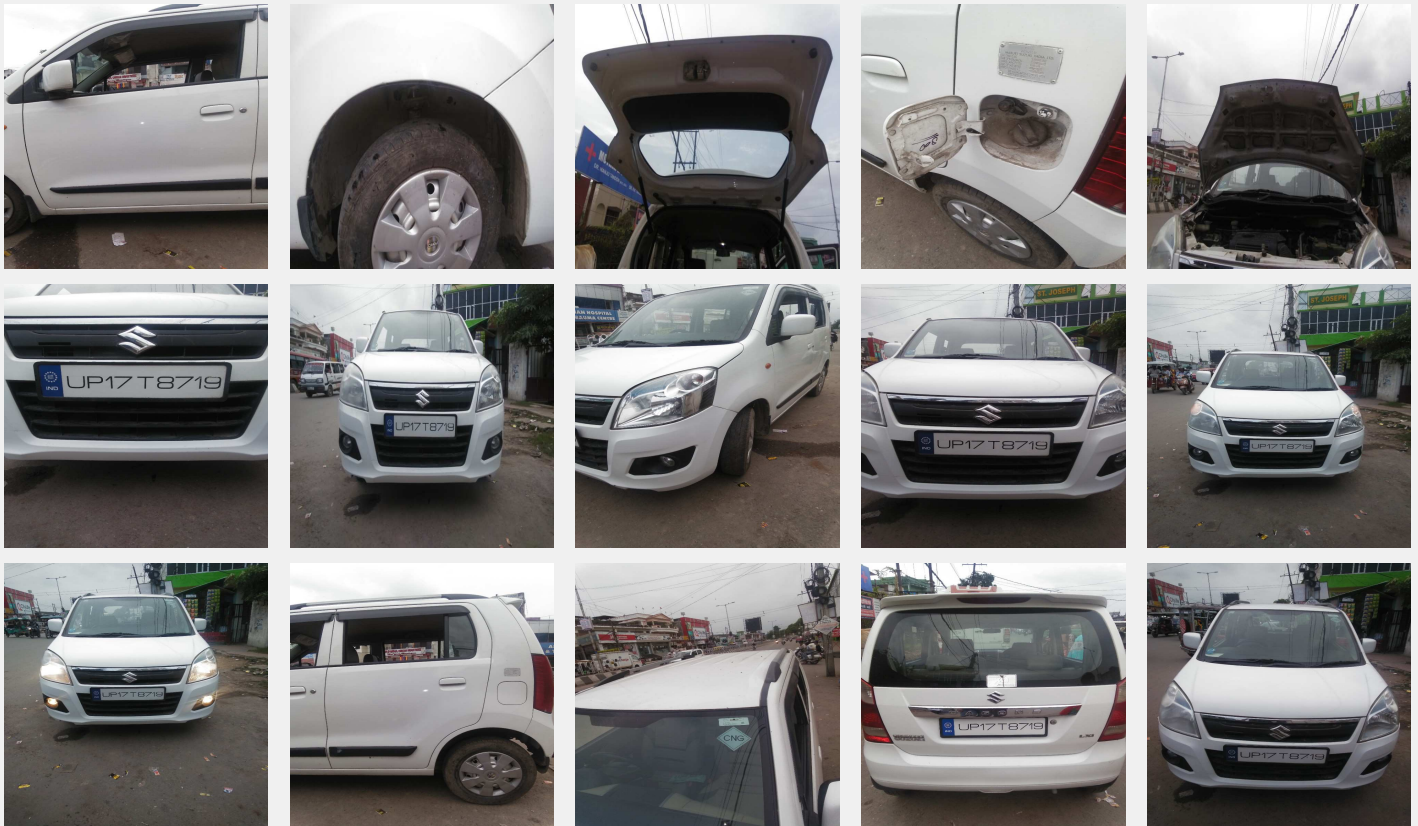
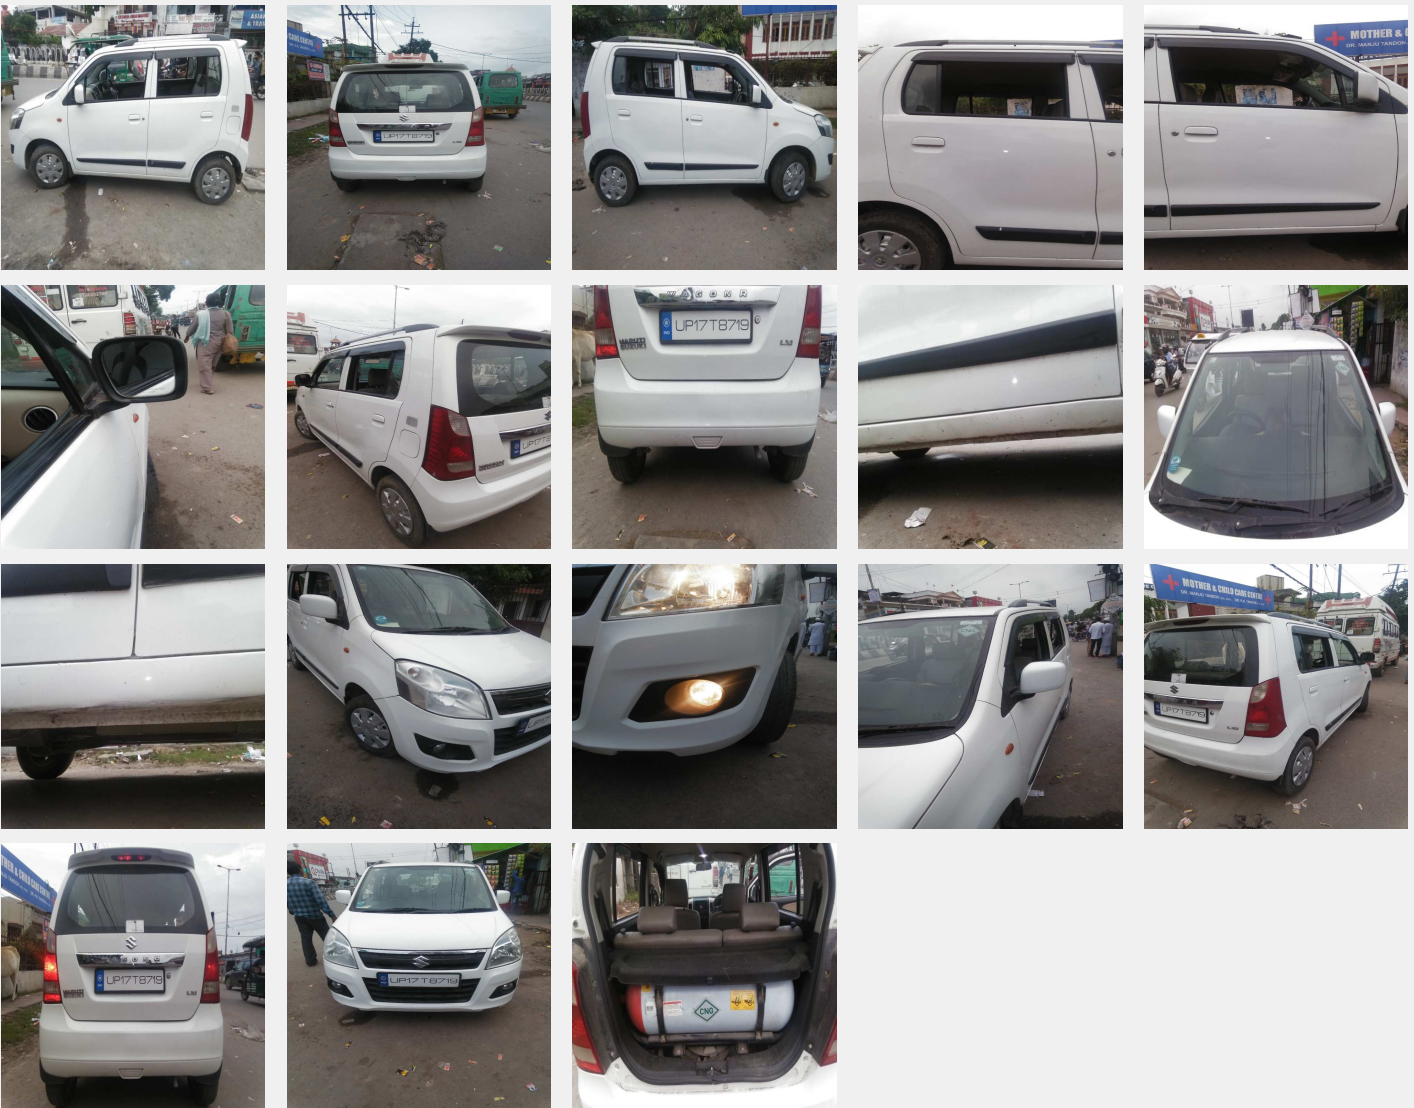
IMAGES

INSPECTION CHECKPOINTS	SCORE(X/10)	REMARKS/COMMENTS	OPTIONAL SPEND EST. (RS)
RH FRONT DOOR	6	RH FRONT DOOR IS IN AVERAGE CONDITION	1500
RH FENDER	6	RH FENDER IS IN AVERAGE CONDITION	0
BODY RUST	6	BODY RUST 25%-MINOR	0
ROOF (REGULAR)	6	ROOF IS IN AVERAGE CONDITION	0
PAINT CONDITION	6	PAINT IS IN AVERAGE CONDITION	0
