ECO INSPECTION CERTIFICATE

121 Points Vehicle Inspection Certificate

Mercedes-Benz C-Class C220 D, 2013

VEHICLE INFORMATION			
MAKE	MERCEDES-BENZ	ENGINE NUMBER	6519113170
MODEL	C-CLASS	REGISTRATION NO.	UP78DF0555
MFG. DATE	07/2013	VIN/CHASSIS NUMBER	WDD2040026L069804
TRIM	C220 D	ODOMETER READING	76236
COLOR	POLAR WHITE	INSURANCE EXPIRY	2019-1-13
BODY TYPE	SEDAN	VEHICLE PASSING	PRIVATE
FUEL TYPE	DIESEL	ENGINE SOUND LINK	LISTEN ENGINE SOUND

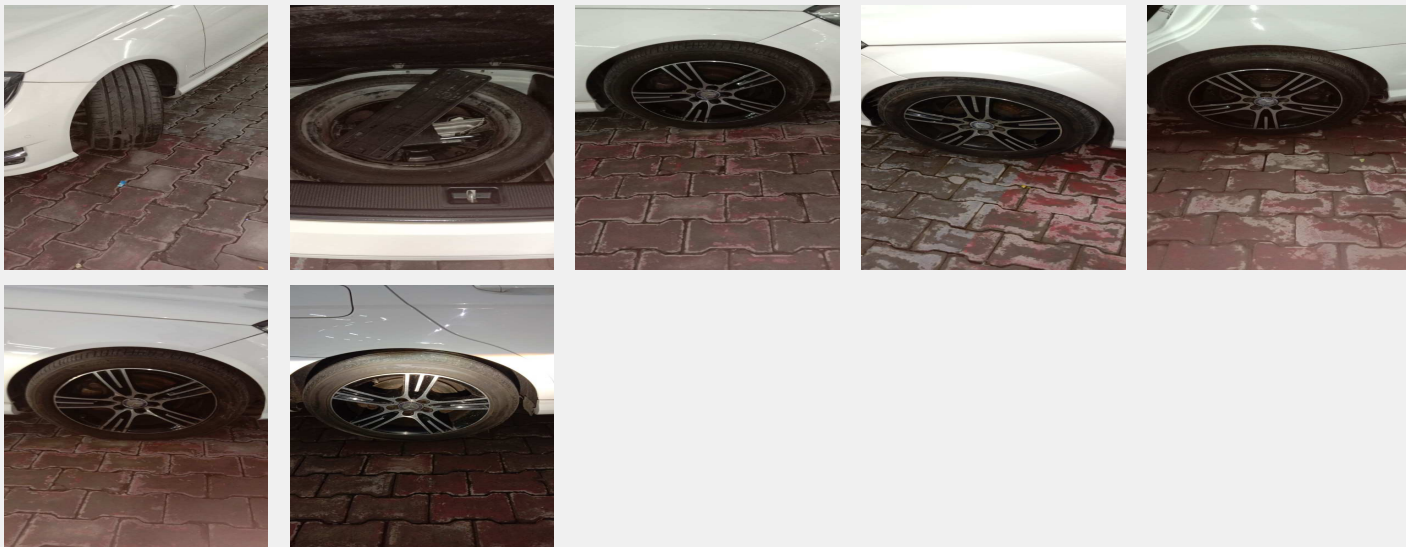
INSPECTION CHECKPOINTS	SCORE(X/10)	REMARKS/COMMENTS	OPTIONAL SPEND EST. (RS)
TYRES	6	TIRES ARE IN AVERAGE CONDITION	0
SPARE TYRE (YES)	8	SPARE TYRE IS IN GOOD CONDITION	0
WHEEL ASSEMBLY (ALLOY RIM)	8	MAJOR PROBLEM IN WHEEL ALIGNMENT.	0

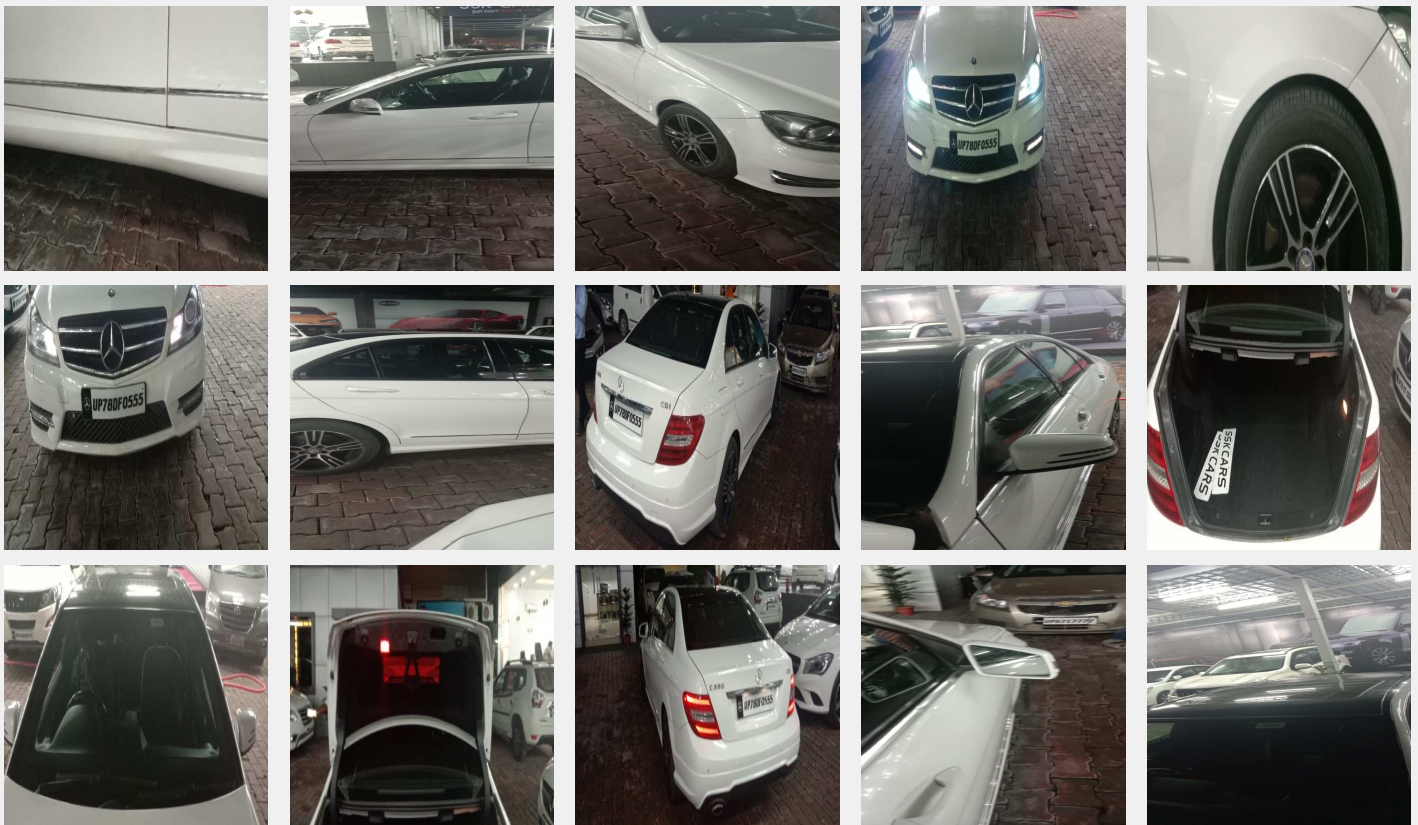
EXTERIOR (CONTINUED)

INSPECTION CHECKPOINTS	SCORE(X/10)	REMARKS/COMMENTS	OPTIONAL SPEND EST. (RS)
RH FRONT DOOR	6	RH FRONT DOOR IS IN AVERAGE CONDITION	0
RH FENDER	6	RH FENDER IS IN AVERAGE CONDITION	0
BODY RUST	6	BODY RUST 25%-MINOR	0
ROOF (SUN ROOF)	6	ROOF IS IN AVERAGE CONDITION	0
PAINT CONDITION	8	PAINT IS IN GOOD CONDITION	0
