ECO INSPECTION CERTIFICATE

Order ID : 118316

121 Points Vehicle Inspection Certificate

Nissan Micra XI Diesel, 2013

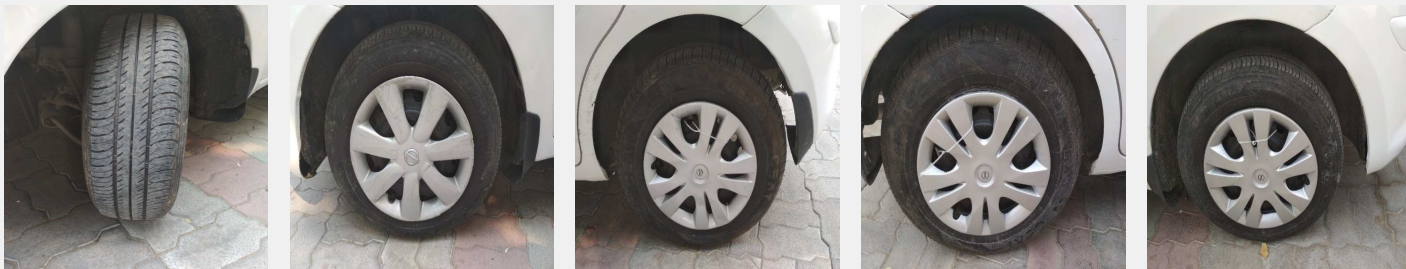
IMAGES

INSPECTION CHECKPOINTS	SCORE(X/10)	REMARKS/COMMENTS	OPTIONAL SPEND EST. (RS)
TYRES	8	TIRES ARE IN GOOD CONDITION	0
SPARE TYRE (YES)	8	SPARE TYRE IS IN GOOD CONDITION	0
WHEEL ASSEMBLY (STEEL RIM)	8	WHEEL ALIGNMENT IS IN GOOD CONDITION.	0

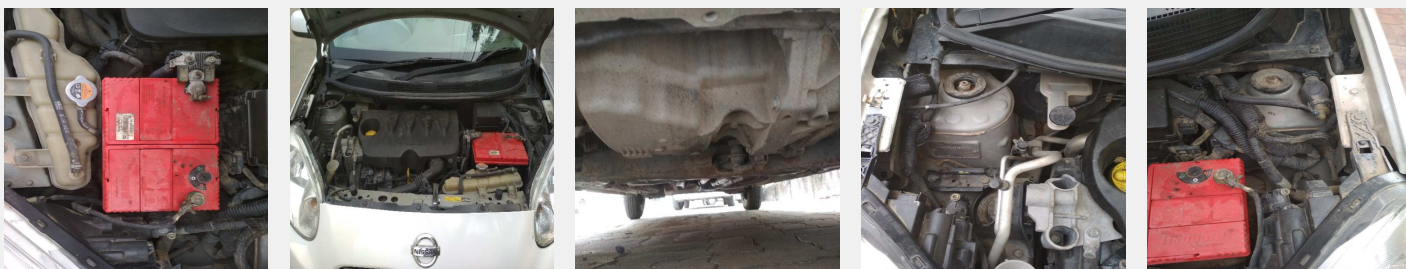
IMAGES

INSPECTION CHECKPOINTS	SCORE(X/10)	REMARKS/COMMENTS	OPTIONAL SPEND EST. (RS)
LH APRON	8	LH APRON IS IN GOOD CONDITION	0
RH APRON	8	RH APRON IS IN GOOD CONDITION	0
RADIATOR	8	RADIATOR IS IN GOOD CONDITION	0
WIRING	8	WIRING HARNESS IS IN GOOD CONDITION	0
BATTERY	8	BATTERY IS IN GOOD CONDITION	0
BRAKE FLUID LEVEL	8	BRAKE FLUID IS IN GOOD CONDITION	0
ENGINE OIL	8	ENGINE OIL IS IN GOOD CONDITION	0
COOLANT LEVEL	8	COOLANT LEVEL IS IN GOOD CONDITION	0
BRAKE & COOLANT HOSE PIPES	8	ALL HOSES/PIPES IS IN GOOD CONDITION	0
UNDERCARRIAGE	8	UNDERCARRIAGE IS IN GOOD CONDITION	0
EXHAUST SYSTEM	8	EXHAUST GAS IS IN GOOD CONDITION	0

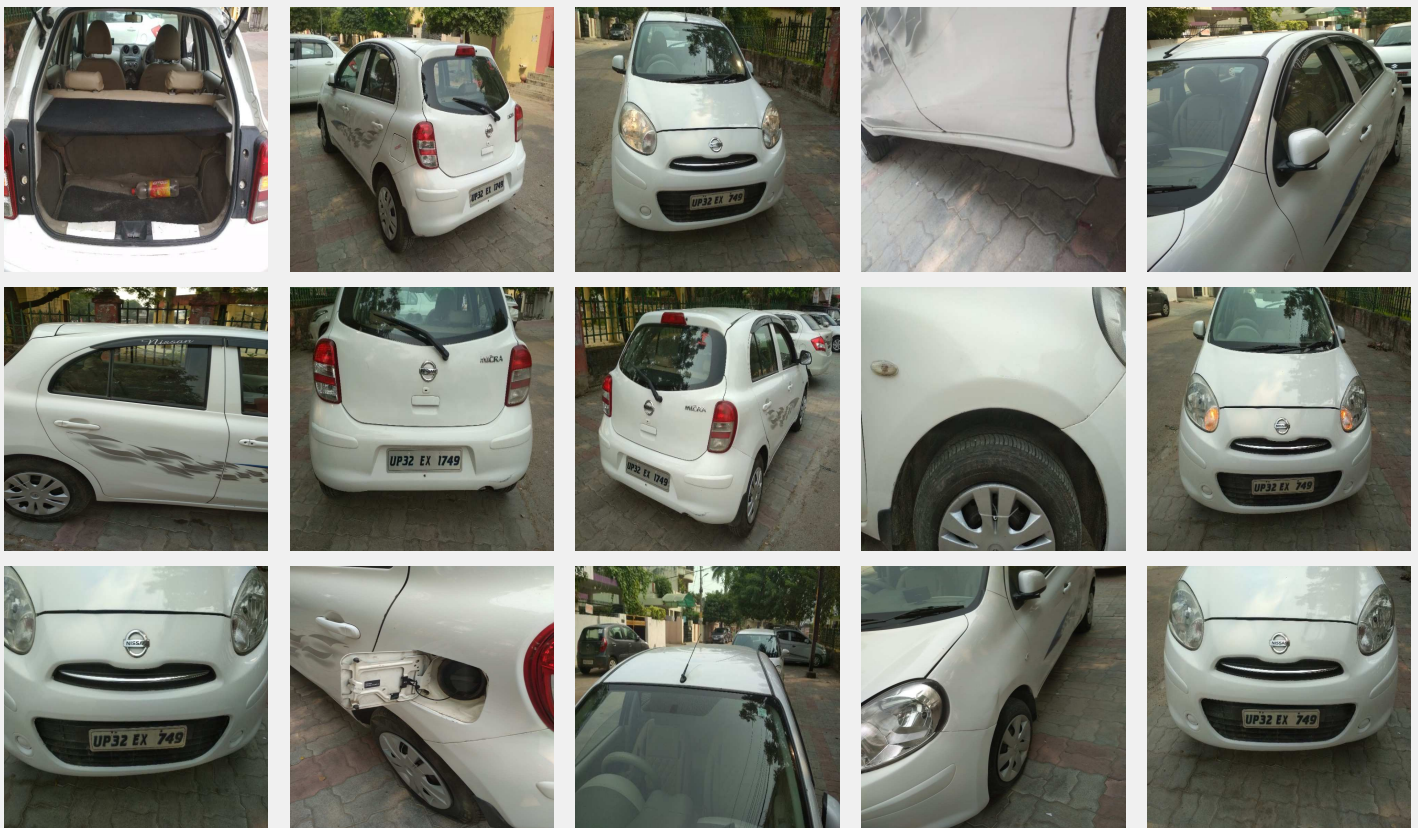
IMAGES

INSPECTION CHECKPOINTS	SCORE(X/10)	REMARKS/COMMENTS	OPTIONAL SPEND EST. (RS)
RH FENDER	8	RH FENDER IS IN GOOD CONDITION	0
BODY RUST	6	BODY RUST 25%-MINOR	0
ROOF (REGULAR)	8	ROOF IS IN GOOD CONDITION	0
PAINT CONDITION	6	PAINT IS IN AVERAGE CONDITION	0
LICENSE PLATE	4	LICENSE PLATE MINOR BLURRED	500
