ECO INSPECTION CERTIFICATE

Order ID : 124496

121 Points Vehicle Inspection Certificate

Hyundai I10 MAGNA 1.2, 2010

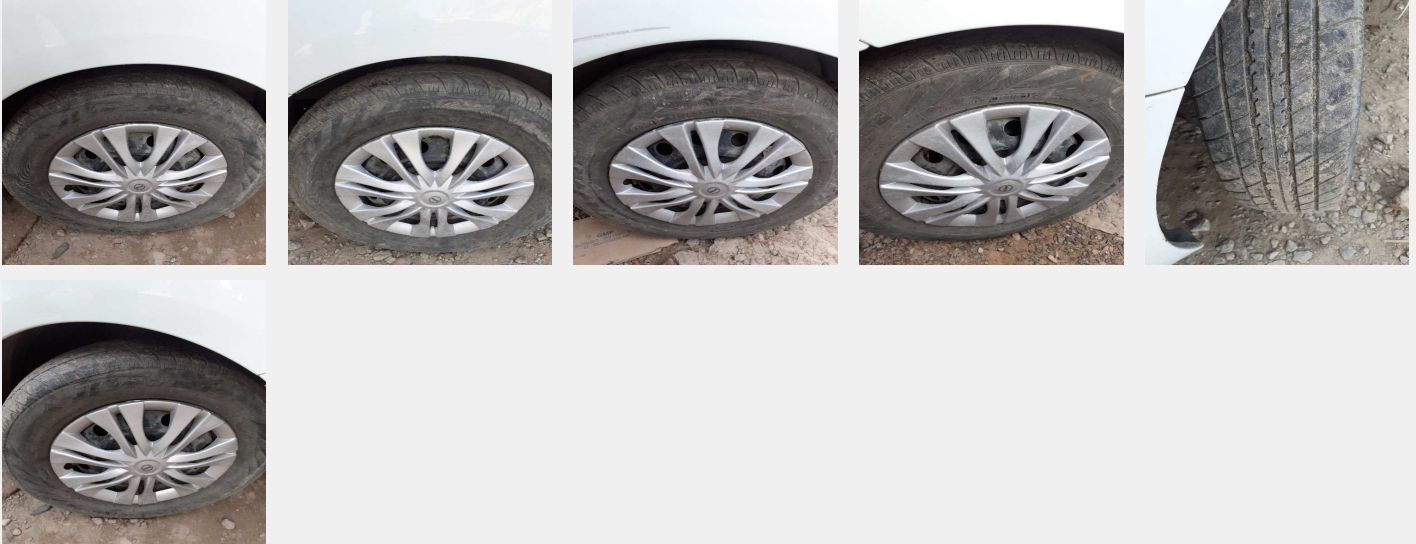
| INSPECTION CHECKPOINTS | SCORE(X/10) | REMARKS/COMMENTS | OPTIONAL SPEND EST. (RS) |
|---|---|--|---|
| TYRES | 6 | TIRES ARE IN AVERAGE CONDITION | 0 |
| SPARE TYRE (YES) | 6 | SPARE TYRE IS IN AVERAGE CONDITION | 0 |
| WHEEL ASSEMBLY (STEEL RIM) | 6 | WHEEL ALIGNMENT IS IN AVERAGE CONDITION. | 0 |

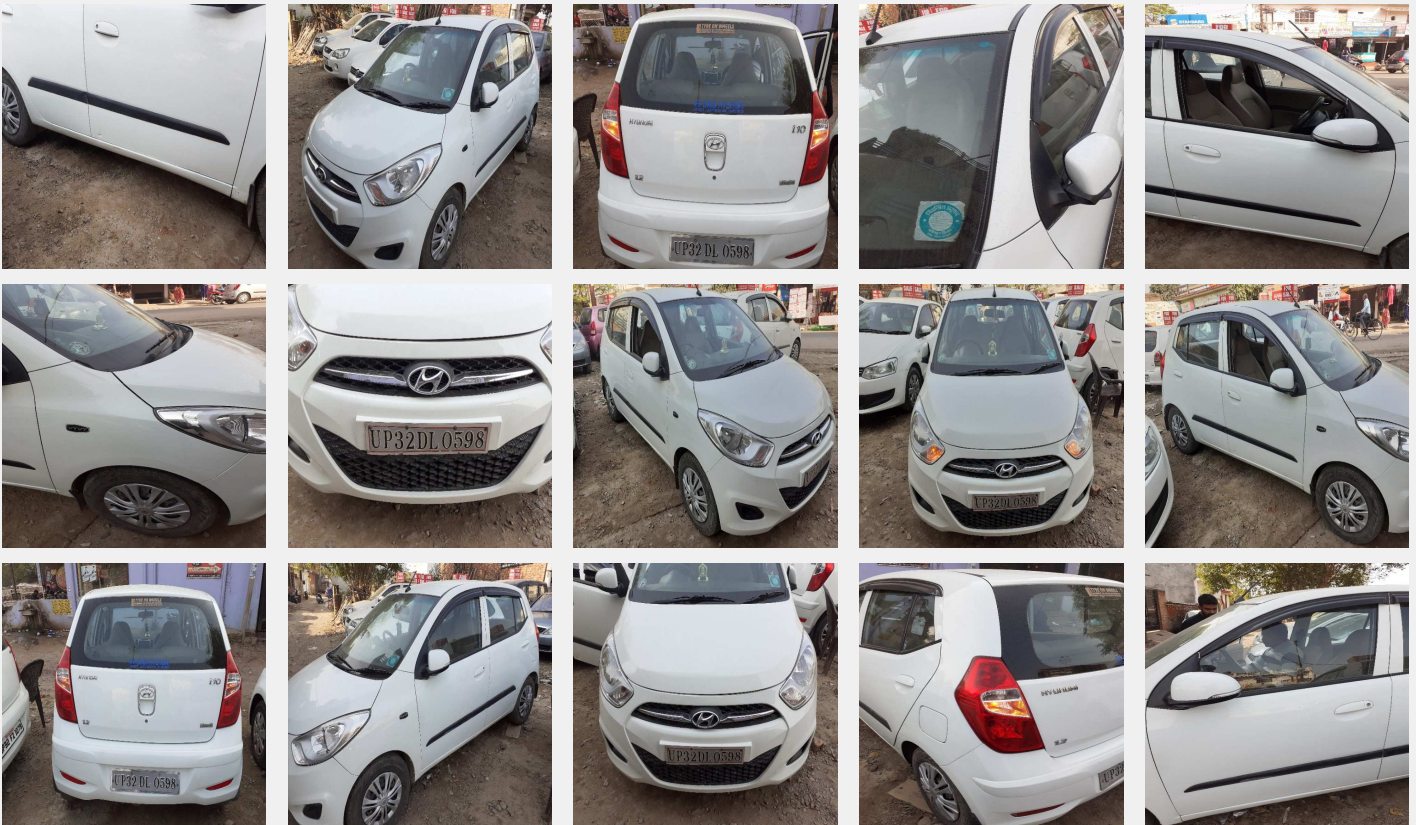
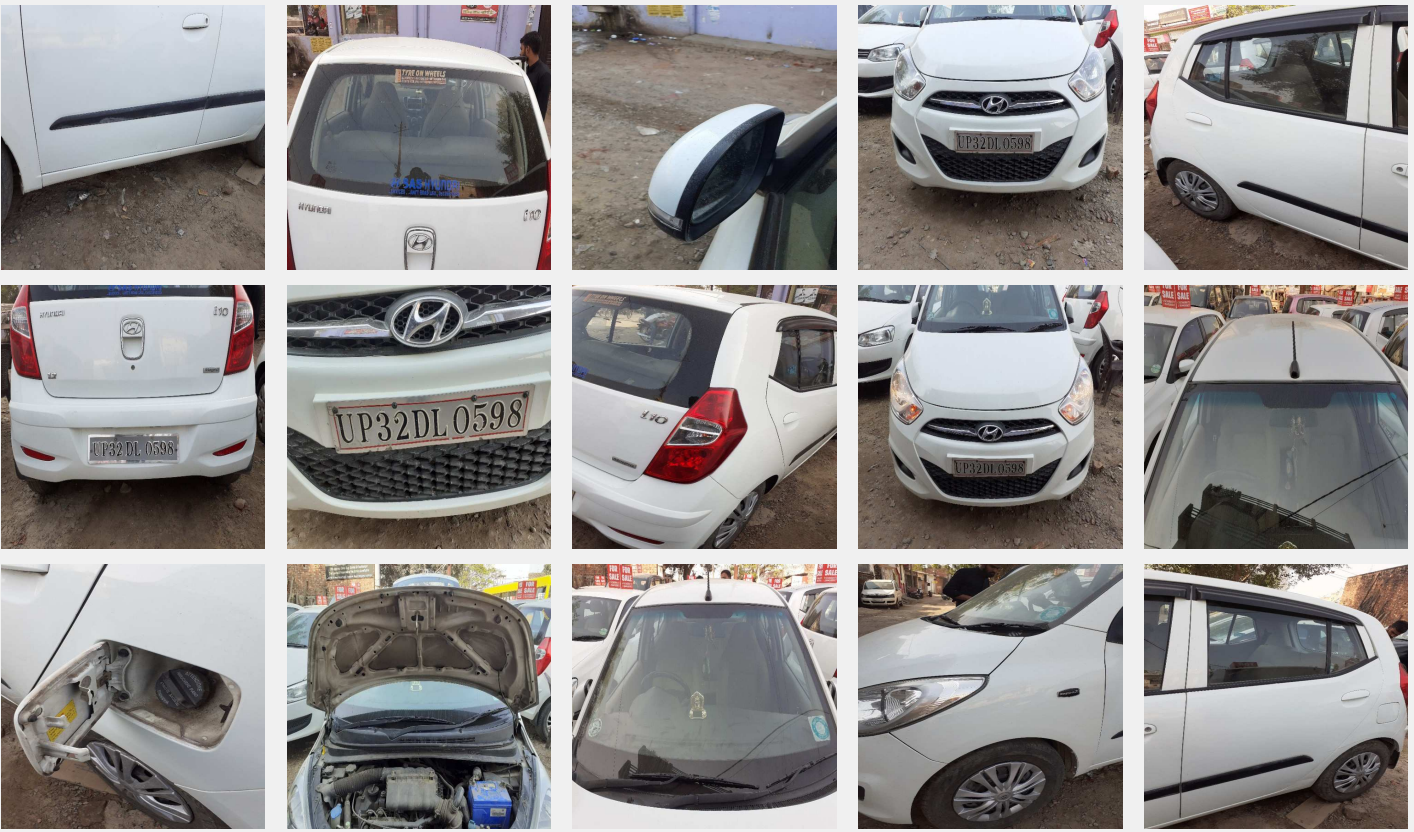
| INSPECTION CHECKPOINTS | SCORE(X/10) | REMARKS/COMMENTS | OPTIONAL SPEND EST. (RS) |
|---|---|---|---|
| ROOF (REGULAR) | 6 | ROOF IS IN AVERAGE CONDITION | 0 |
| PAINT CONDITION | 8 | PAINT IS IN GOOD CONDITION | 0 |
| FOG LAMPS | 0 | FOG LAMPS DAMAGED | 0 |
| TRUNK LID/TAIL GATE | 4 | TRUNK LID DENTED/SCRATCHED-MINOR | 500 |
| LUGGAGE COMPARTMENT LIGHT | 0 | LUGGAGE COMPARTMENT LIGHT NOT AVAILABLE | 0 |
