# ECO INSPECTION REPORT

Order ID : 24627

## Maruti Suzuki Eeco 7 Str, 2013

VEHICLE INFORMATION			
MAKE	MARUTI SUZUKI	TRANSMISSION TYPE	MANUAL
MODEL	EECO	REGISTRATION NO.	WB06H8753
YEAR	2013	VIN/CHASIS NUMBER	MA3ERLF1S00229880
TRIM	7 STR	KMS RUN	35018
COLOR	WHITE	INSURANCE EXPIRY	2019-3-1
BODY TYPE	SEDAN	LOCATION	KALINDI
FUEL TYPE	PETROL	ENGINE SOUND LINK	NIL

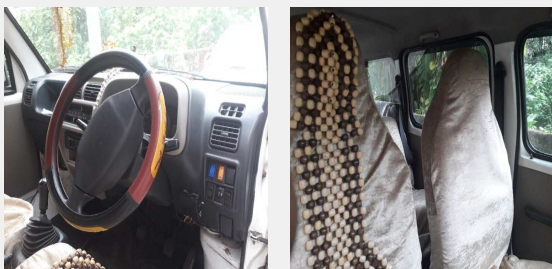
## INTERIOR

INSPECTION CHECKPOINTS	SCORE(X/10)	REMARKS/COMMENTS	OPTIONAL SPEND EST. (RS)
DOOR PANEL	6	OK	0
DOOR HINGES	7		0
CARPET & FLOOR MAT	6		0
SEAT & SEAT BELT	6	OK	0
DASHBOARD & INSTRUMENT PANEL	6	OK	0
HORN	6	AVERAGE	0
SPEAKERS & MUSIC SYSTEM	6	OK	0
HANDBRAKE	6	AVERAGE	0
STEERING-MOUNTED CONTROLS	6	OK	0
PEDALS	6	OK	0
CENTRAL LOCK	6	NOT AVAILABLE	0
A/C VENTS & HEATER	6	NOT AVAILABLE	0
CUP HOLDERS	6	OK	0
NAVIGATION (NO)	6	NOT AVAILABLE	0
ODOMETER	6	OK	0
POWER WINDOWS (NO)	10		0
HAZARD LIGHT	6	OK	0

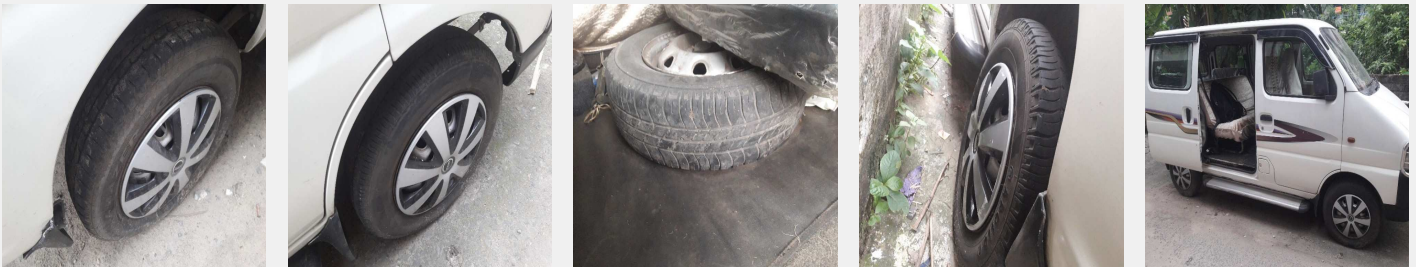
## WHEEL

INSPECTION CHECKPOINTS	SCORE(X/10)	REMARKS/COMMENTS	OPTIONAL SPEND EST. (RS)
TYRES	6	AVERAGE	0
WHEEL ASSEMBLY	6	AVERAGE	0
SPARE TYRE (YES)	5	REQUIRED	2500

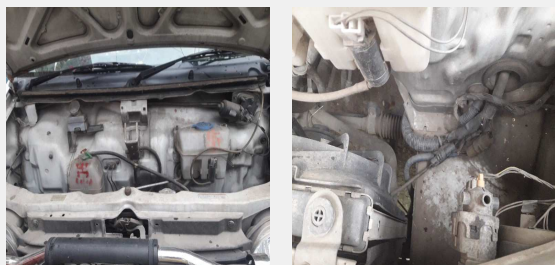
## HOOD

INSPECTION CHECKPOINTS	SCORE(X/10)	REMARKS/COMMENTS	OPTIONAL SPEND EST. (RS)
LH APRON	6	AVERAGE	0
RH APRON	6	AVERAGE	0
RADIATOR	6	AVERAGE	0
BATTERY	6	OK	0
BRAKE FLUID LEVEL	6	OK	0
ENGINE OIL	6	OK	0

COOLANT LEVEL	6	OK	0
BRAKE & COOLANT HOSE PIPES	6	OK	0
UNDERCARRIAGE	7	OK	0
EXHAUST SYSTEM	6	OK	0
WIRING	5	REQUIRED	20000

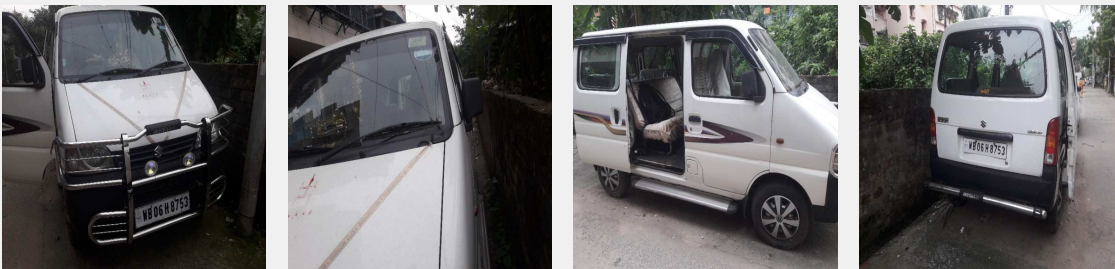
EXTERIOR

INSPECTION CHECKPOINTS	SCORE(X/10)	REMARKS/COMMENTS	OPTIONAL SPEND EST. (RS)
LICENSE PLATE	6	AVERAGE	0
FRONT BUMPER	6	OK	0
HEAD LIGHTS	6	OK	0
GRILLE	6	OK	0
TURN SIGNAL	6	OK	0
FOG LAMPS	6	OK	0
HOOD	6	AVERAGE	0
PILLAR	6	AVERAGE	0
FRONT WINDSHIELD	6	OK	0
SIDE VIEW MIRRORS	6	OK	0
LH FENDER	6	AVERAGE	0
LH FRONT DOOR	6	OK	0
LH REAR DOOR	6	OK	0
LH RUNNING BOARD	6	OK	0
LH QUARTER PANEL	6	OK	0
FUEL LID	6	AVERAGE	0
REAR WINDSHIELD	6	OK	0
REAR BUMPER	6	OK	0
TAIL LIGHT	6	OK	0
TRUNK LID/TAIL GATE	6	OK	0
LUGGAGE COMPARTMENT LIGHT	6	OK	0
RH QUARTER PANEL	6	OK	0
RH RUNNING BOARD	6	OK	0
RH REAR DOOR	6	OK	0

INSPECTION CHECKPOINTS	SCORE(X/10)	REMARKS/COMMENTS	OPTIONAL SPEND EST. (RS)
RH FRONT DOOR	6	OK	0
RH FENDER	7	OK	0
BODY RUST	6	OK	0
ROOF (REGULAR)	6	OK	0
<b>PAINT CONDITION</b>	<b>5</b>	<b>REQUIRED</b>	<b>40000</b>
