ECO INSPECTION REPORT

Order ID : 24885

Ordered By : MINTU	Inspection Date : 2018-09-29	Valid Till : 2018-12-29
-----------------------	---------------------------------	----------------------------

Tata Indigo Ecs Lx, 2012

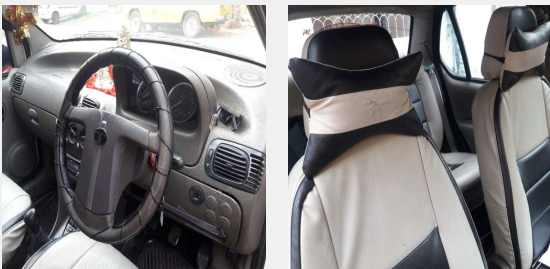
INSPECTION CHECKPOINTS	SCORE(X/10)	REMARKS/COMMENTS	OPTIONAL SPEND EST. (RS)
DOOR PANEL	6	OK	0
DOOR HINGES	6	OK	0
CARPET & FLOOR MAT	6	OK	0
SEAT & SEAT BELT	6	OK	0
DASHBOARD & INSTRUMENT PANEL	6	OK	0
HORN	6	OK	0
SPEAKERS & MUSIC SYSTEM	6	OK	0
HANDBRAKE	6	OK	0
STEERING-MOUNTED CONTROLS	7	OK	0
PEDALS	7	OK	0
CENTRAL LOCK	6	OK	0
A/C VENTS & HEATER	7	OK	0
CUP HOLDERS	7	AVERAGE	0
NAVIGATION (NO)	6	NOT AVAILABLE	0
ODOMETER	6	OK	0
POWER WINDOWS (YES)	6	OK	0
HAZARD LIGHT	6	OK	0

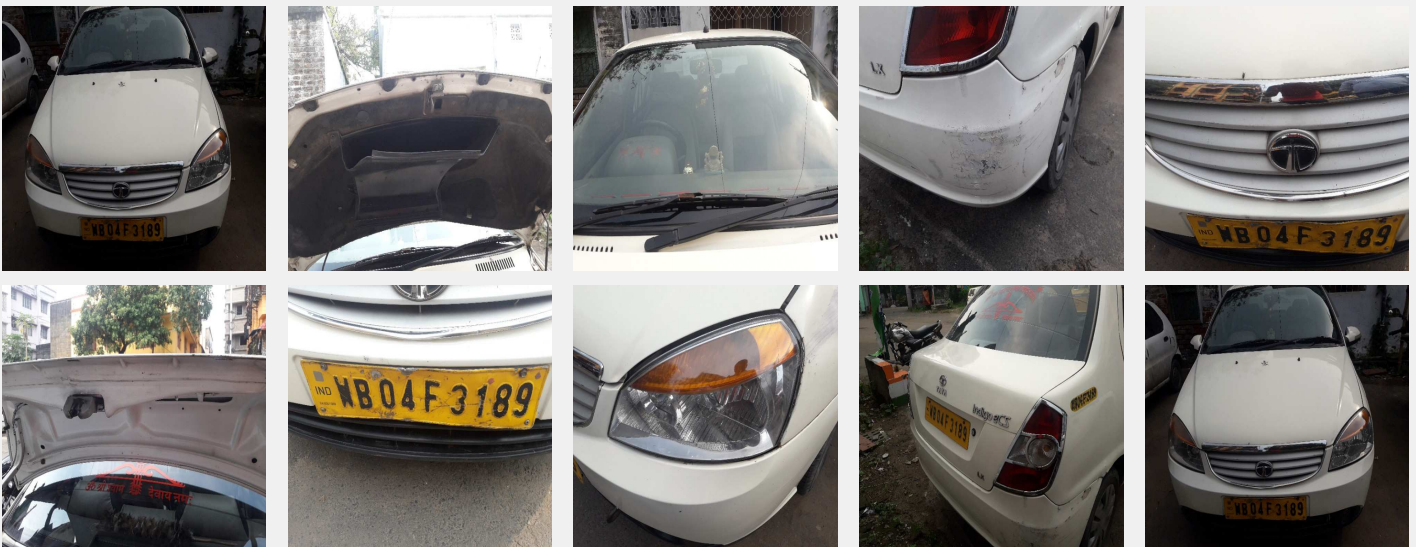
INSPECTION CHECKPOINTS	SCORE(X/10)	REMARKS/COMMENTS	OPTIONAL SPEND EST. (RS)
LICENSE PLATE	5	CHANGES	500
HOOD	5	NEED TO CHANGE	1000
LH FENDER	5	DENT	500
LH QUARTER PANEL	5	DENT	500
PAINT CONDITION	5	REQUIRED	25000
