# ECO INSPECTION CERTIFICATE

Order ID : 28493

121 Points Vehicle Inspection Certificate

## Mahindra Xuv500 W8, 2012

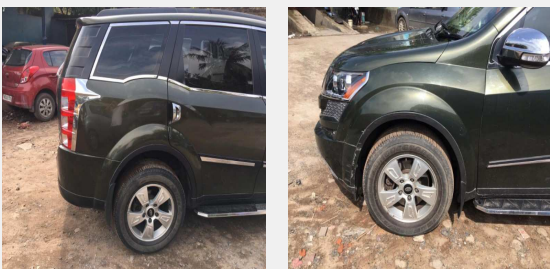
## NEED ATTENTION

INSPECTION CHECKPOINTS	SCORE(X/10)	REMARKS/COMMENTS	OPTIONAL SPEND EST. (RS)
TYRES	7	OK	0

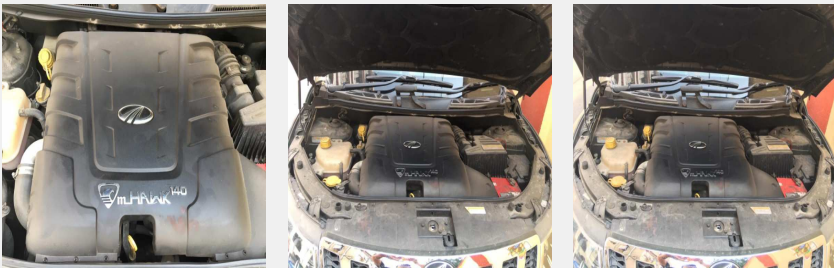
## NEED ATTENTION

INSPECTION CHECKPOINTS	SCORE(X/10)	REMARKS/COMMENTS	OPTIONAL SPEND EST. (RS)
LH APRON	7	OK	0
RH APRON	6	OK	0
RADIATOR	7	OK	0
WIRING	6	OK	0
BATTERY	7	OK	0
BRAKE FLUID LEVEL	6	OK	0
ENGINE OIL	7	OK	0
COOLANT LEVEL	7	OK	0

BRAKE & COOLANT HOSE PIPES	7	OK	0
UNDERCARRIAGE	6	OK	0
EXHAUST SYSTEM	7	OK	0
