# ECO INSPECTION CERTIFICATE

Order ID : 32619

121 Points Vehicle Inspection Certificate

## Nissan Micra XV PREMIUM DIESEL, 2012

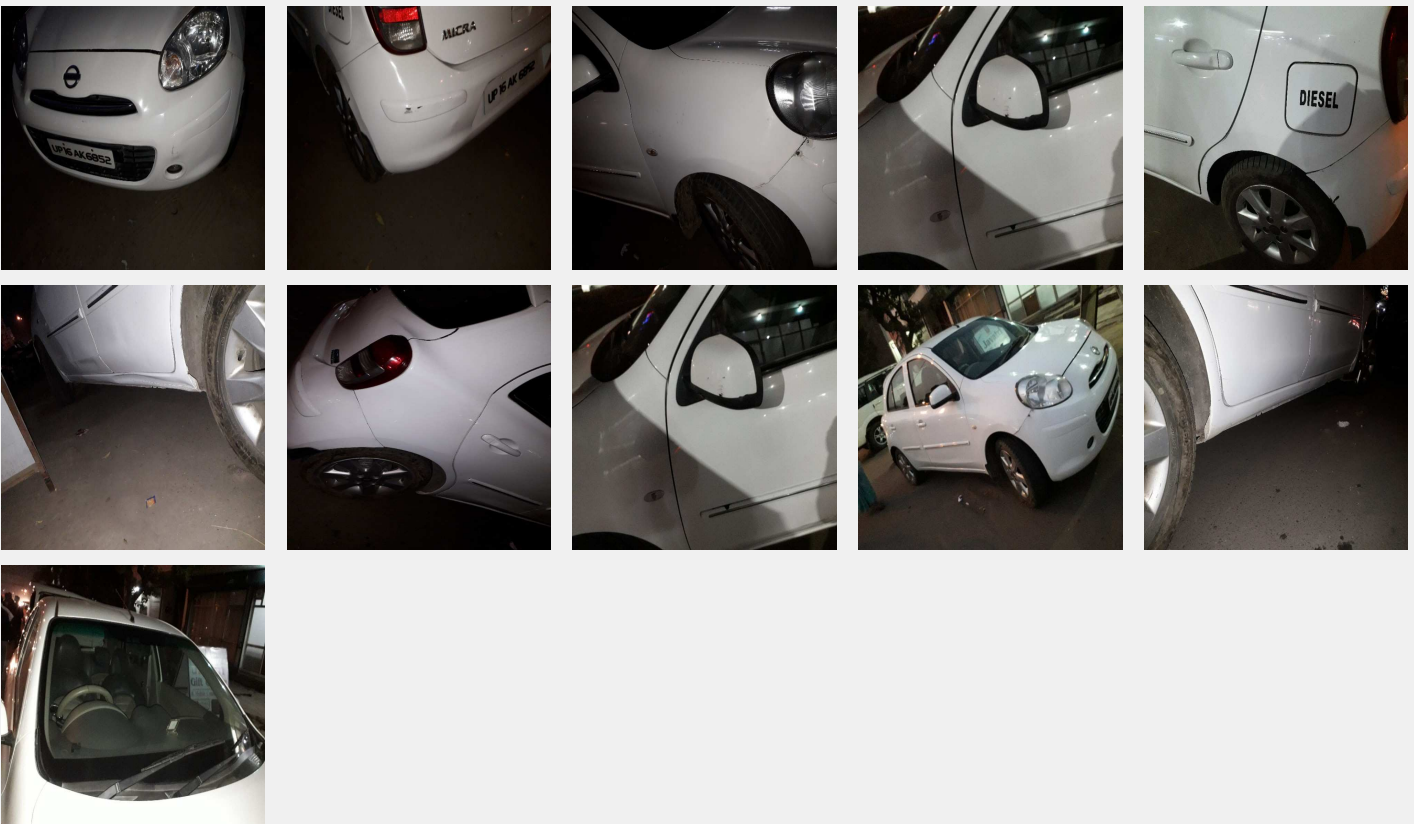
INSPECTION CHECKPOINTS	SCORE(X/10)	REMARKS/COMMENTS	OPTIONAL SPEND EST. (RS)
REAR BUMPER	5	PAINTED AND SCRATCH	1000
RH QUARTER PANEL	5	PAINTED	0
RH RUNNING BOARD	5	PAINTED	0
RH FENDER	5	PAINTED	0
PAINT CONDITION	5	40% PAINTED	0

NEED ATTENTION ⚠️

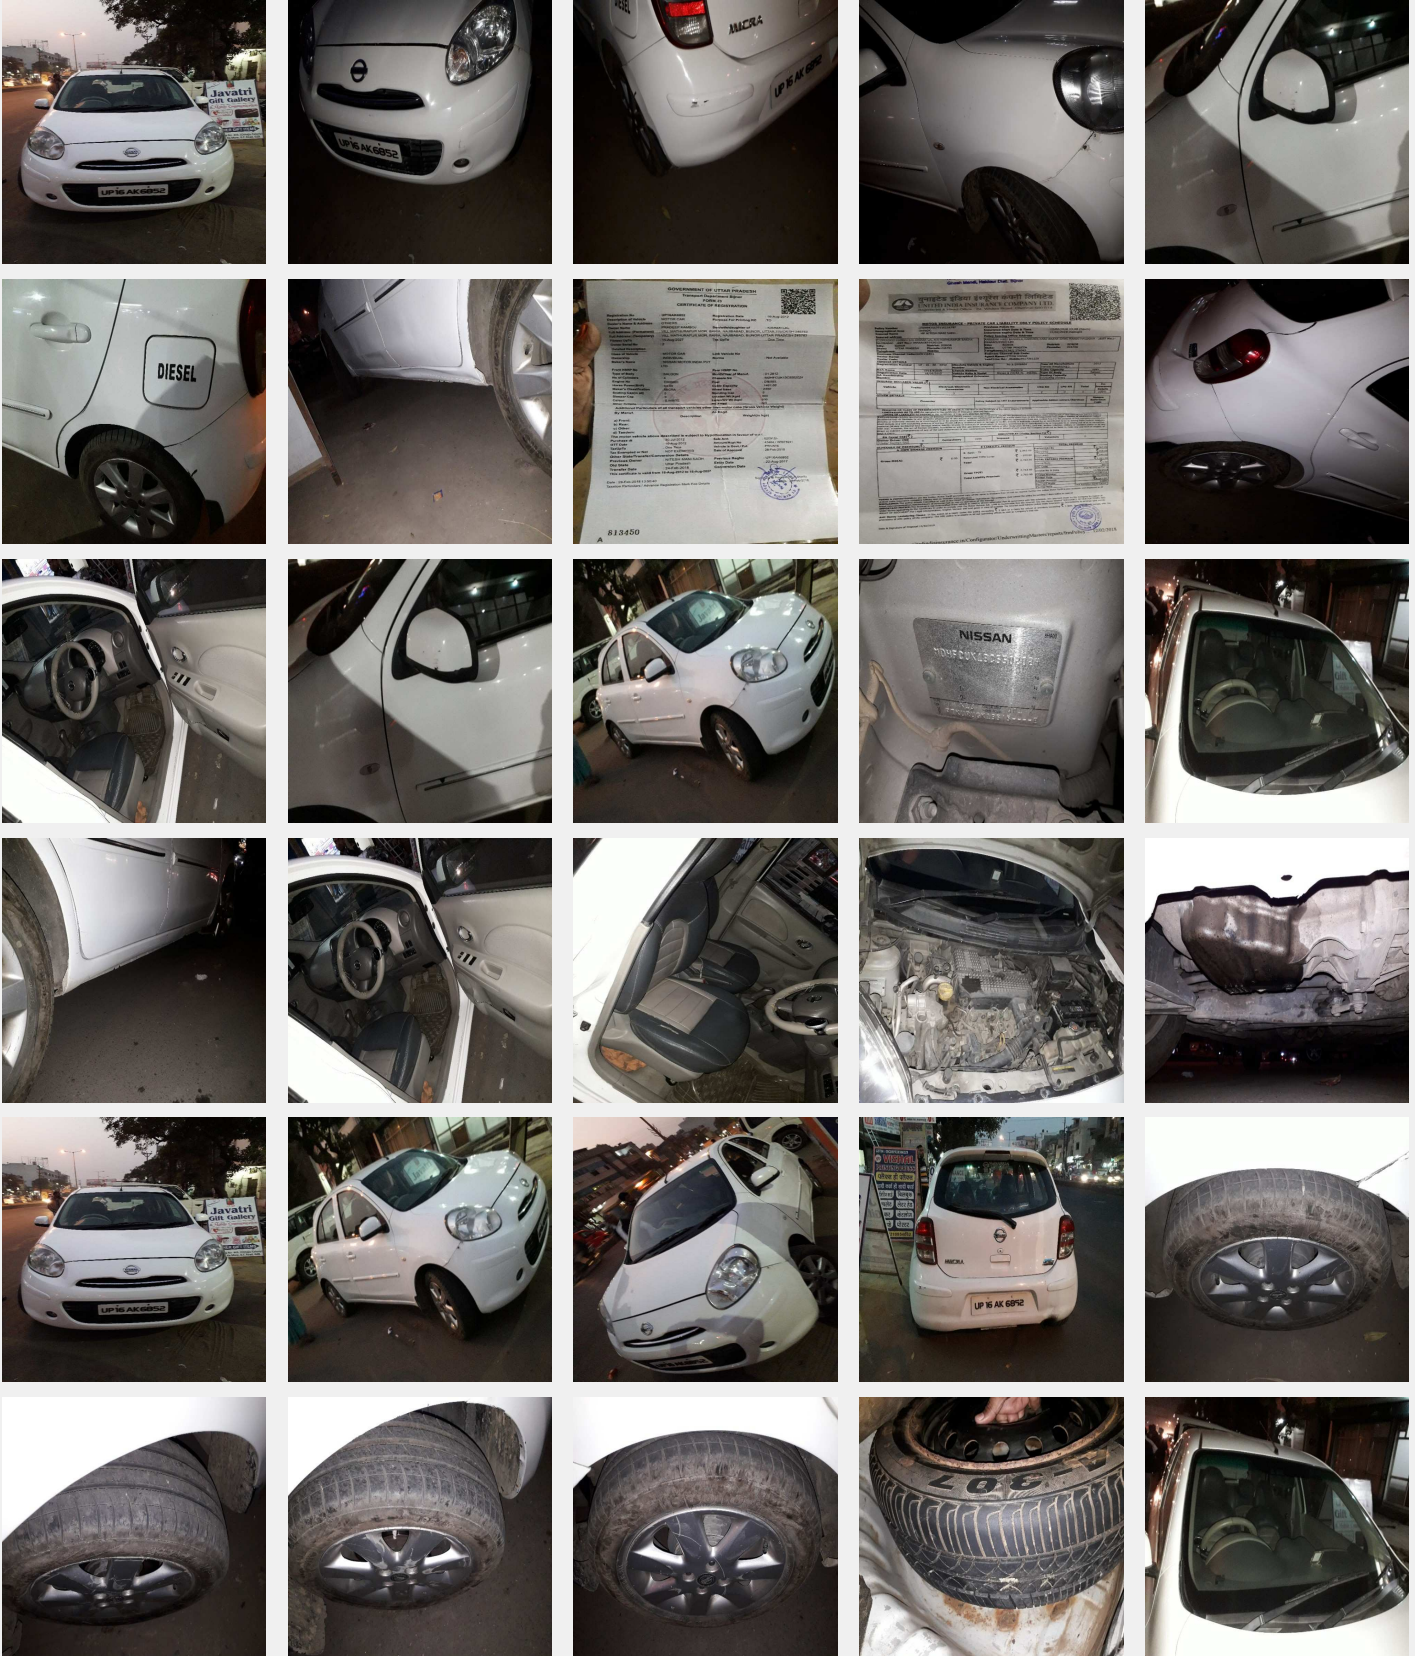
car is better canditon engine is major issues frant windshield is already changed 40% car painted
