ECO INSPECTION CERTIFICATE

Order ID : 32715

121 Points Vehicle Inspection Certificate

Ford Endeavour 3.0L THUNDER PLUS 4X4, 2009

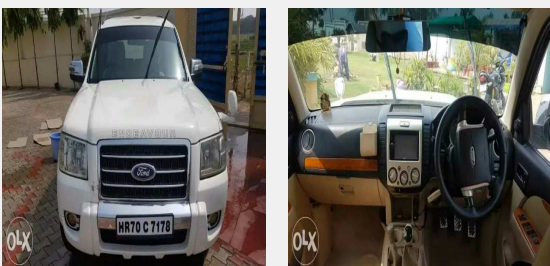
INSPECTION CHECKPOINTS	SCORE(X/10)	REMARKS/COMMENTS	OPTIONAL SPEND EST. (RS)
STEERING PERFORMANCE	6		0
BRAKE PERFORMANCE	7		0
CLUTCH PERFORMANCE	6		0
ENGINE NOISE	7		0
IGNITION SYSTEM	6		0
SUSPENSION PERFORMANCE	7		0
SUSPENSION FRONT SHOCKS	6		0
SUSPENSION REAR SHOCKS	6		0
TRANSMISSION ENGAGE	7		0
CRUISE CONTROL (YES)	6		0
REAR PARKING SENSORS (NO)	10		0
REAR VIEW CAMERA (NO)	10		0
