ECO INSPECTION CERTIFICATE

Order ID : 34511

121 Points Vehicle Inspection Certificate

Mahindra Kuv100 Nxt K8 D 6 STR DUAL TONE, 2017

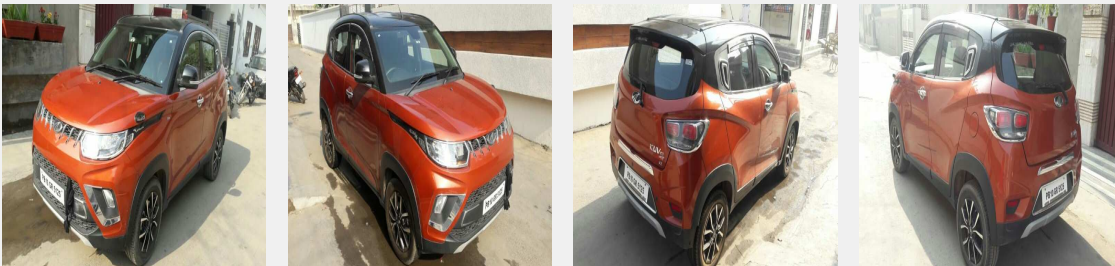
INSPECTION CHECKPOINTS	SCORE(X/10)	REMARKS/COMMENTS	OPTIONAL SPEND EST. (RS)
RH FENDER	7		0
BODY RUST	7		0
ROOF (REGULAR)	8		0
PAINT CONDITION	8		0
FRONT WINDSHIELD	5	SCAR	8000
