ECO INSPECTION CERTIFICATE

Order ID : 34998

121 Points Vehicle Inspection Certificate

Tata Indigo GLS, 2005

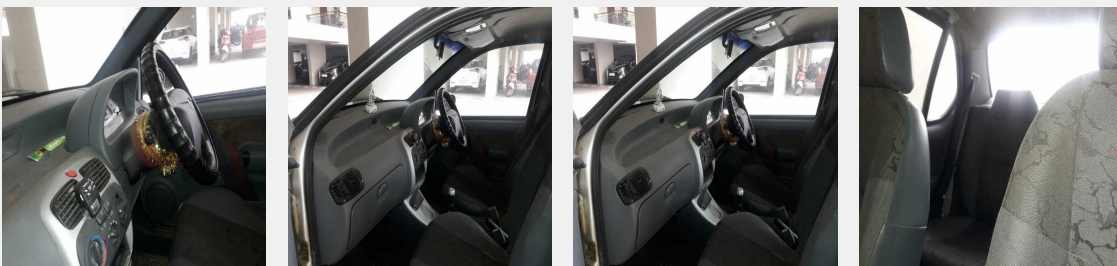
INSPECTION CHECKPOINTS	SCORE(X/10)	REMARKS/COMMENTS	OPTIONAL SPEND EST. (RS)
DOOR PANEL	7	OK	0
DOOR HINGES	7	OK	0
CARPET & FLOOR MAT	7	OK	0
SEAT & SEAT BELT	6	OK	0
DASHBOARD & INSTRUMENT PANEL	7	OK	0
HORN	6	OK	0
SPEAKERS & MUSIC SYSTEM	6	OK	0
HANDBRAKE	6	AVERAGE	0
STEERING-MOUNTED CONTROLS	7	OK	0
PEDALS	6	AVERAGE	0
CENTRAL LOCK	6	NOT AVAILABLE	0
A/C VENTS & HEATER	6	OK	0
CUP HOLDERS	6	AVAILABLE	0
NAVIGATION (NO)	10		0
ODOMETER	6	OK	0
POWER WINDOWS (YES - FRONT ONLY)	6	OK	0
HAZARD LIGHT	6	AVERAGE	0

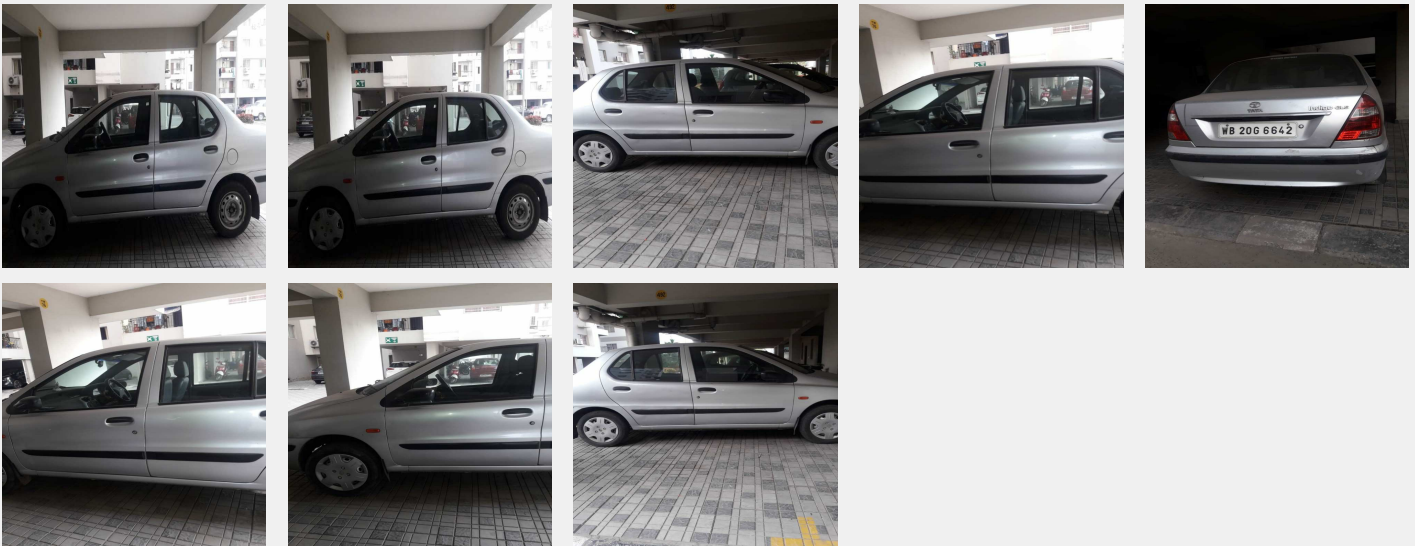
INSPECTION CHECKPOINTS	SCORE(X/10)	REMARKS/COMMENTS	OPTIONAL SPEND EST. (RS)
RH FENDER	6	OK	0
BODY RUST	6	AVERAGE	0
ROOF (REGULAR)	6	AVERAGE	0
PAINT CONDITION	6	OK	0
REAR BUMPER	5	DENT	2000
