# ECO INSPECTION CERTIFICATE

Order ID : 35376

121 Points Vehicle Inspection Certificate

## Volvo Xc90 D5 AWD, 2013

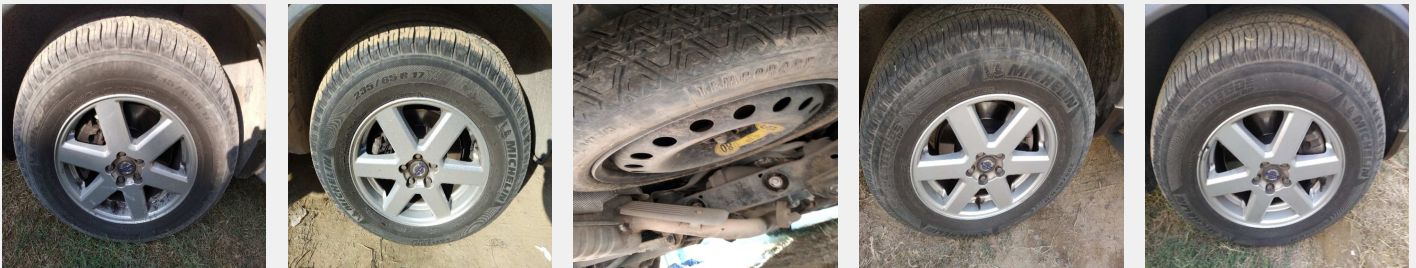
## IMAGES

INSPECTION CHECKPOINTS	SCORE(X/10)	REMARKS/COMMENTS	OPTIONAL SPEND EST. (RS)
TYRES	8	GOOD CONDITION	0
SPARE TYRE (YES)	8	GOOD CONDITION	0
WHEEL ASSEMBLY (ALLOY RIM)	8	GOOD CONDITION	0
