# ECO INSPECTION CERTIFICATE

121 Points Vehicle Inspection Certificate

## Tata Zest QUADRAJET 1.3 75PS XE, 2017

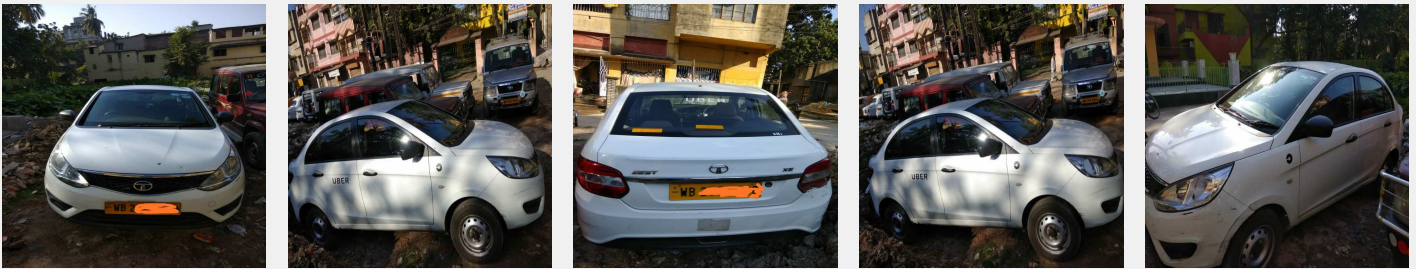
## IMAGES

INSPECTION CHECKPOINTS	SCORE(X/10)	REMARKS/COMMENTS	OPTIONAL SPEND EST. (RS)
BODY RUST	6	AVERAGE	0
ROOF (REGULAR)	6	OK	0
PAINT CONDITION	6	AVERAGE	0
LH FENDER	5	DENT	1200
TAIL LIGHT	5	BROKEN	1500
