ECO INSPECTION CERTIFICATE

Order ID : 38862

121 Points Vehicle Inspection Certificate

Fiat Punto EMOTION PACK 1.4, 2011

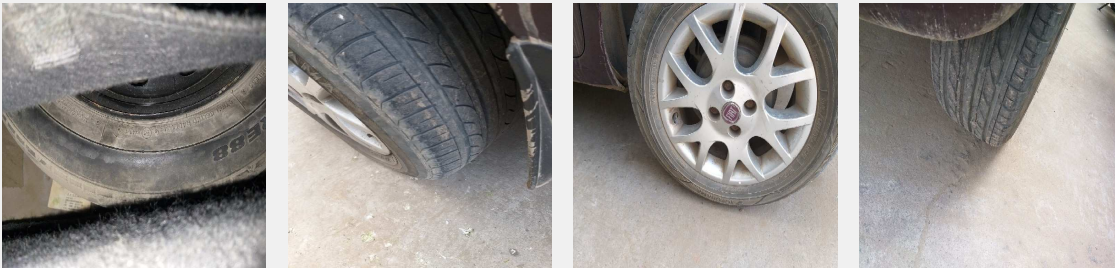
INSPECTION CHECKPOINTS	SCORE(X/10)	REMARKS/COMMENTS	OPTIONAL SPEND EST. (RS)
TYRES	6	GOOD CONDITION AND WORKING PROPERLY	0
SPARE TYRE (YES)	6	NORMAL CONDITION	0
WHEEL ASSEMBLY (ALLOY RIM)	6	GOOD CONDITION AND WORKING PROPERLY	0

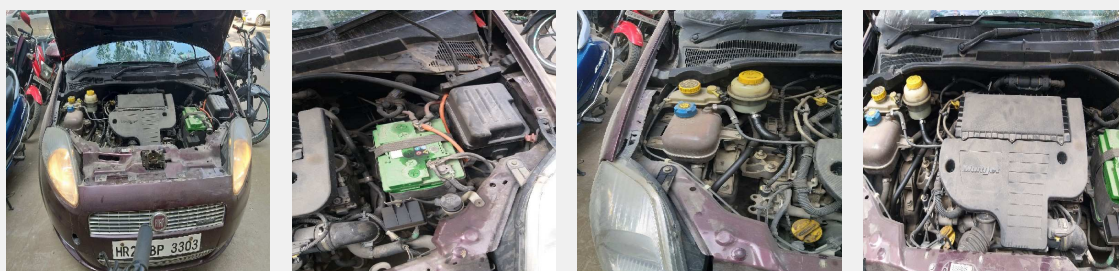
INSPECTION CHECKPOINTS	SCORE(X/10)	REMARKS/COMMENTS	OPTIONAL SPEND EST. (RS)
LH APRON	6	GOOD CONDITION	0
RH APRON	6	GOOD CONDITION	0
RADIATOR	6	GOOD CONDITION AND WORKING PROPERLY	0
WIRING	6	GOOD CONDITION AND WORKING PROPERLY	0

BATTERY	6	GOOD CONDITION AND WORKING PROPERLY	0
BRAKE FLUID LEVEL	6	MAXIMUM LAVAL	0
ENGINE OIL	7	MAXIMUM LAVAL	0
COOLANT LEVEL	7	MAXIMUM LAVAL	0
BRAKE & COOLANT HOSE PIPES	7	GOOD CONDITION AND WORKING PROPERLY	0
UNDERCARRIAGE	6	GOOD	0
EXHAUST SYSTEM	6	GOOD	0

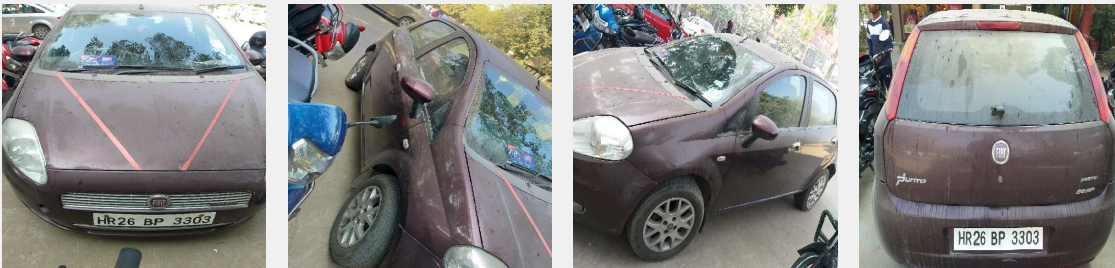
INSPECTION CHECKPOINTS	SCORE(X/10)	REMARKS/COMMENTS	OPTIONAL SPEND EST. (RS)
RH FRONT DOOR	6	MINORS SCRATCHES	3500
RH FENDER	6	GOOD CONDITION	0
BODY RUST	6	NEED TO BE REAPING	5000
ROOF (REGULAR)	6	GOOD CONDITION	0
PAINT CONDITION	6	GOOD	0
