# ECO INSPECTION CERTIFICATE

121 Points Vehicle Inspection Certificate

## Volkswagen Vento 1.5 TDI HIGHLINE AT, 2015

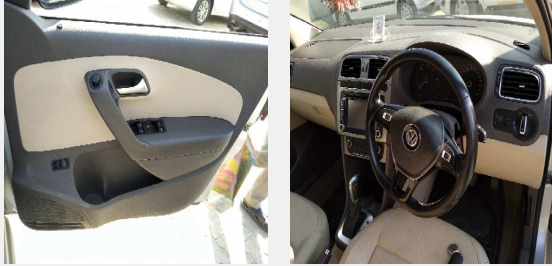
## IMAGES

INSPECTION CHECKPOINTS	SCORE(X/10)	REMARKS/COMMENTS	OPTIONAL SPEND EST. (RS)
DOOR PANEL	7	GOOD CONDITION	0
DOOR HINGES	7	GOOD CONDITION	0
CARPET & FLOOR MAT	7	GOOD CONDITION	0
SEAT & SEAT BELT	7	GOOD CONDITION	0
DASHBOARD & INSTRUMENT PANEL	7	GOOD CONDITION	0
HORN	7	GOOD WORKING	0
SPEAKERS & MUSIC SYSTEM	7	GOOD WORKING	0
HANDBRAKE	7	GOOD WORKING	0
STEERING-MOUNTED CONTROLS	7	GOOD WORKING	0
PEDALS	7	GOOD CONDITION	0
CENTRAL LOCK	7	GOOD WORKING	0
A/C VENTS & HEATER	7	GOOD CONDITION	0
CUP HOLDERS	7	GOOD CONDITION	0
NAVIGATION (NO)	10		0
ODOMETER	7	GOOD CONDITION	0
POWER WINDOWS (YES)	7	GOOD CONDITION	0
HAZARD LIGHT	7	GOOD CONDITION	0

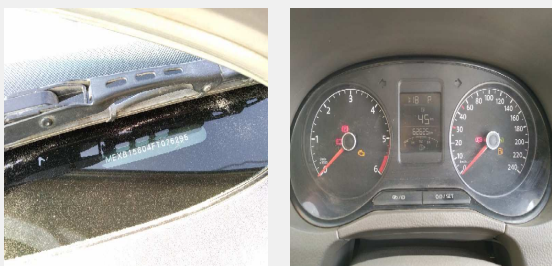
**IMAGES**

INSPECTION CHECKPOINTS	SCORE(X/10)	REMARKS/COMMENTS	OPTIONAL SPEND EST. (RS)
STEERING PERFORMANCE	7	GOOD CONDITION	0
BRAKE PERFORMANCE	7	GOOD CONDITION	0
CLUTCH PERFORMANCE	7	GOOD CONDITION	0
ENGINE NOISE	7	GOOD CONDITION	0
IGNITION SYSTEM	7	GOOD CONDITION	0
SUSPENSION PERFORMANCE	7	GOOD CONDITION	0
SUSPENSION FRONT SHOCKS	7	GOOD CONDITION	0
SUSPENSION REAR SHOCKS	7	GOOD CONDITION	0
TRANSMISSION ENGAGE	7	GOOD CONDITION	0
CRUISE CONTROL (NO)	10		0
REAR PARKING SENSORS (YES)	7	GOOD WORKING	0
REAR VIEW CAMERA (YES)	7	GOOD WORKING	0

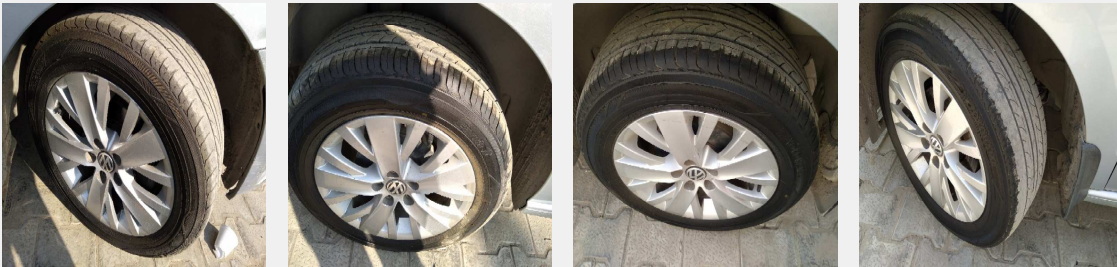
## IMAGES

INSPECTION CHECKPOINTS	SCORE(X/10)	REMARKS/COMMENTS	OPTIONAL SPEND EST. (RS)
SPARE TYRE (YES)	6	TIRE WEAR NEED TO BE CHANGE	5000
WHEEL ASSEMBLY (ALLOY RIM)	7	GOOD CONDITION	0
<b>TYRES</b>	<b>5</b>	<b>FRONT ALL TIRE WEAR NEED TO BE CHANGE</b>	<b>10000</b>

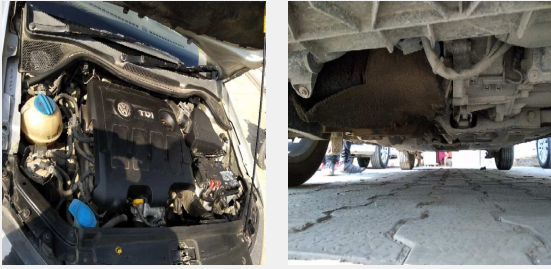
IMAGES

INSPECTION CHECKPOINTS	SCORE(X/10)	REMARKS/COMMENTS	OPTIONAL SPEND EST. (RS)
LH APRON	7	GOOD CONDITION	0
RH APRON	7	GOOD CONDITION	0
RADIATOR	7	GOOD CONDITION	0
WIRING	7	GOOD CONDITION	0
<b>BATTERY</b>	<b>6</b>	<b>BATTERY WEEK NEED TO CHARGE</b>	<b>0</b>

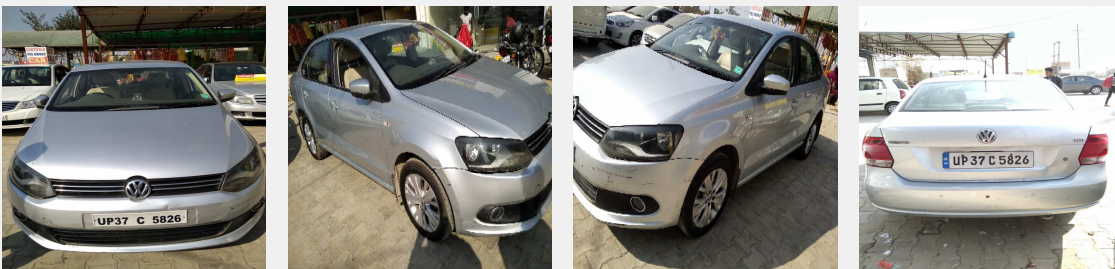
## IMAGES

RH FENDER	6	MINOR DENT NEEDVTO BE REPAIR	1000
-----------	---	------------------------------	------

INSPECTION CHECKPOINTS	SCORE(X/10)	REMARKS/COMMENTS	OPTIONAL SPEND EST. (RS)
BODY RUST	7	GOOD CONDITION	0
ROOF (REGULAR)	7	GOOD CONDITION	0
PAINT CONDITION	7	GOOD CONDITION	0
FRONT BUMPER	5	MINOR SCRATCH NEED TO BE REPAIR	1500
GRILLE	4	DEMAGE NEED TO BE CHANGE	1500
