ECO INSPECTION CERTIFICATE

Order ID : 40231

121 Points Vehicle Inspection Certificate

Jaguar Xf 3.0L DIESEL PREMIUM LUXURY, 2012

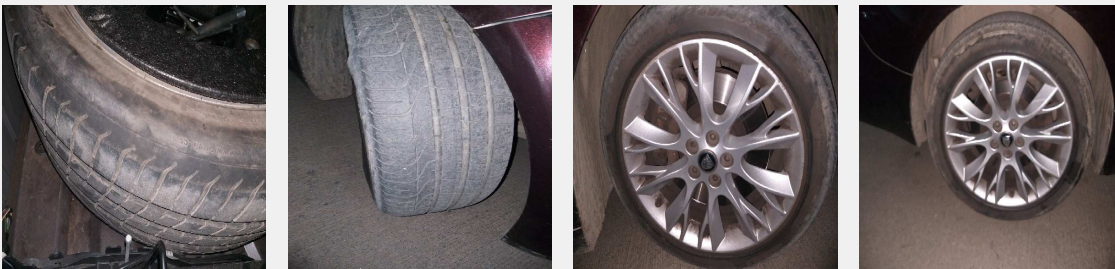
IMAGES

INSPECTION CHECKPOINTS	SCORE(X/10)	REMARKS/COMMENTS	OPTIONAL SPEND EST. (RS)
TYRES	8	FRONT RIGHT HAND SIDE TYRE FULLY CONDITION	0
SPARE TYRE (YES)	8	GOODCONDITION AND WORKING PROPERLY	0
WHEEL ASSEMBLY (ALLOY RIM)	8	GOODCONDITION AND WORKING PROPERLY	0

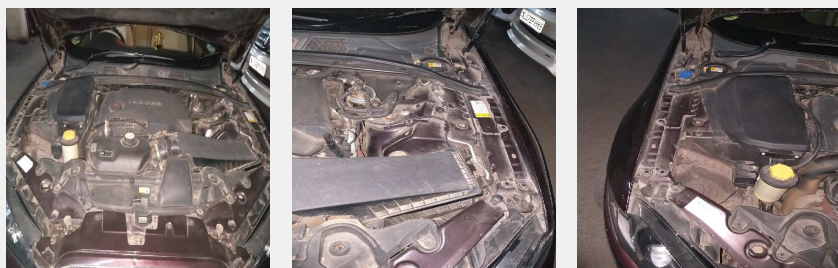
IMAGES

INSPECTION CHECKPOINTS	SCORE(X/10)	REMARKS/COMMENTS	OPTIONAL SPEND EST. (RS)
LH APRON	8	GOODCONDITION	0
RH APRON	8	GOOD	0
RADIATOR	8	GOODCONDITION AND WORKING PROPERLY	0
		GOODCONDITION AND

WIRING	8	WORKING PROPERLY	0
BATTERY	8	GOOD CONDITION AND WORKING PROPERLY	0
BRAKE FLUID LEVEL	8	MAXIMUM LAVAL	0
ENGINE OIL	8	MAXIMUM LAVAL	0
COOLANT LEVEL	8	MAXIMUM LAVAL	0
BRAKE & COOLANT HOSE PIPES	8	GOOD	0
UNDERCARRIAGE	8	GOOD	0
EXHAUST SYSTEM	8	GOOD	0

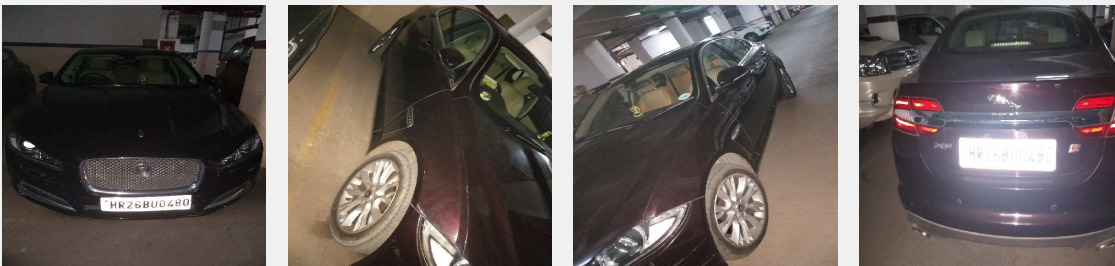
IMAGES

INSPECTION CHECKPOINTS	SCORE(X/10)	REMARKS/COMMENTS	OPTIONAL SPEND EST. (RS)
LICENSE PLATE	8	GOOD	0
FRONT BUMPER	8	NEED TO BE PAINT	25000
HEAD LIGHTS	8	GOODCONDITION AND WORKING PROPERLY	0
GRILLE	8	GOOD CONDITION	0
TURN SIGNAL	8	GOODCONDITION AND WORKING PROPERLY	0
FOG LAMPS	8	NO FOG LAMPS	0
HOOD	8	GOODCONDITION AND WORKING PROPERLY	0
PILLAR	8	GOOD	0
FRONT WINDSHIELD	8	GOODVISIBILITY	0
SIDE VIEW MIRRORS	8	GOODCONDITION AND WORKING PROPERLY	0
LH FENDER	8	GOOD	0
LH FRONT DOOR	8	GOODCONDITION AND WORKING PROPERLY	0
LH REAR DOOR	8	GOODCONDITION AND WORKING PROPERLY	0
LH RUNNING BOARD	8		0
LH QUARTER PANEL	8	GOOD	0
FUEL LID	8	GOODCONDITION AND WORKING PROPERLY	0
REAR WINDSHIELD	8	GOOD VISIBILITY	0
REAR BUMPER	7	MINORS SCRATCHES	5000
TAIL LIGHT	8	GOODCONDITION AND WORKING PROPERLY	0
TRUNK LID/TAIL GATE	8	GOODCONDITION AND WORKING PROPERLY	0
LUGGAGE COMPARTMENT LIGHT	8	GOOD	0

RH QUARTER PANEL	6	NEED TO BE REAPING AND	25000
RH RUNNING BOARD	8	GOOD	0
RH REAR DOOR	8		0

INSPECTION CHECKPOINTS	SCORE(X/10)	REMARKS/COMMENTS	OPTIONAL SPEND EST. (RS)
RH FRONT DOOR	8	GOODCONDITION AND WORKING PROPERLY	0
RH FENDER	8	GOOD	0
BODY RUST	8		0
ROOF (SUN ROOF)	8	GOODCONDITION AND WORKING PROPERLY	0
PAINT CONDITION	8	GOOD	0

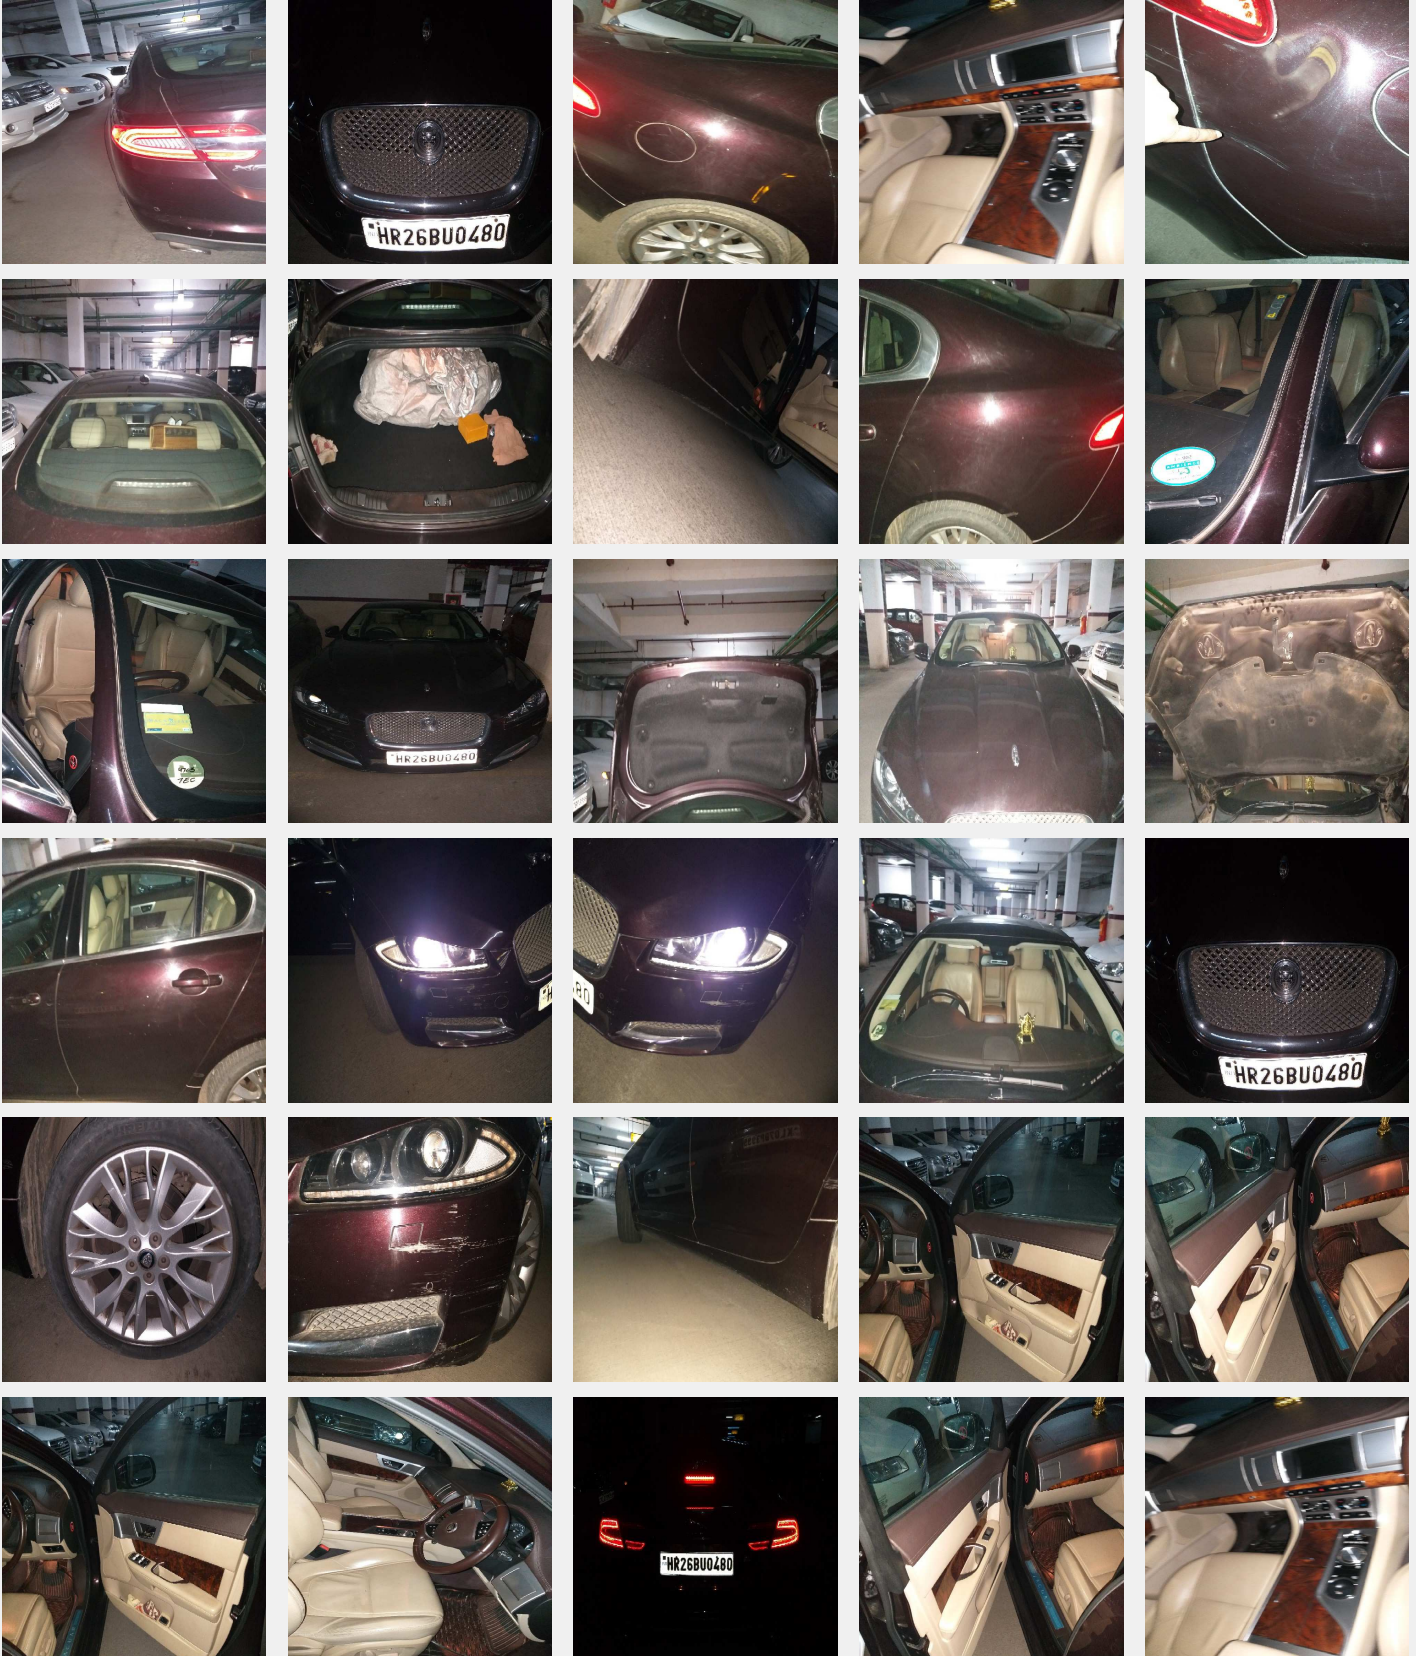
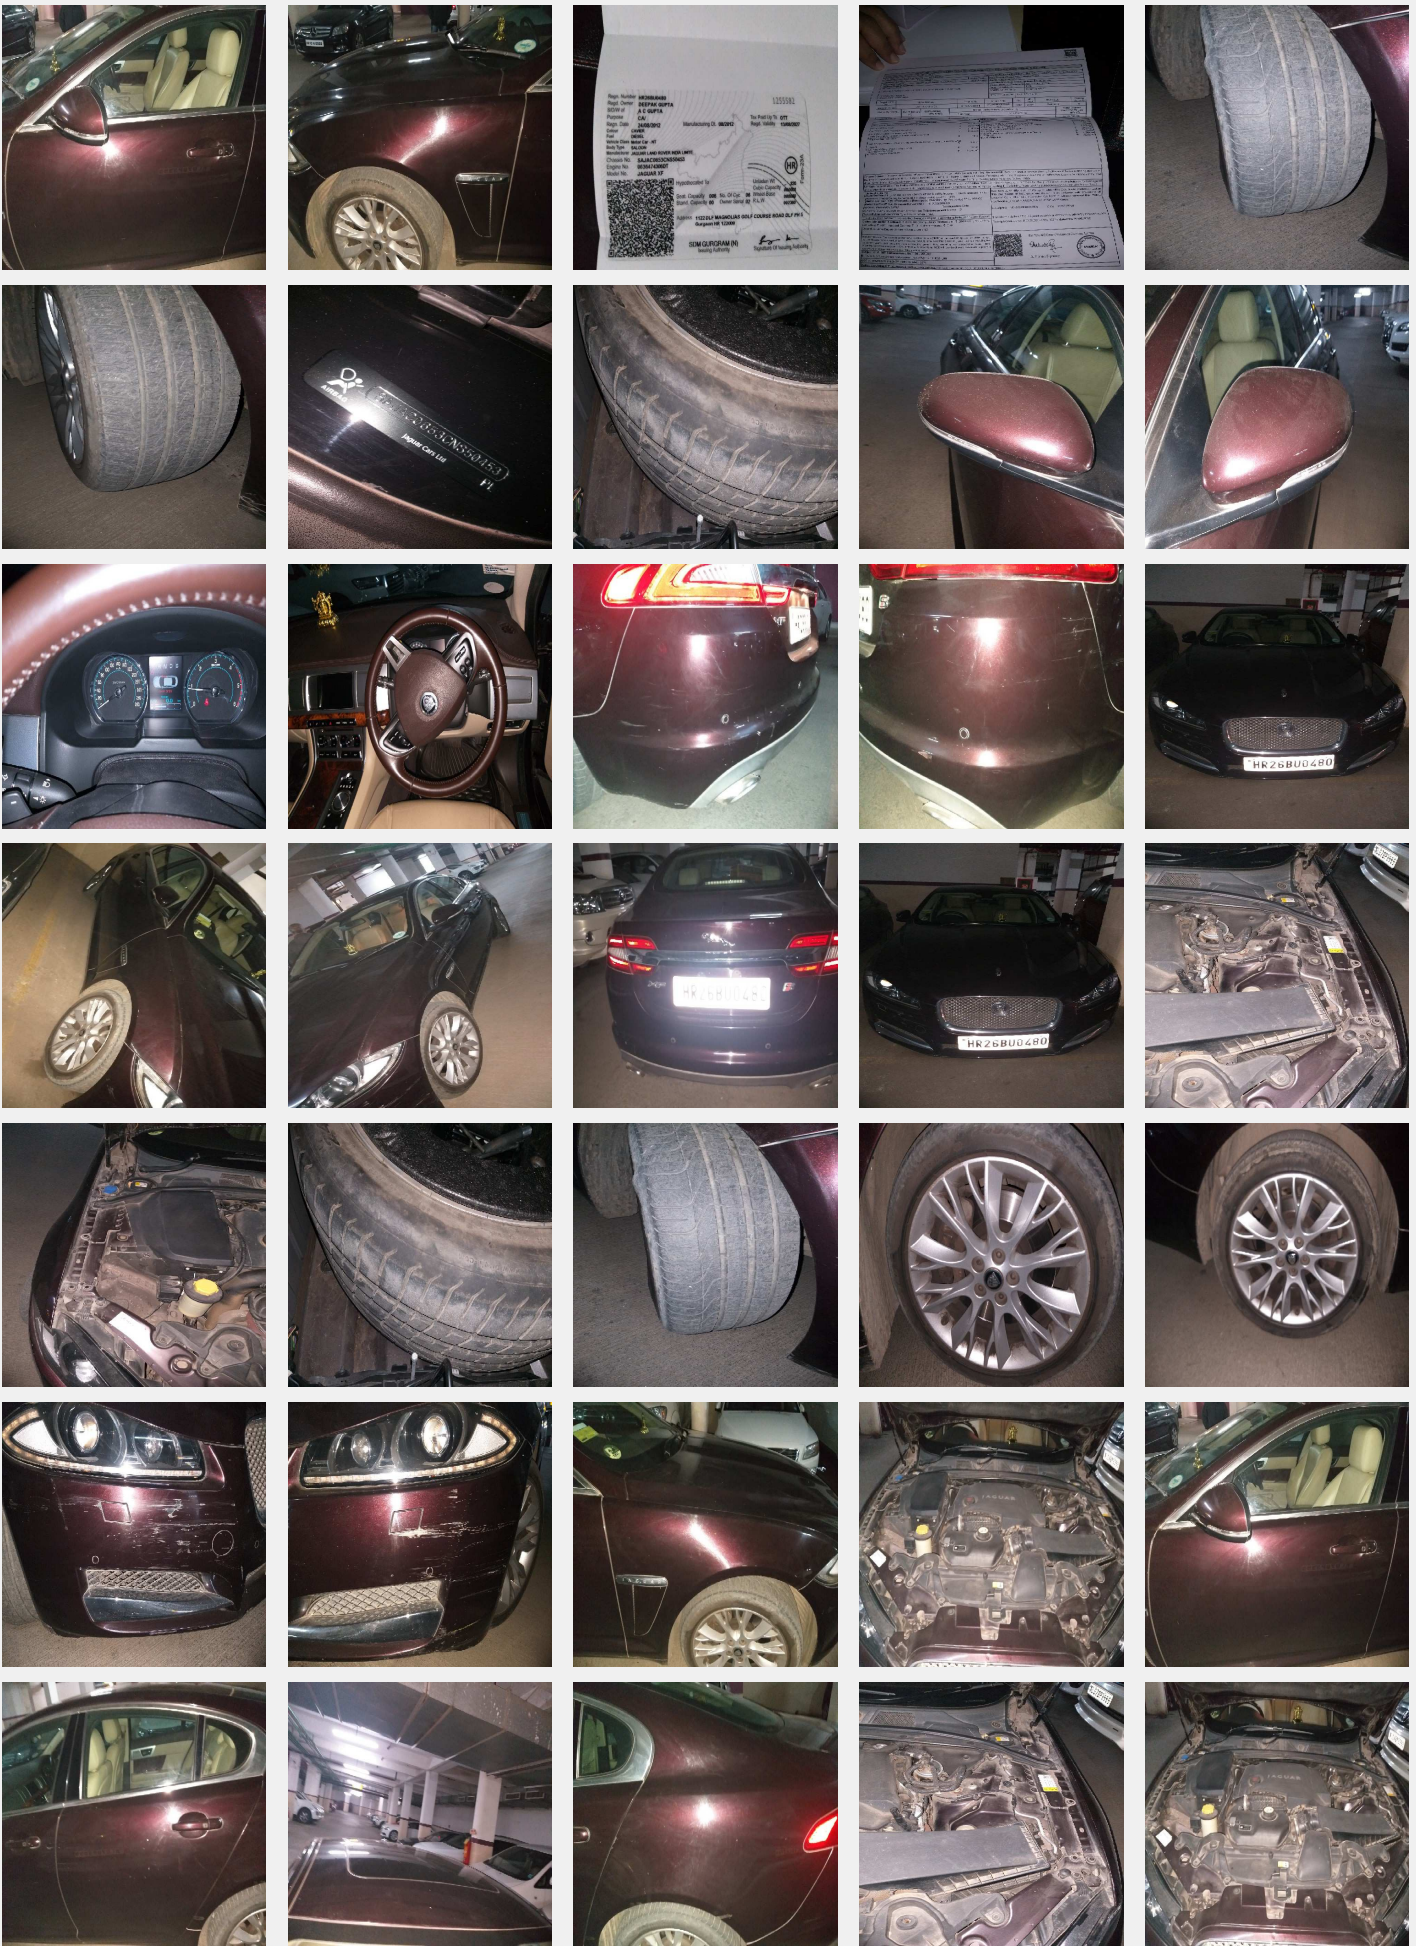
IMAGES

minor scratches minor dent and 1 tyres need to be replace frt
