ECO INSPECTION CERTIFICATE

Order ID : 42732

121 Points Vehicle Inspection Certificate

Mercedes-Benz S-Class 350 L, 2007

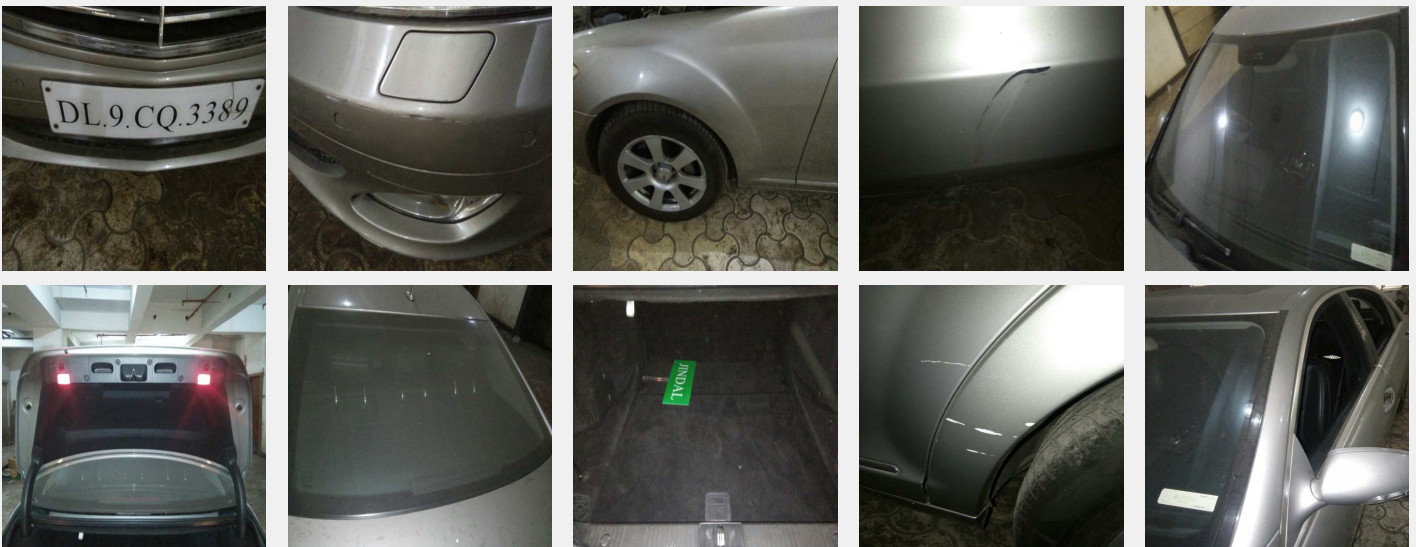
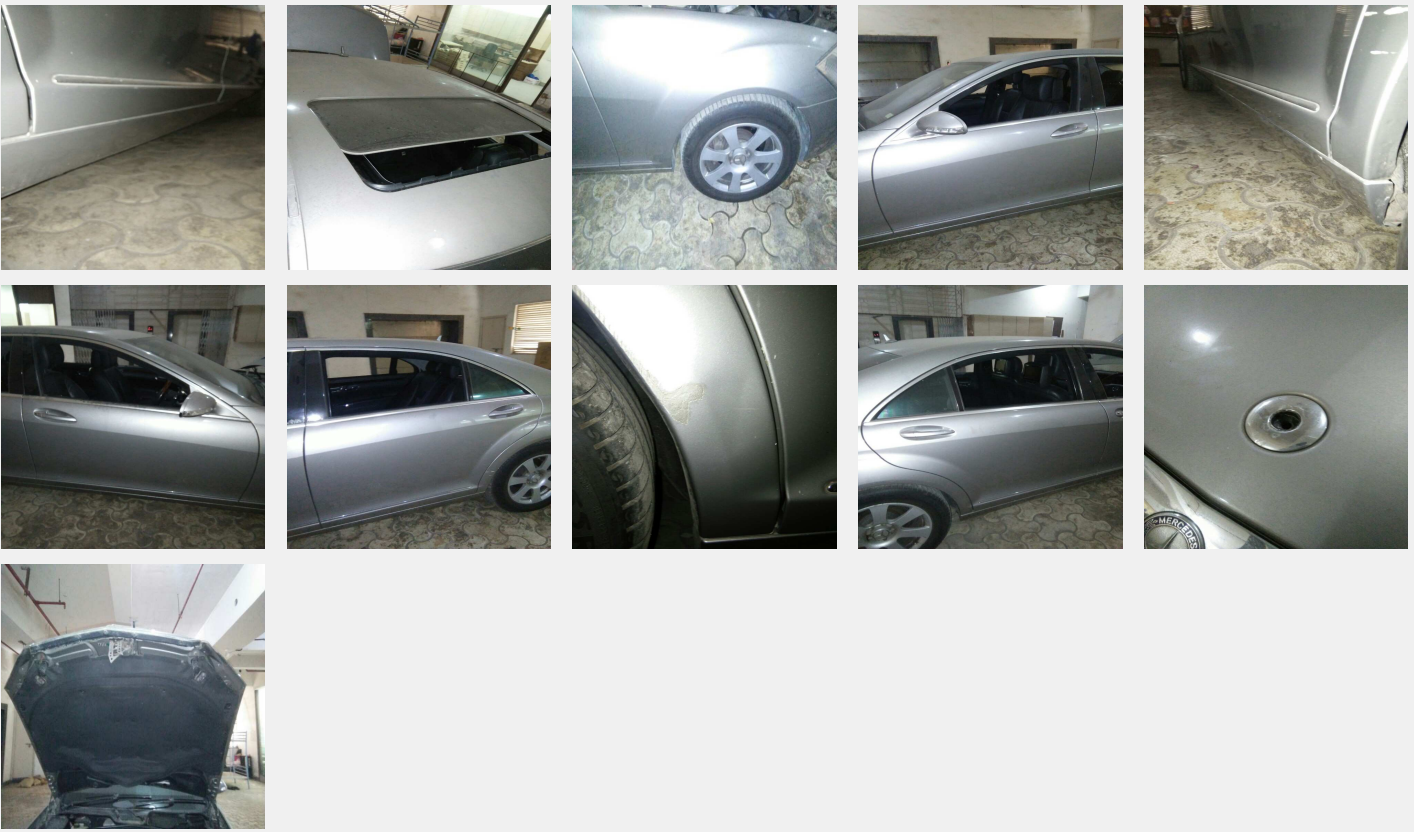
INSPECTION CHECKPOINTS	SCORE(X/10)	REMARKS/COMMENTS	OPTIONAL SPEND EST. (RS)
FRONT BUMPER	4	PAINTING REQUIRE	10000
HOOD	4	SYMBOL NOT AVAILABLE	25000
LH QUARTER PANEL	4	PAINTING REQUIRE	10000
REAR BUMPER	4	PAINTING REQUIRE	10000
RH QUARTER PANEL	4	PAINTING REQUIRE	10000

NEED ATTENTION ⚠️

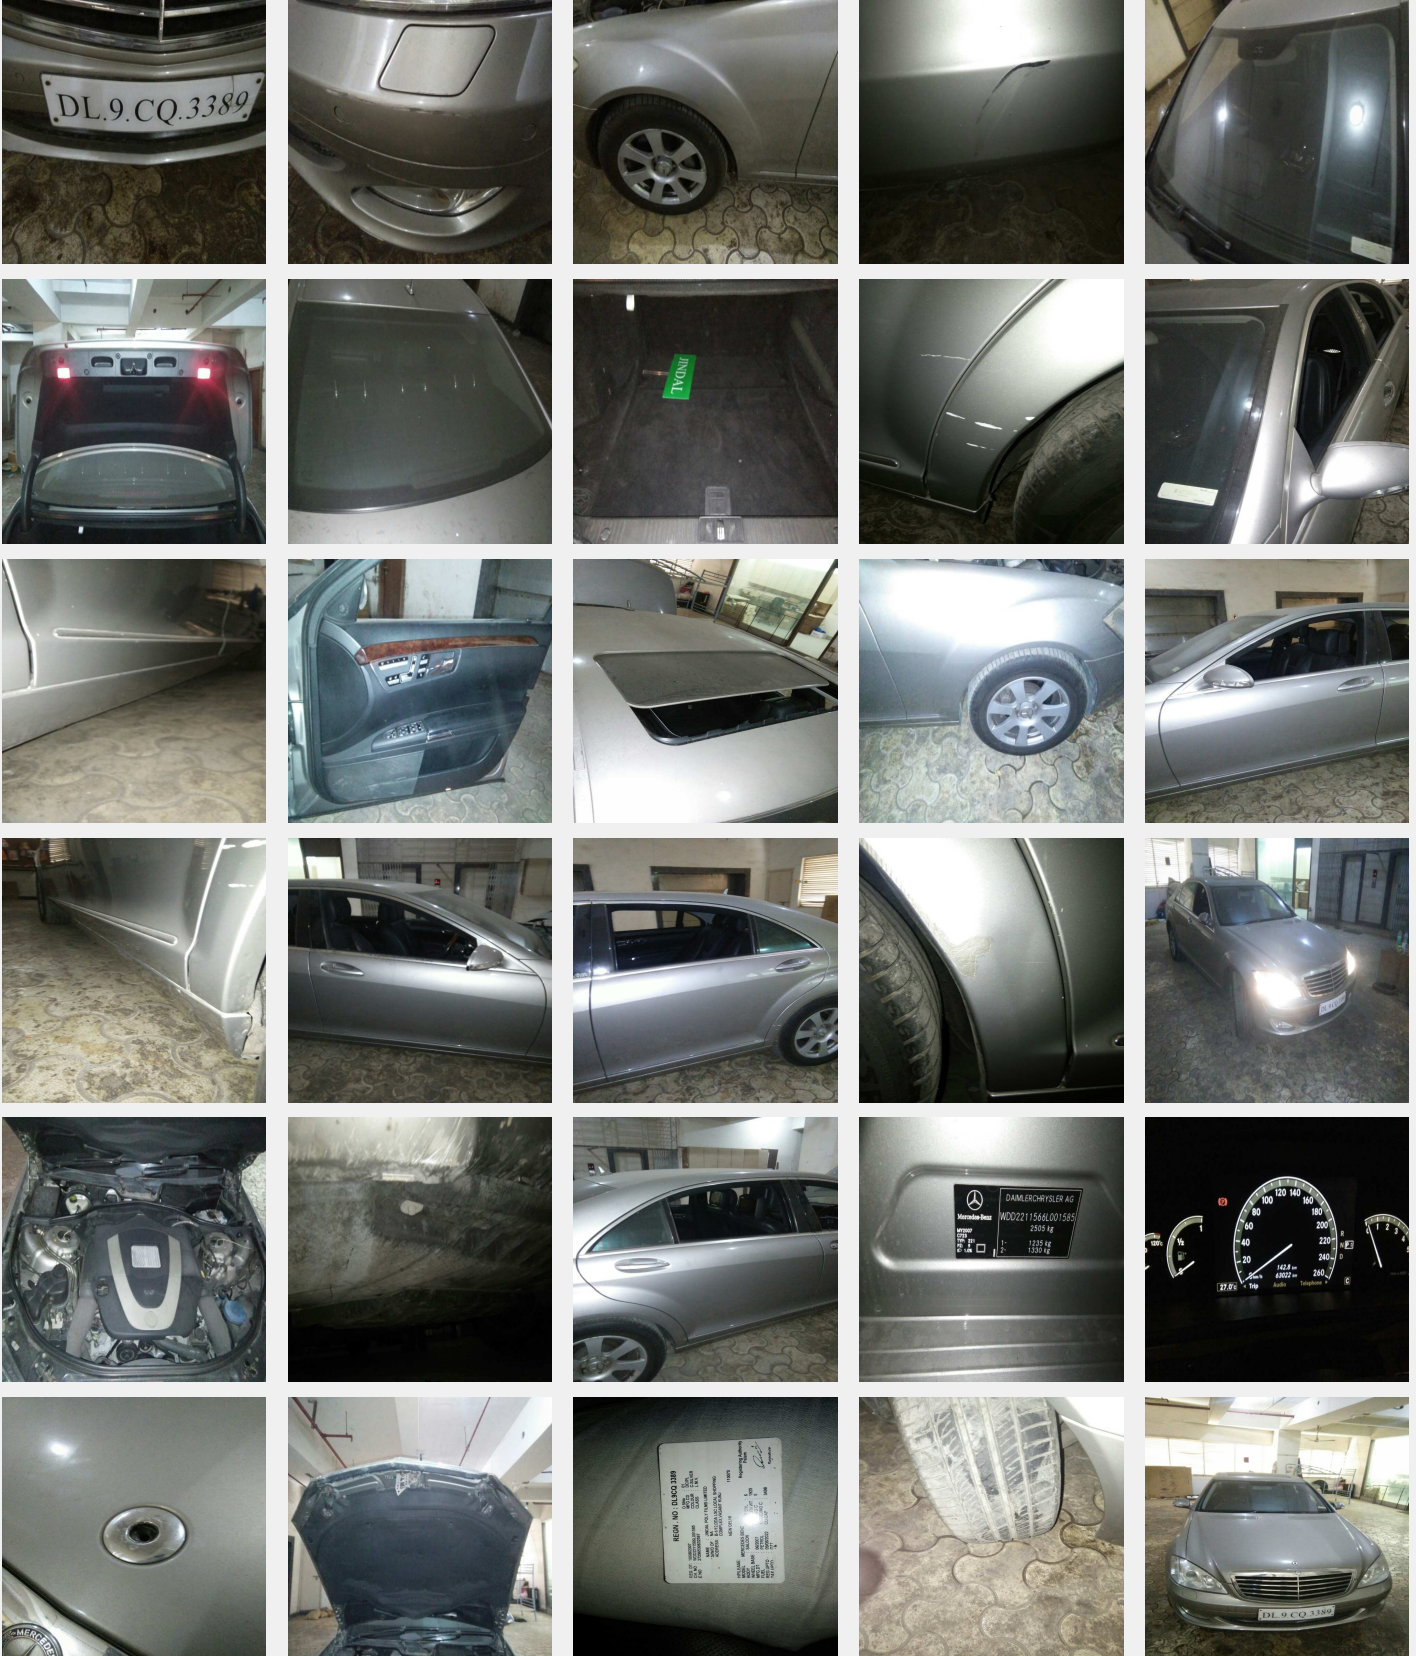
acceptable condition car but engine oil leak. repair cost 1,00,000
